Shop-Fabricated Aboveground Storage Tank Inspections – Expect the Unexpected...

Mott-Smith Consulting Group, LLC

Marshall T. Mott-Smith, President Mott-Smith Consulting Group, LLC

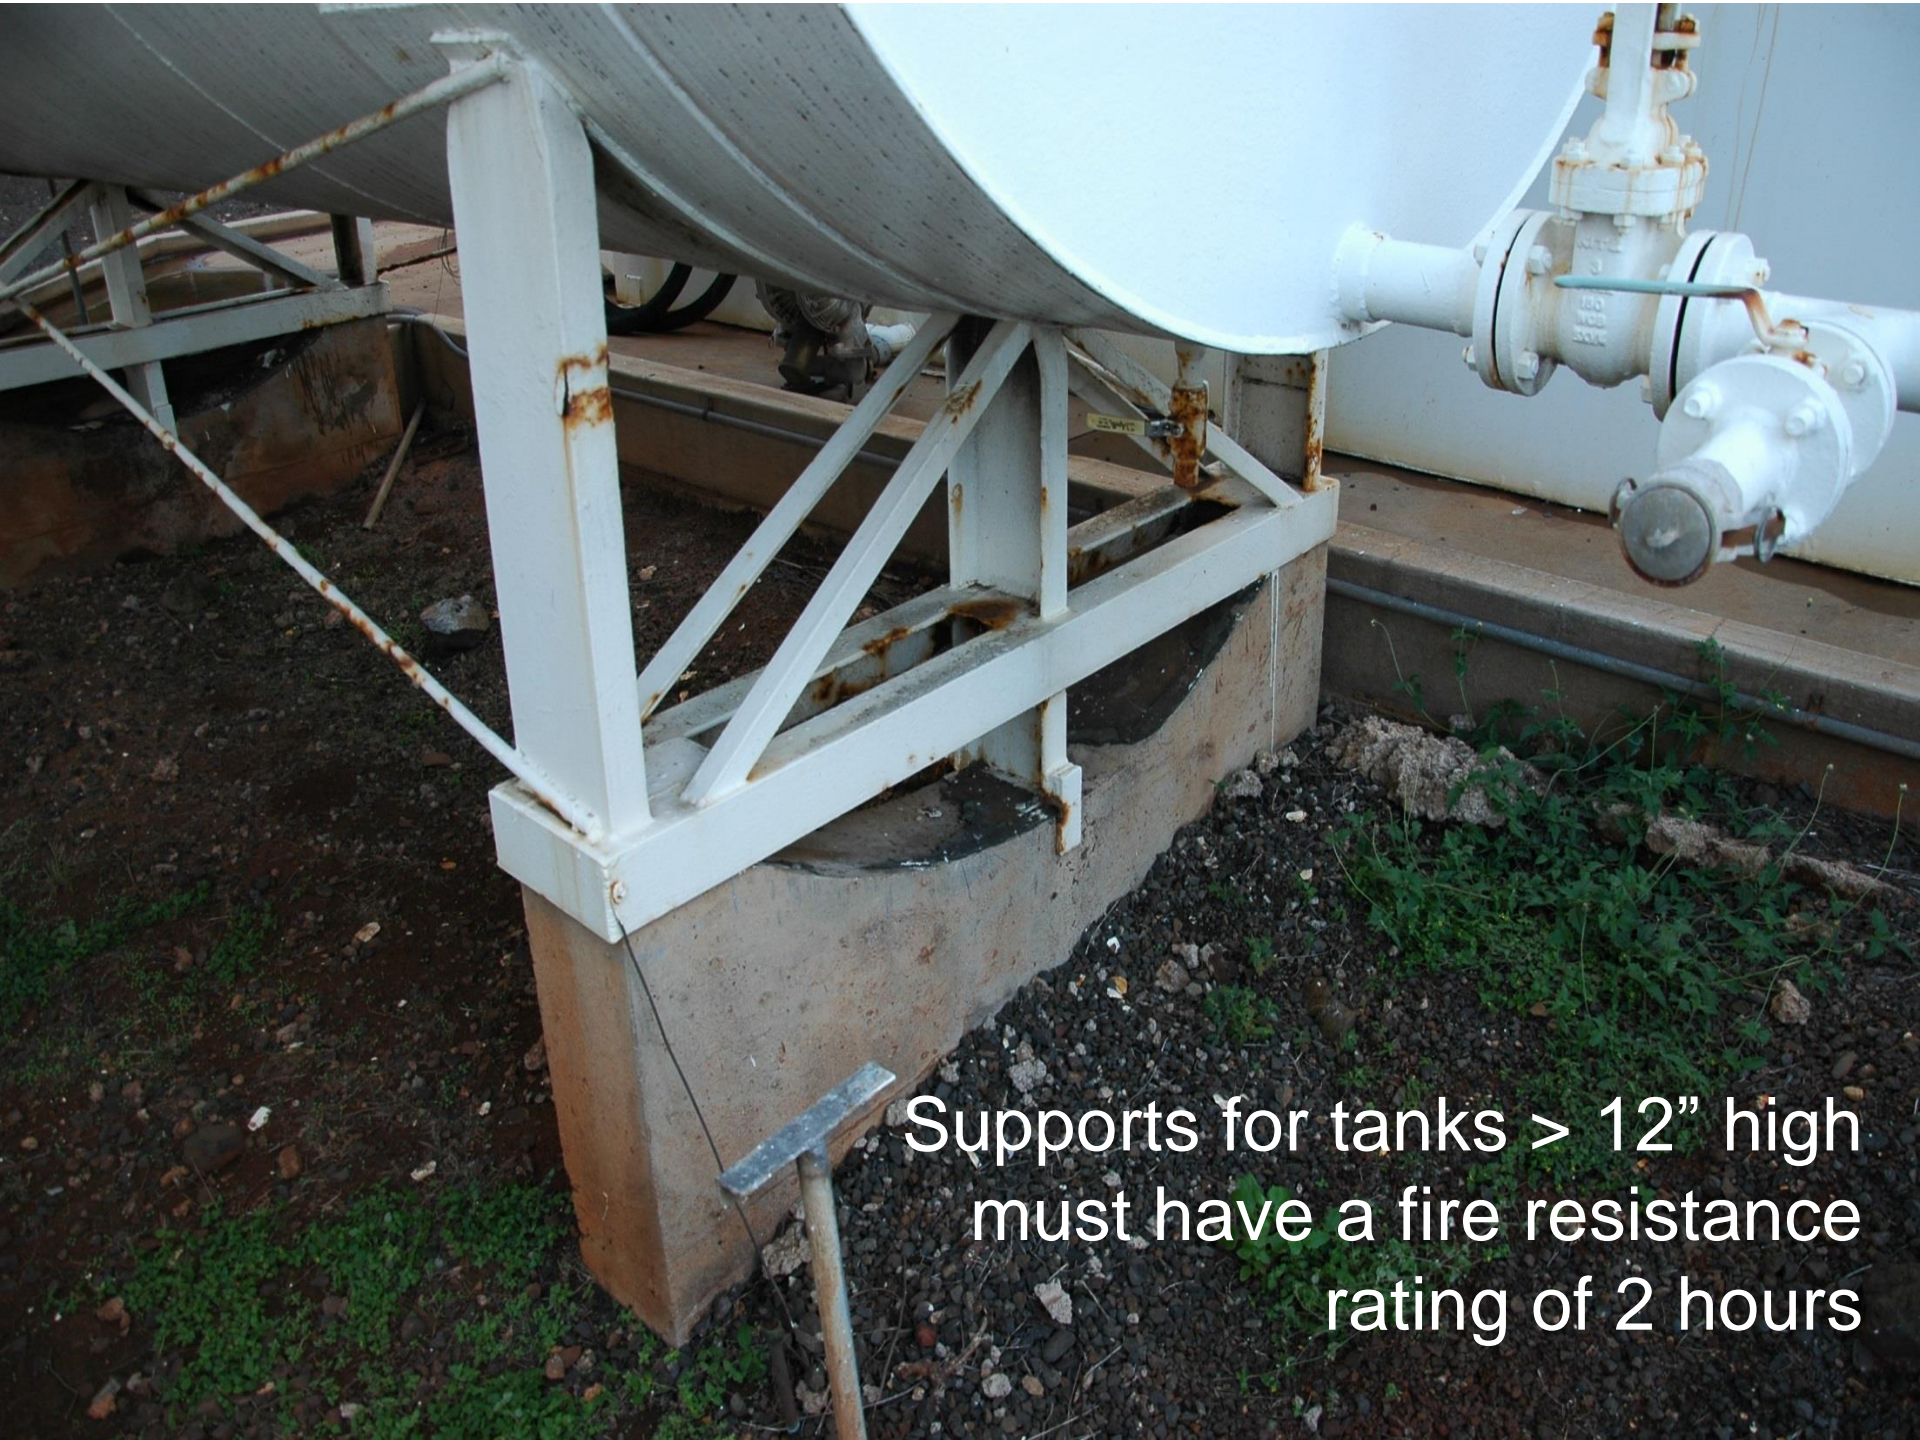
Supports for tanks > 12" high
must have a fire resistance
rating of 2 hours

What's Wrong with these Tanks?

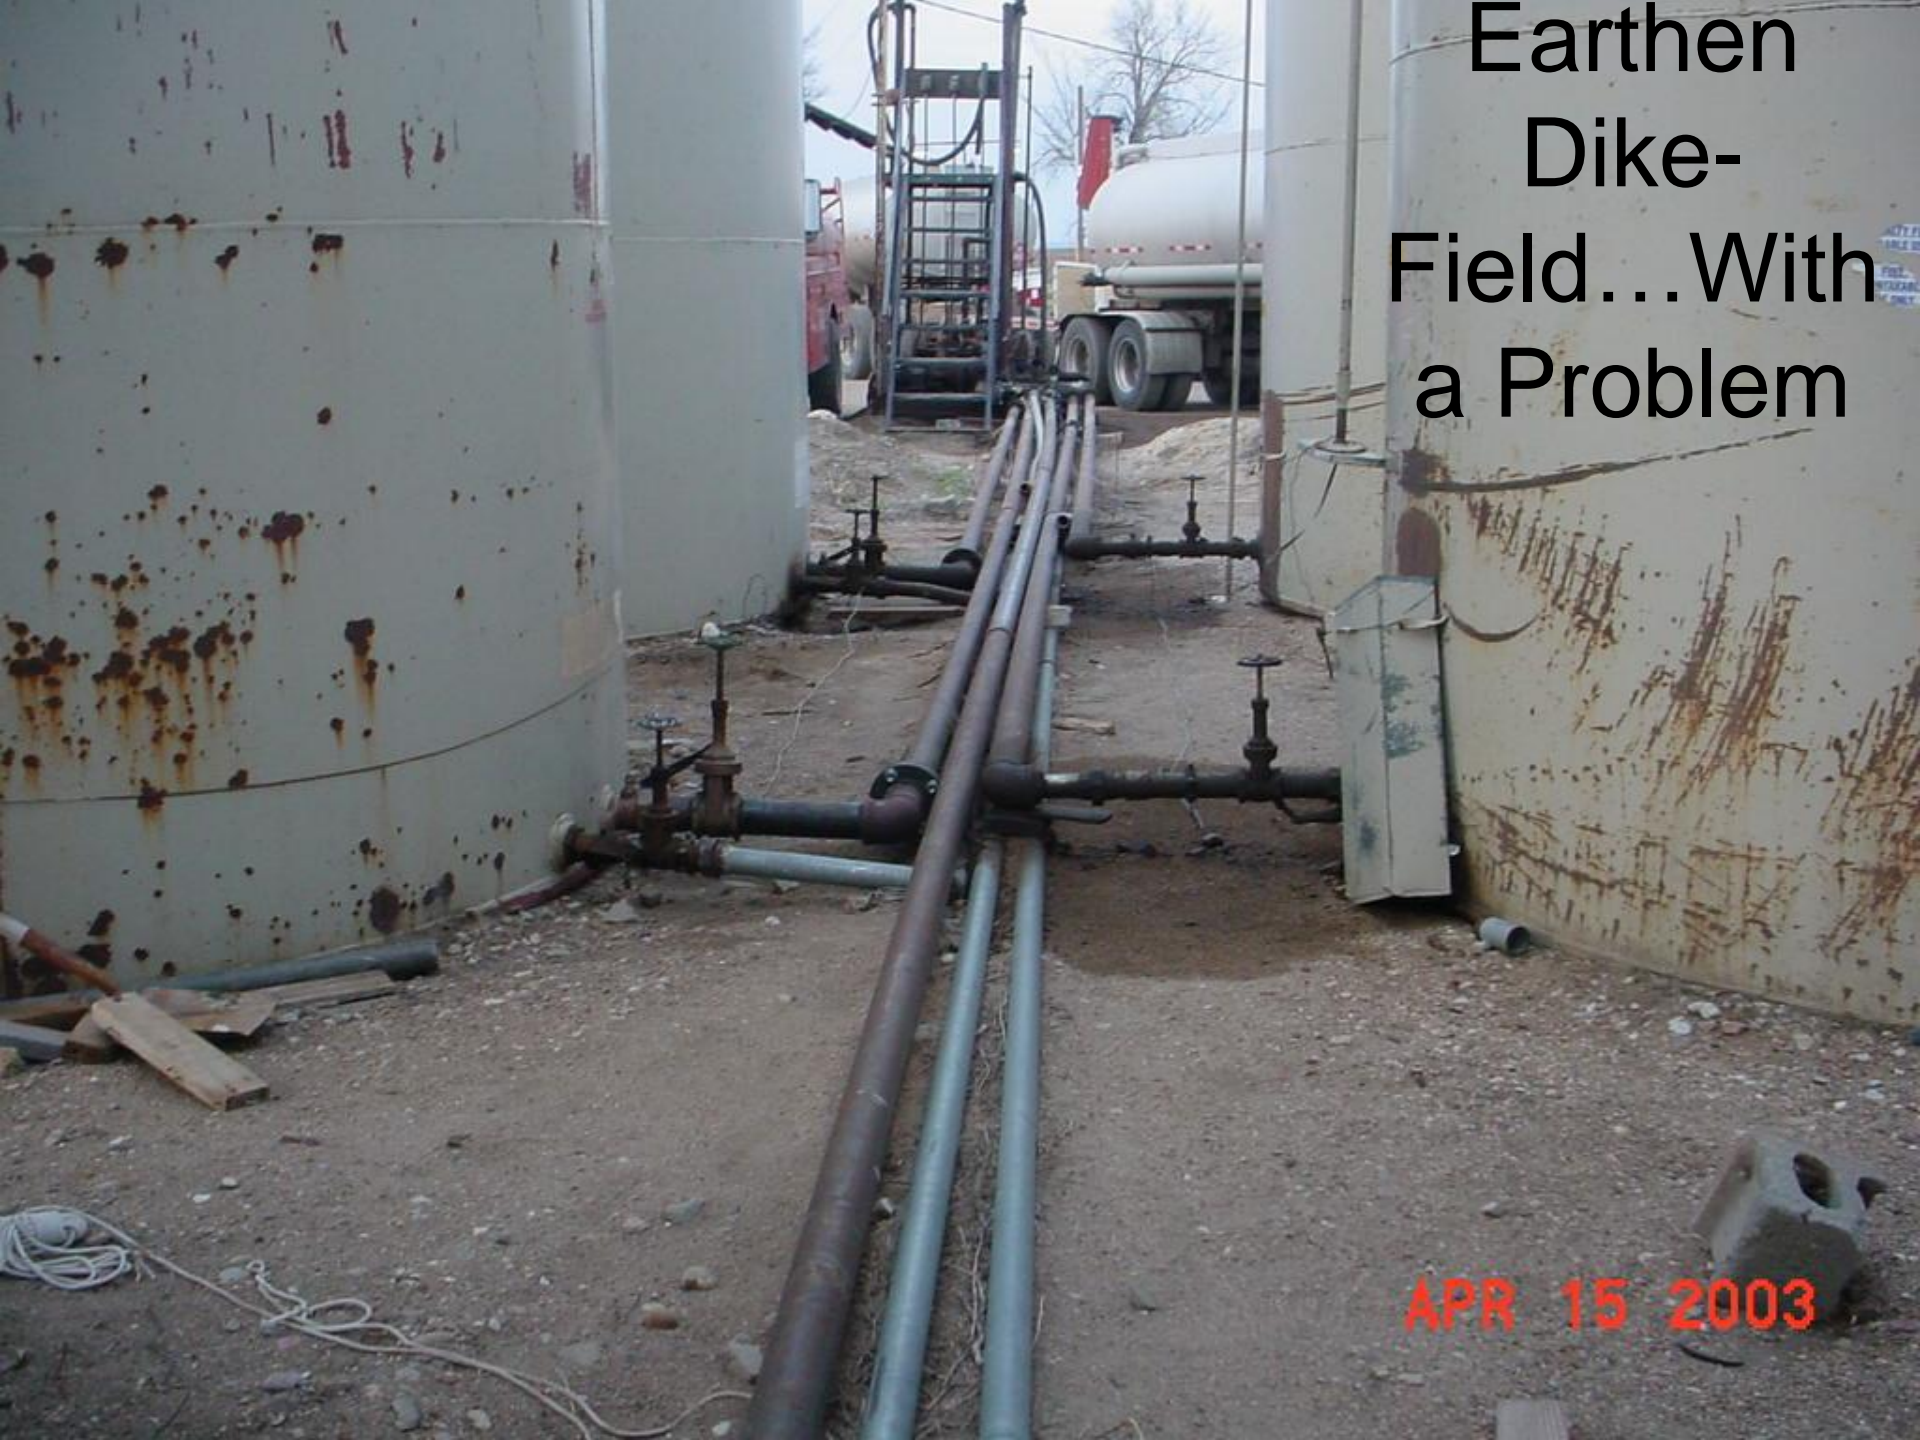
Earthen Dike- Field...With a Problem

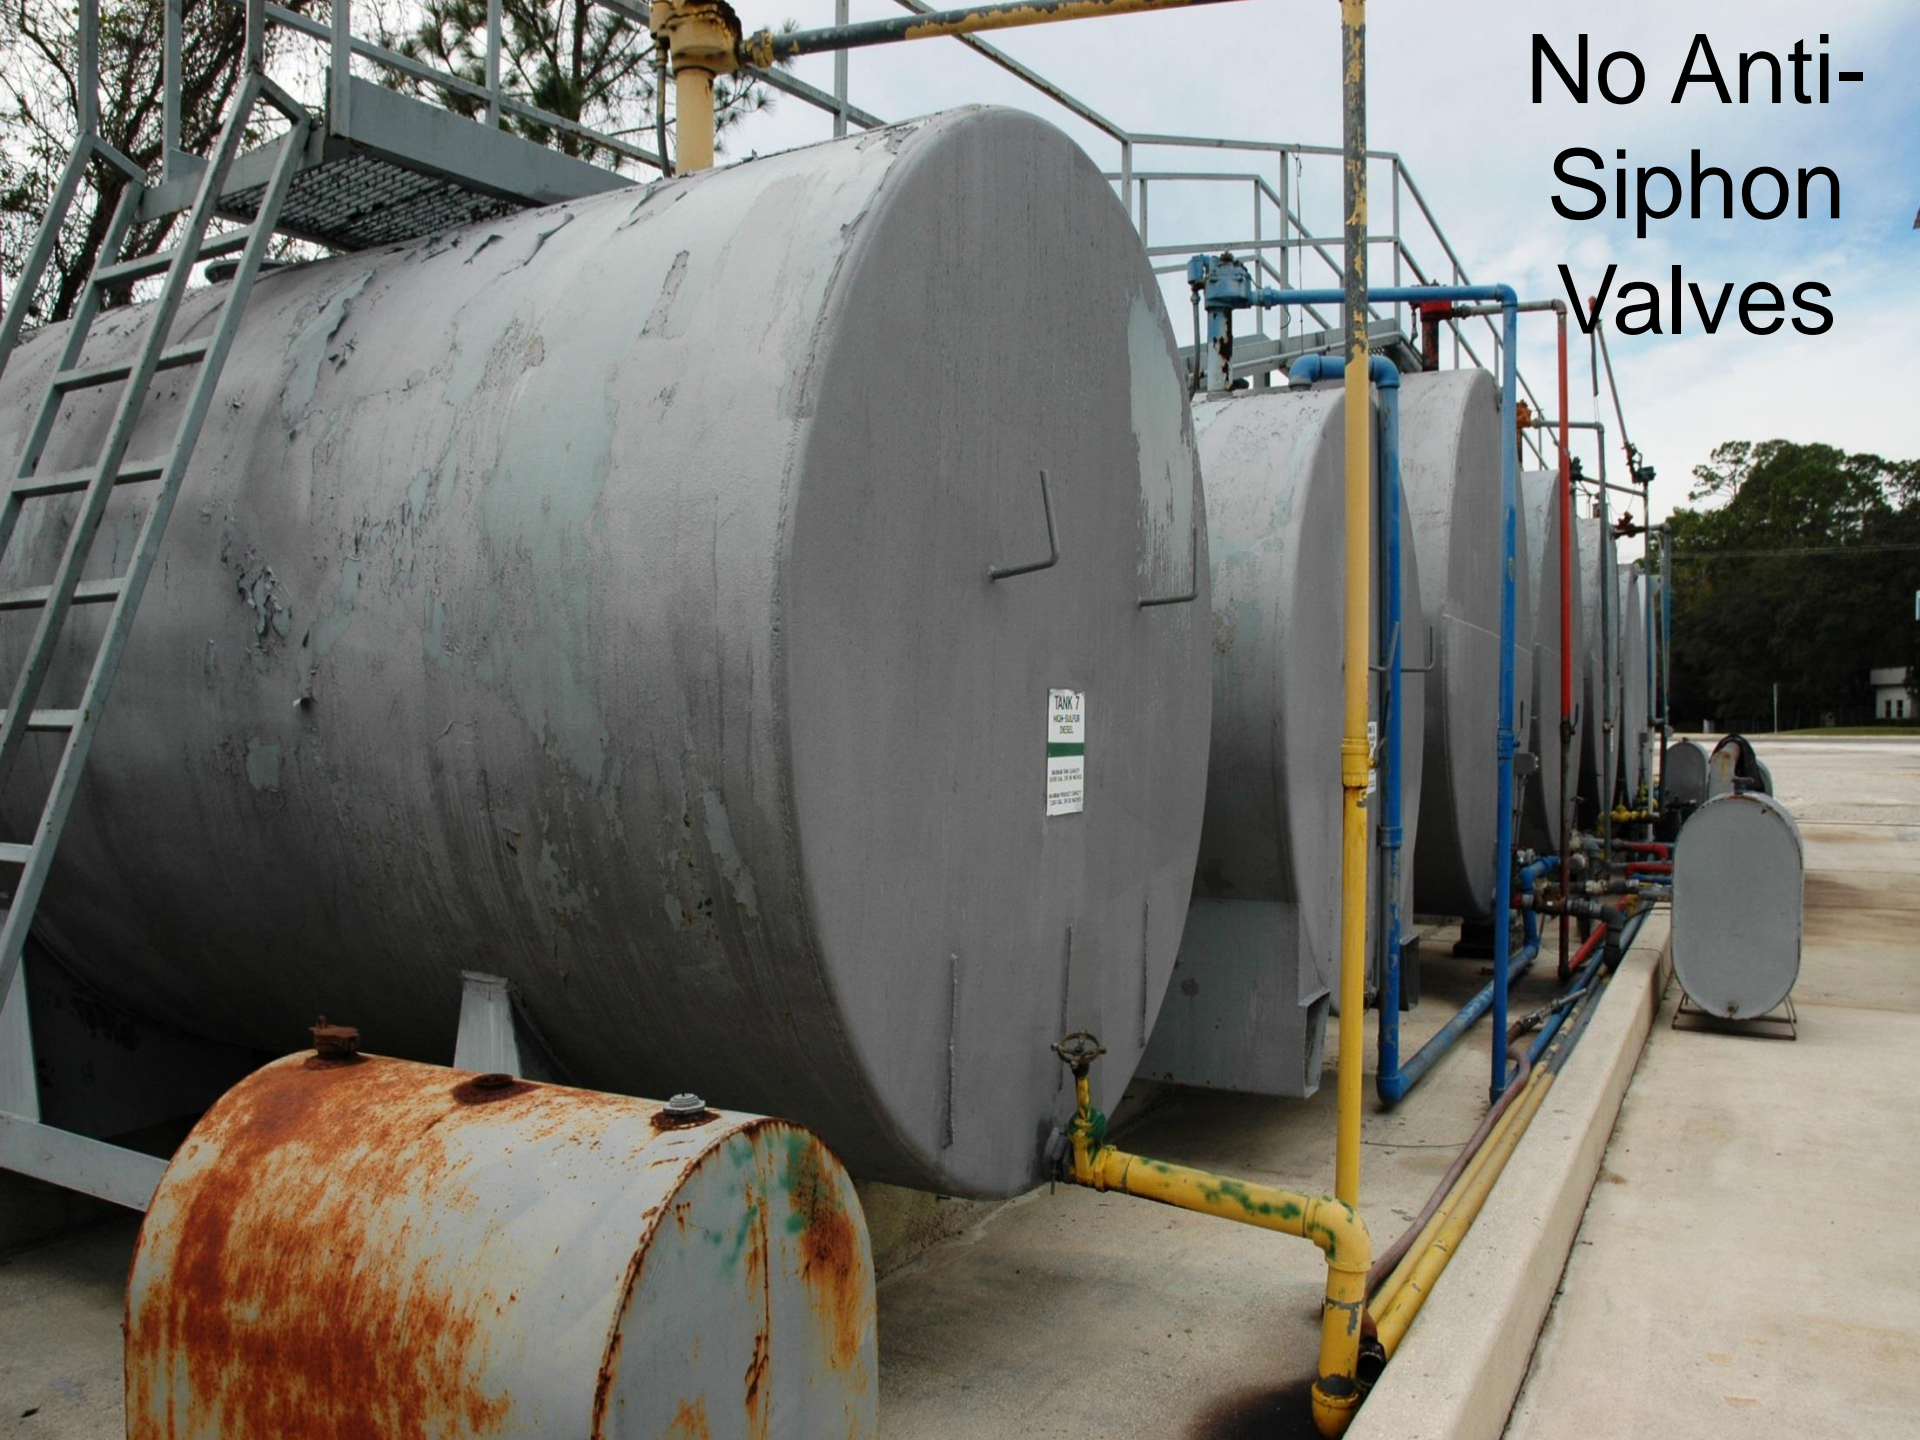
No Anti-Siphon Valves

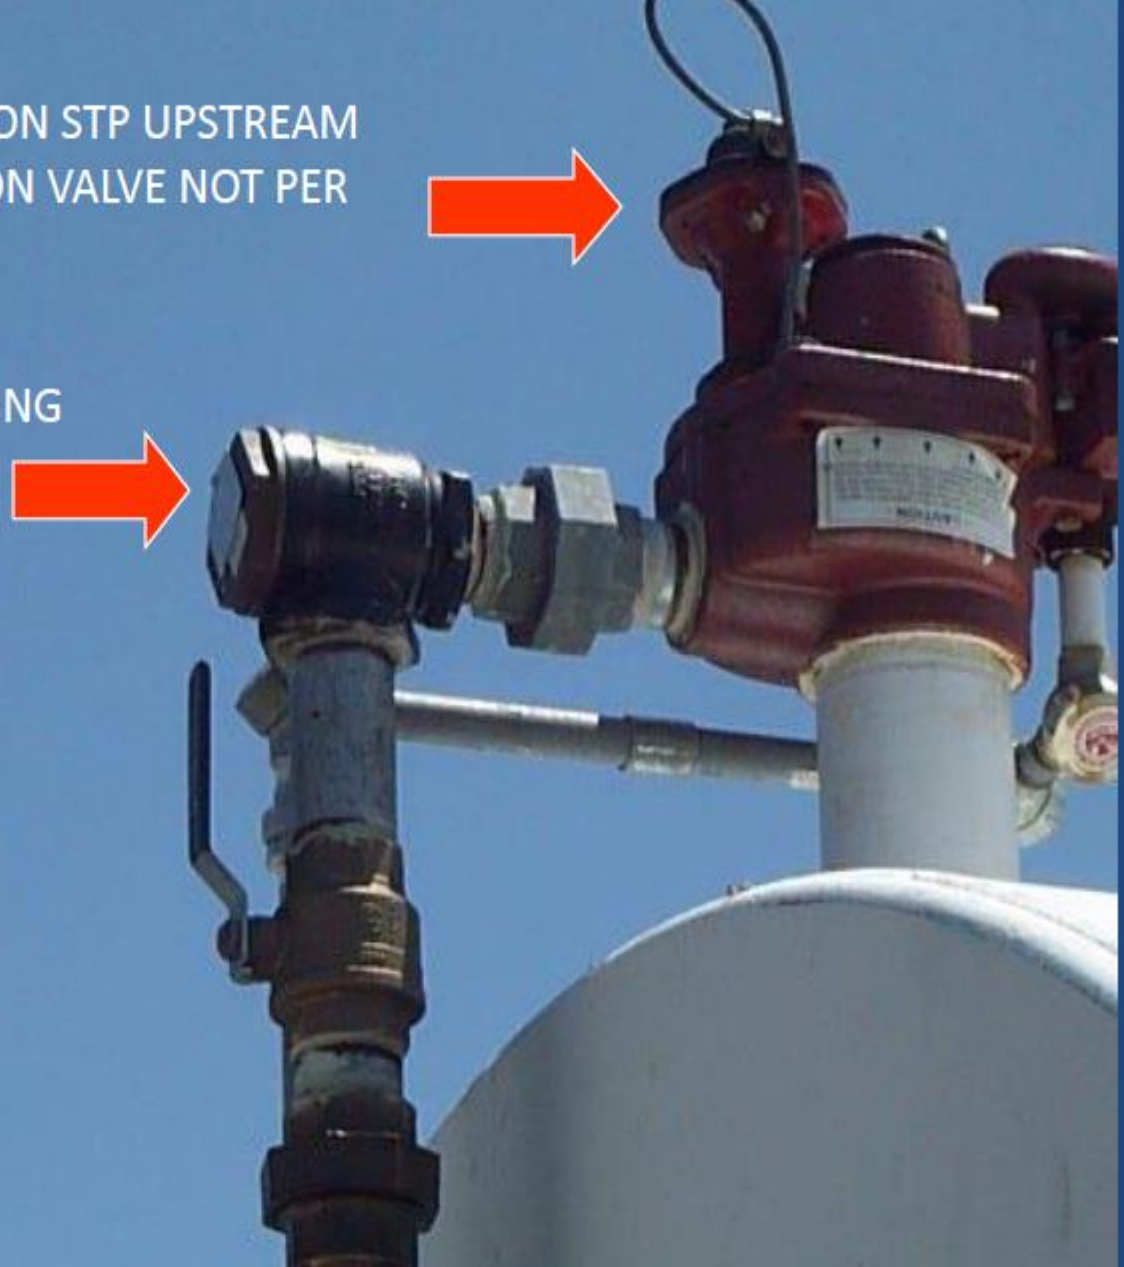
MLLD INSTALLED ON STP UPSTREAM
FROM ANTI SIPHON VALVE NOT PER
PEI/RP 200-96.

Line-Leak Detector installed incorrectly upstream

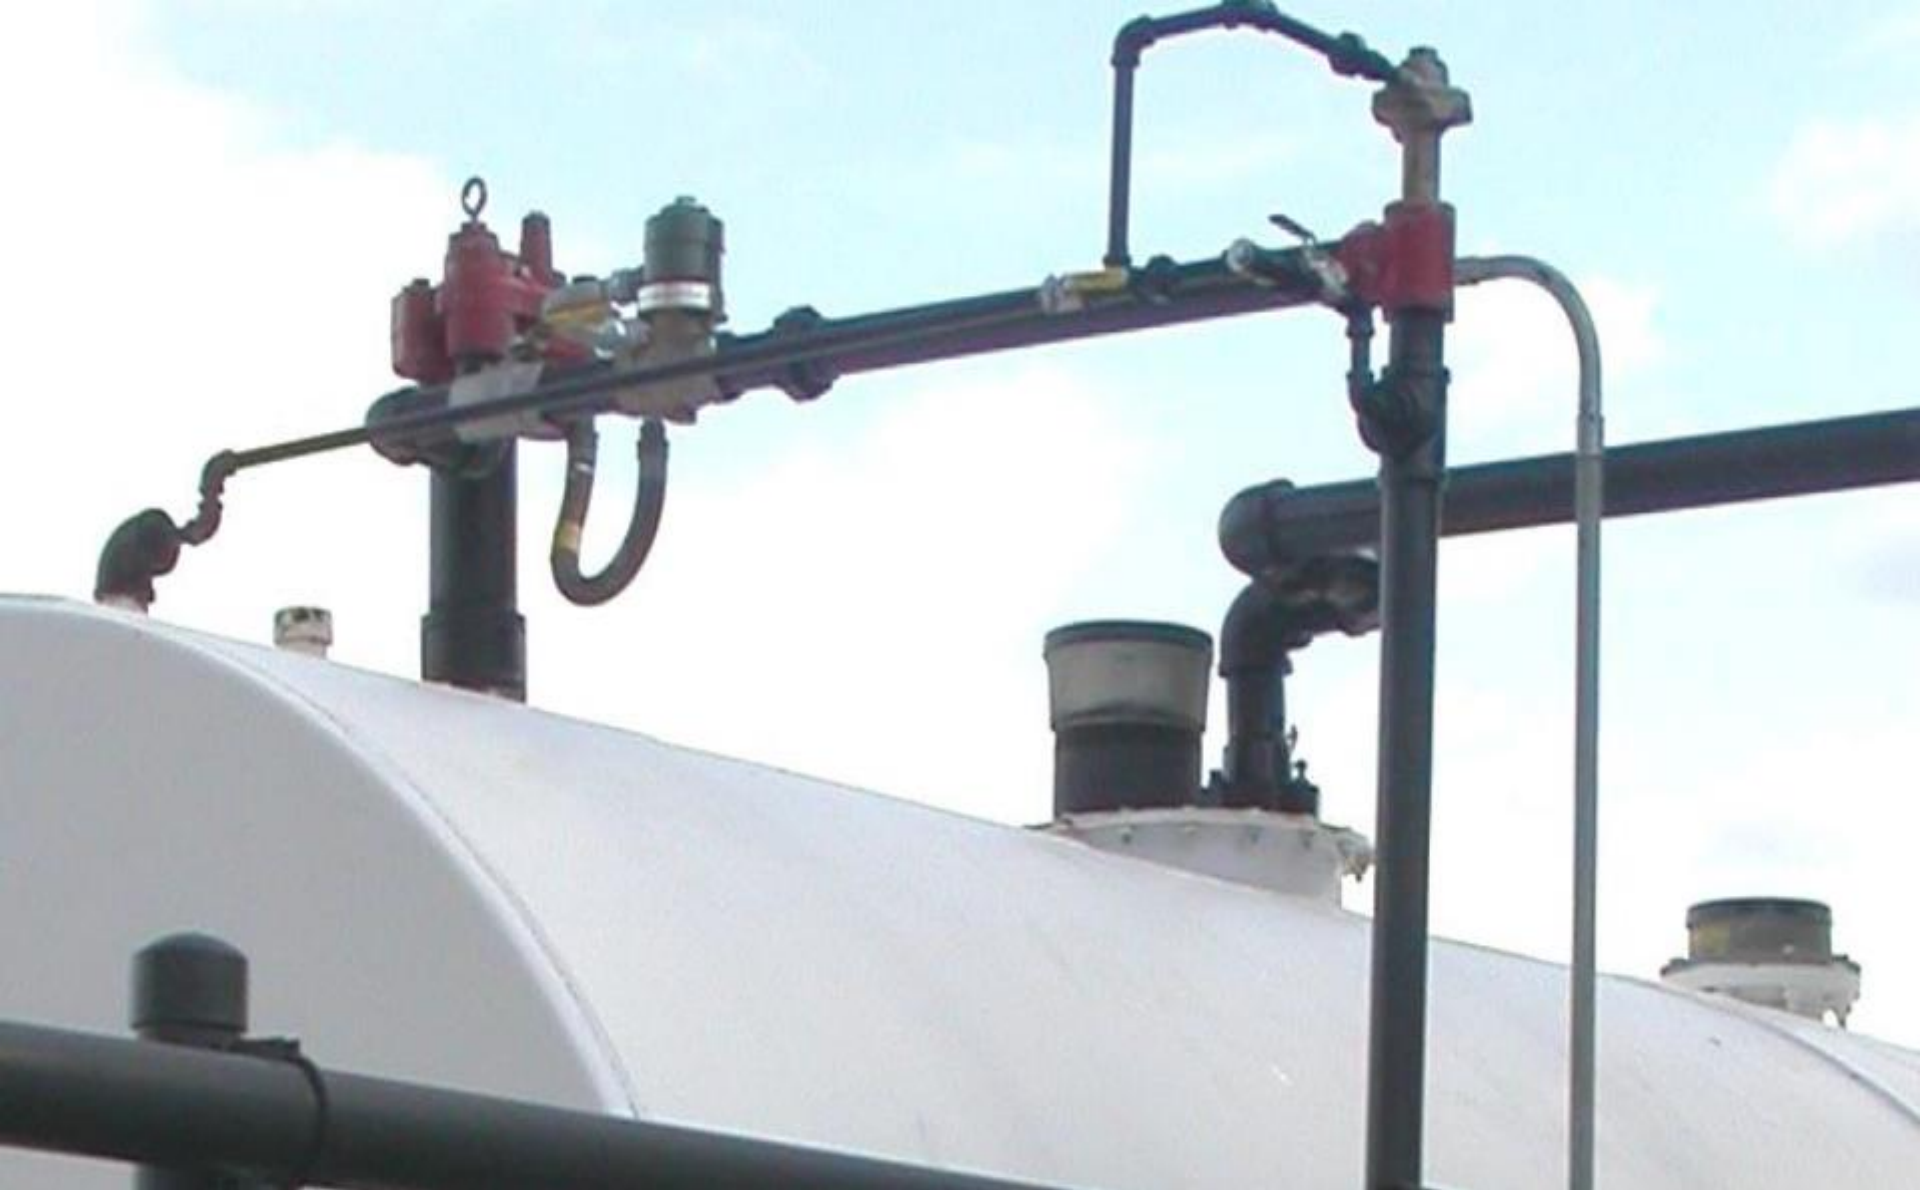
Line-Leak Detector installed correctly
here...

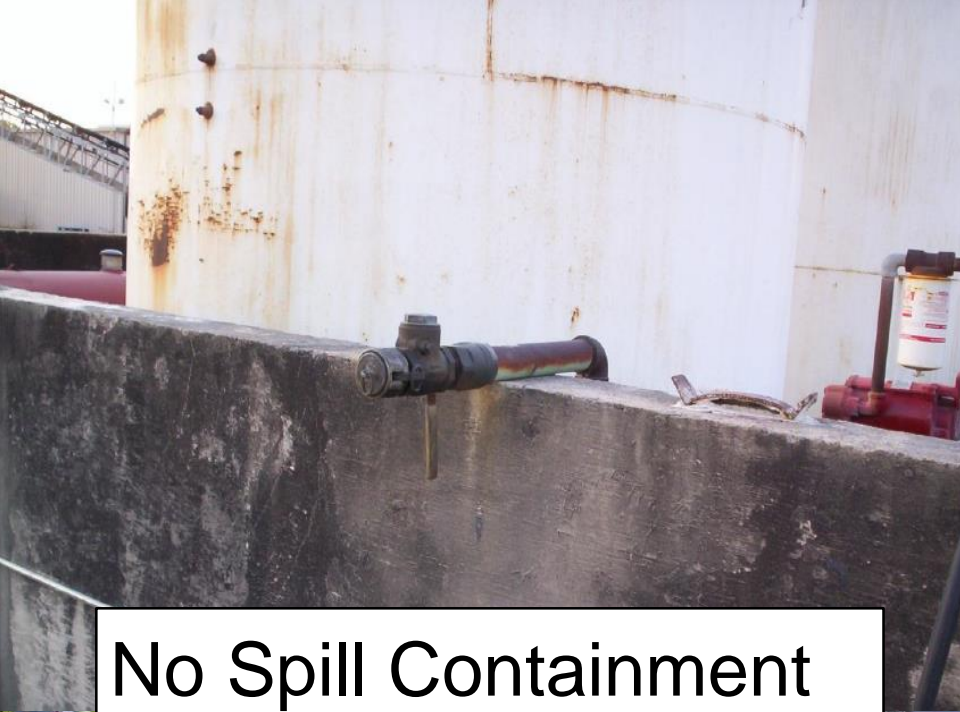
No Spill Containment

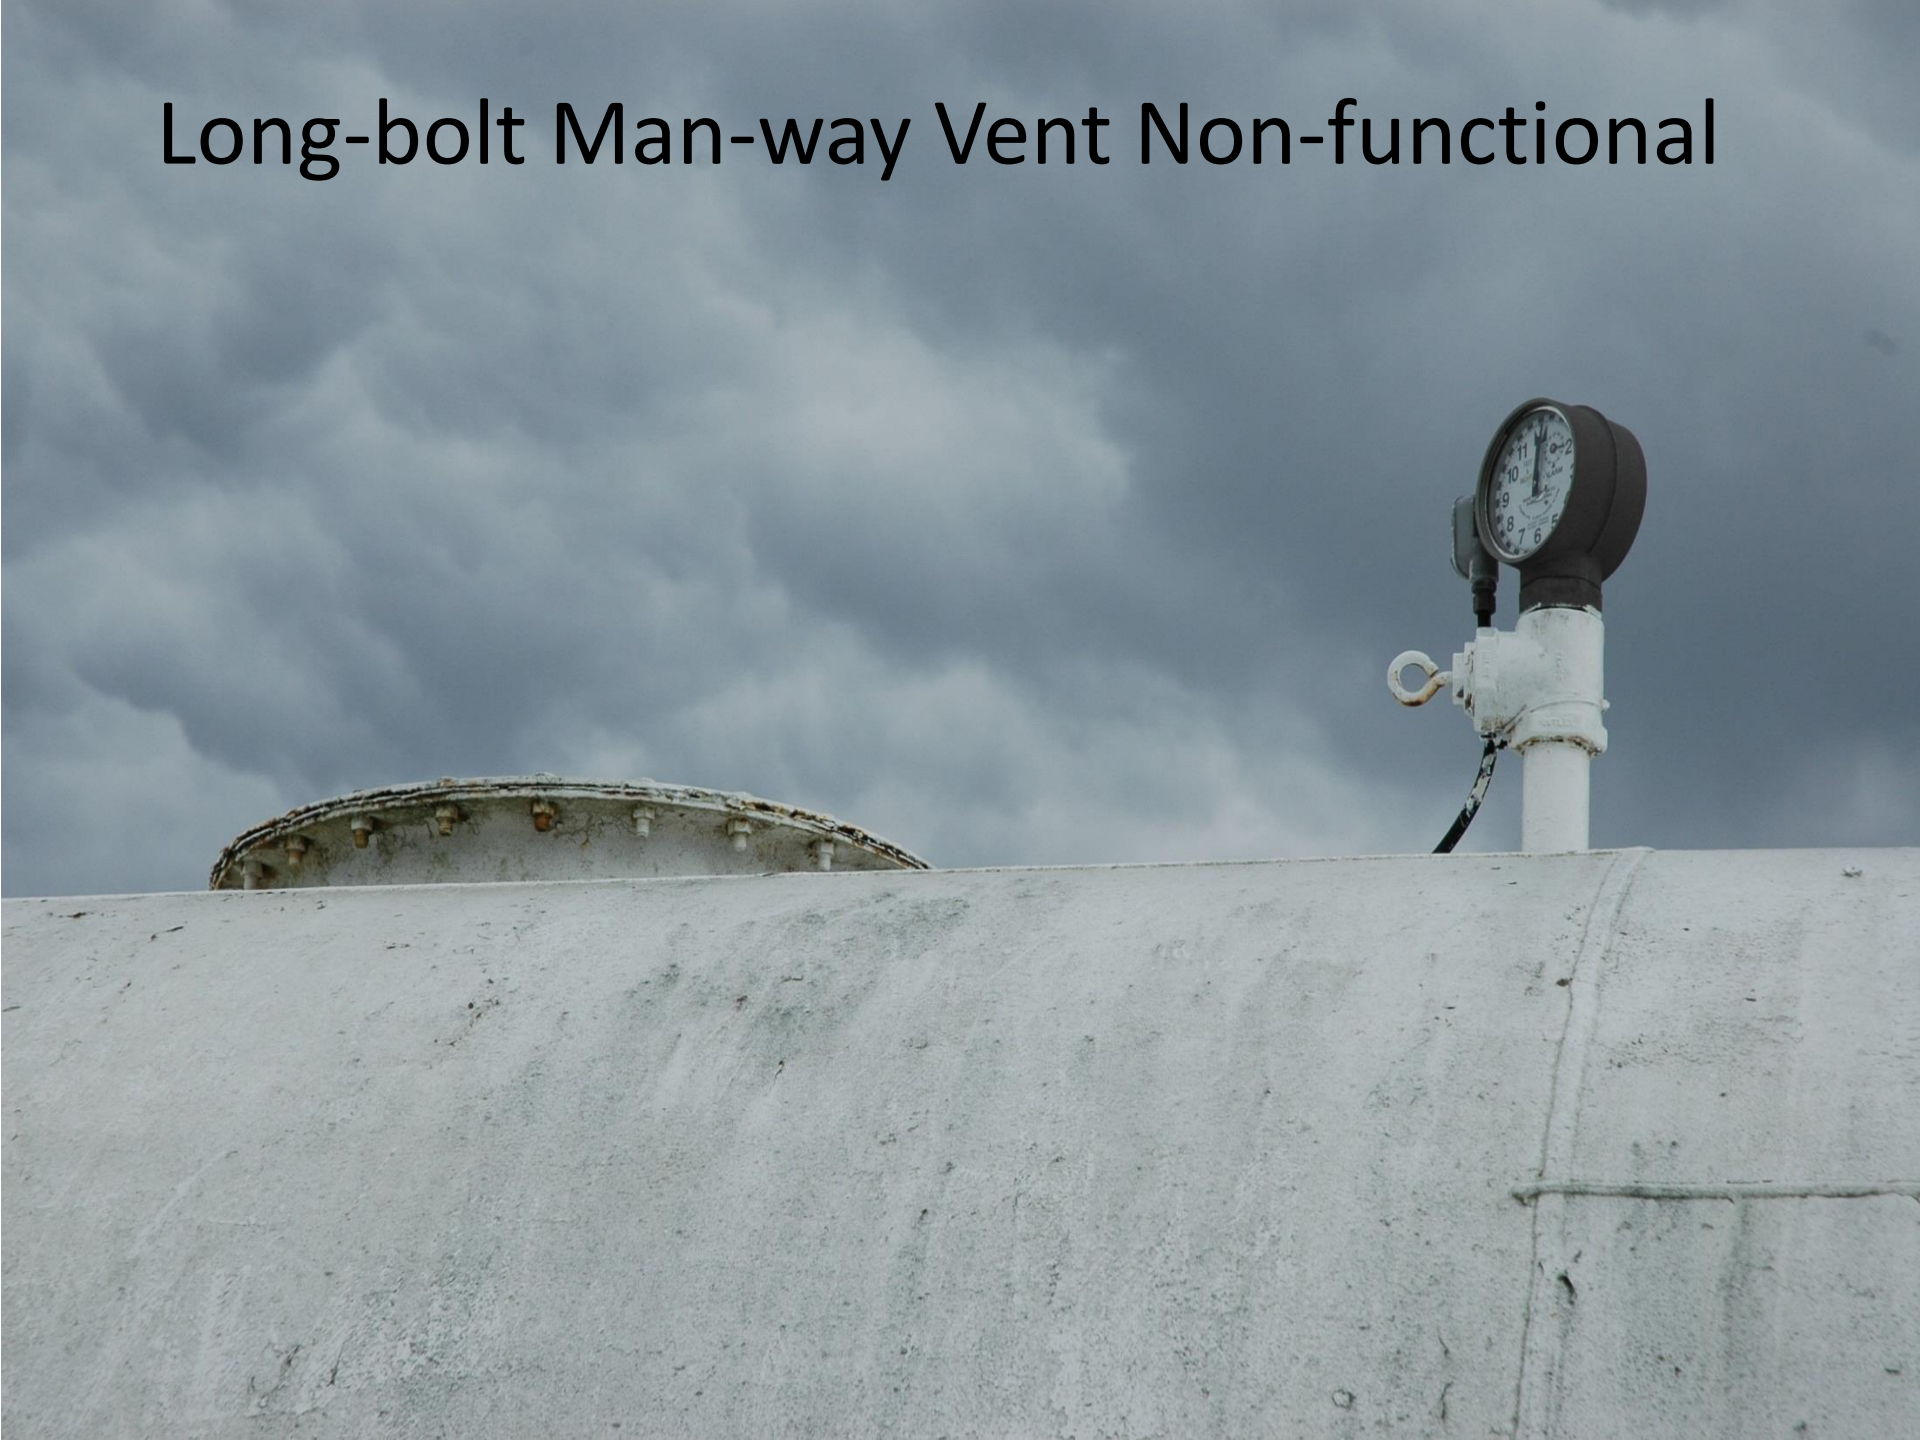
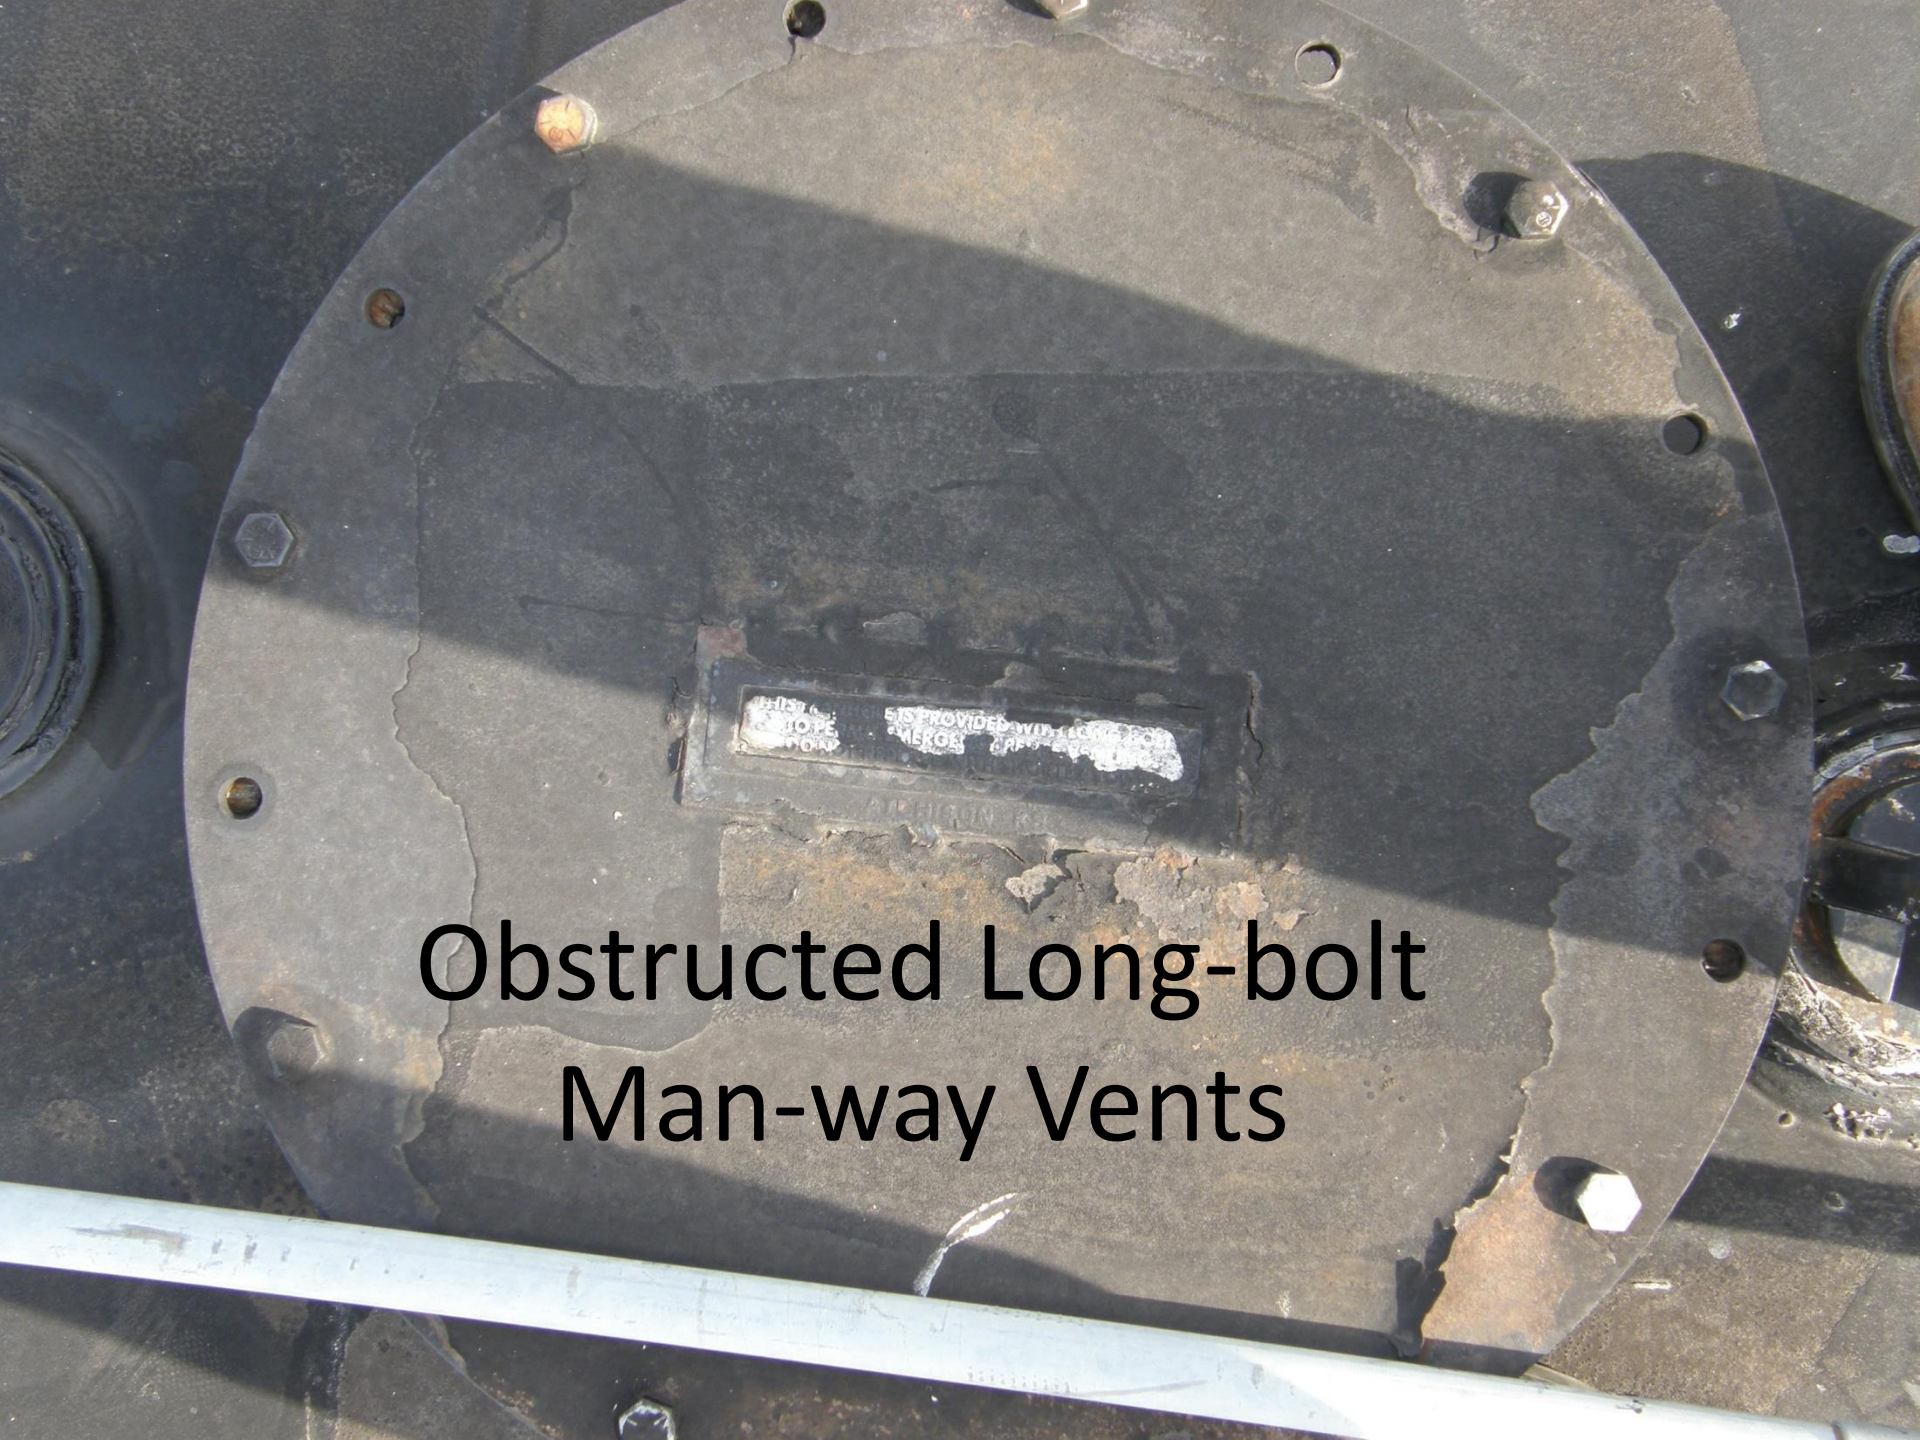
Long-bolt Man-way Vent Non-functional

Obstructed Long-bolt
Man-way Vents

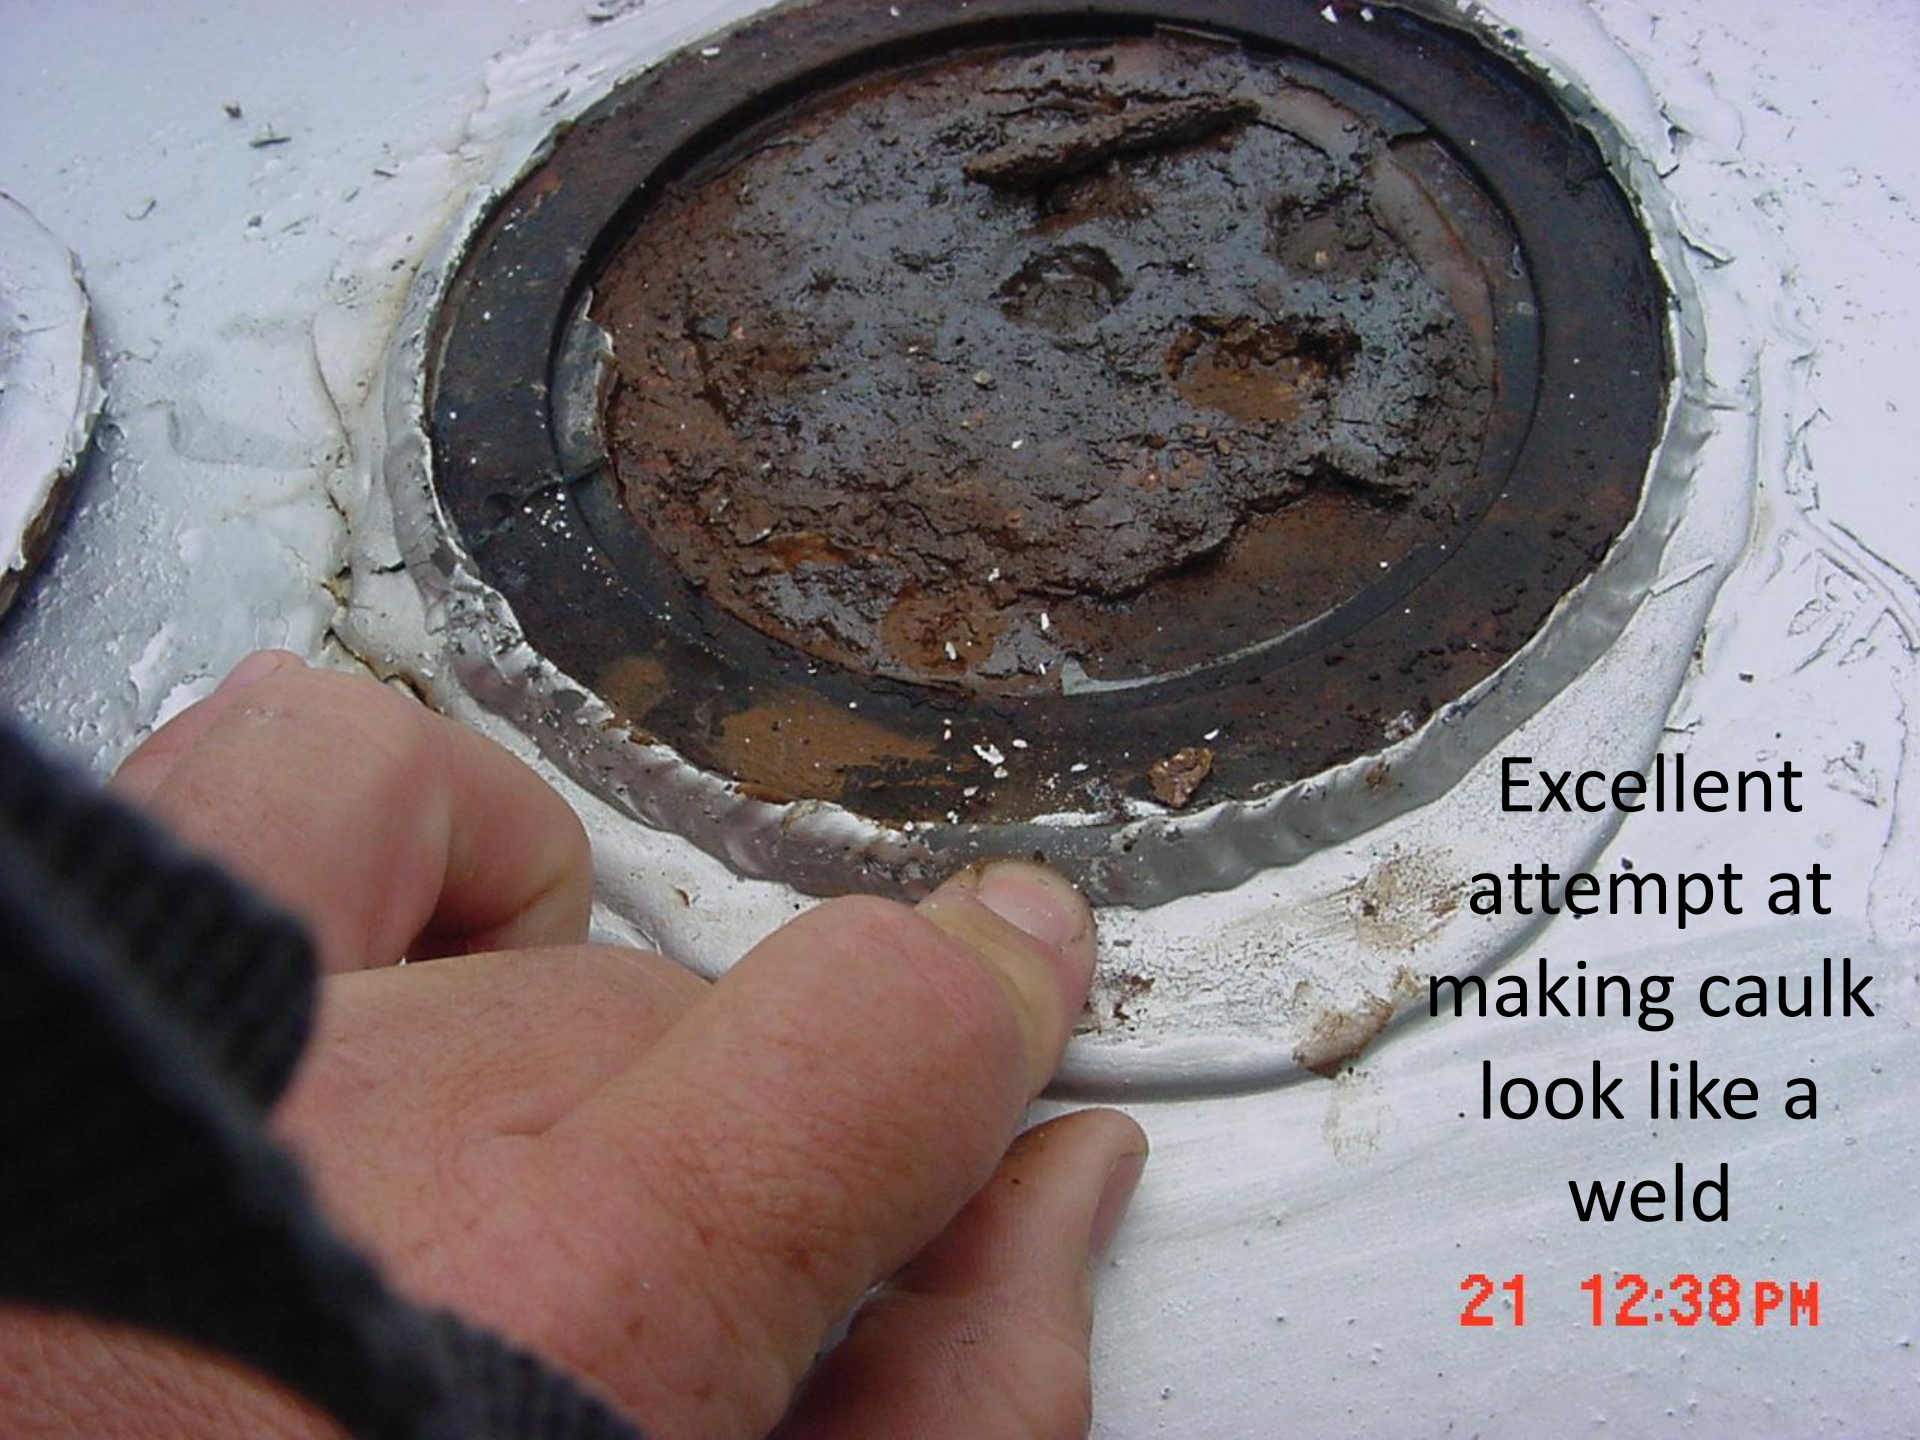
Excellent
attempt at
making caulk
look like a
weld

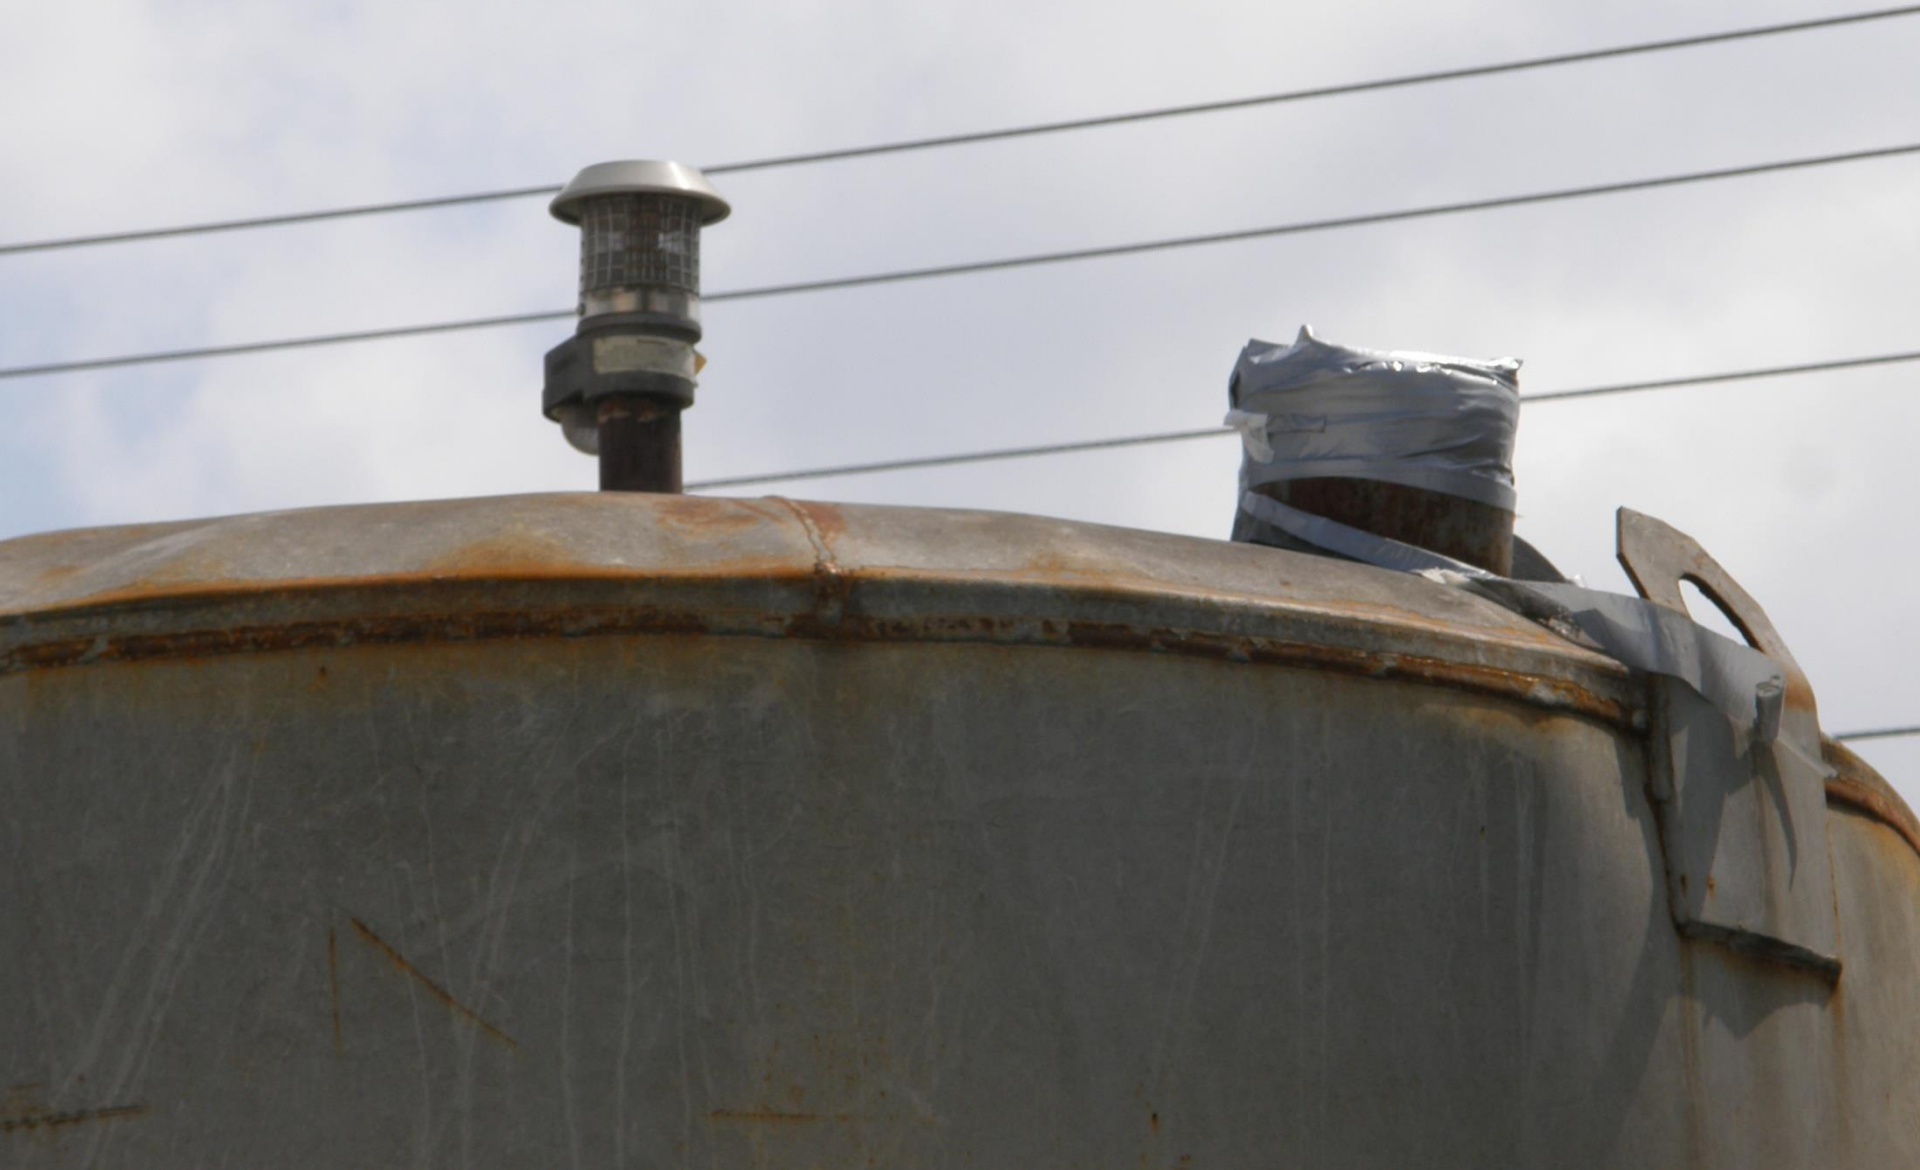
Duct tape E-vents must be replaced every 30 days unless clearly marked “industrial grade”
