Shop-Fabricated Aboveground Storage Tank Inspections – Expect the Unexpected...

Mott-Smith Consulting Group, LLC

Marshall T. Mott-Smith, President Mott-Smith Consulting Group, LLC

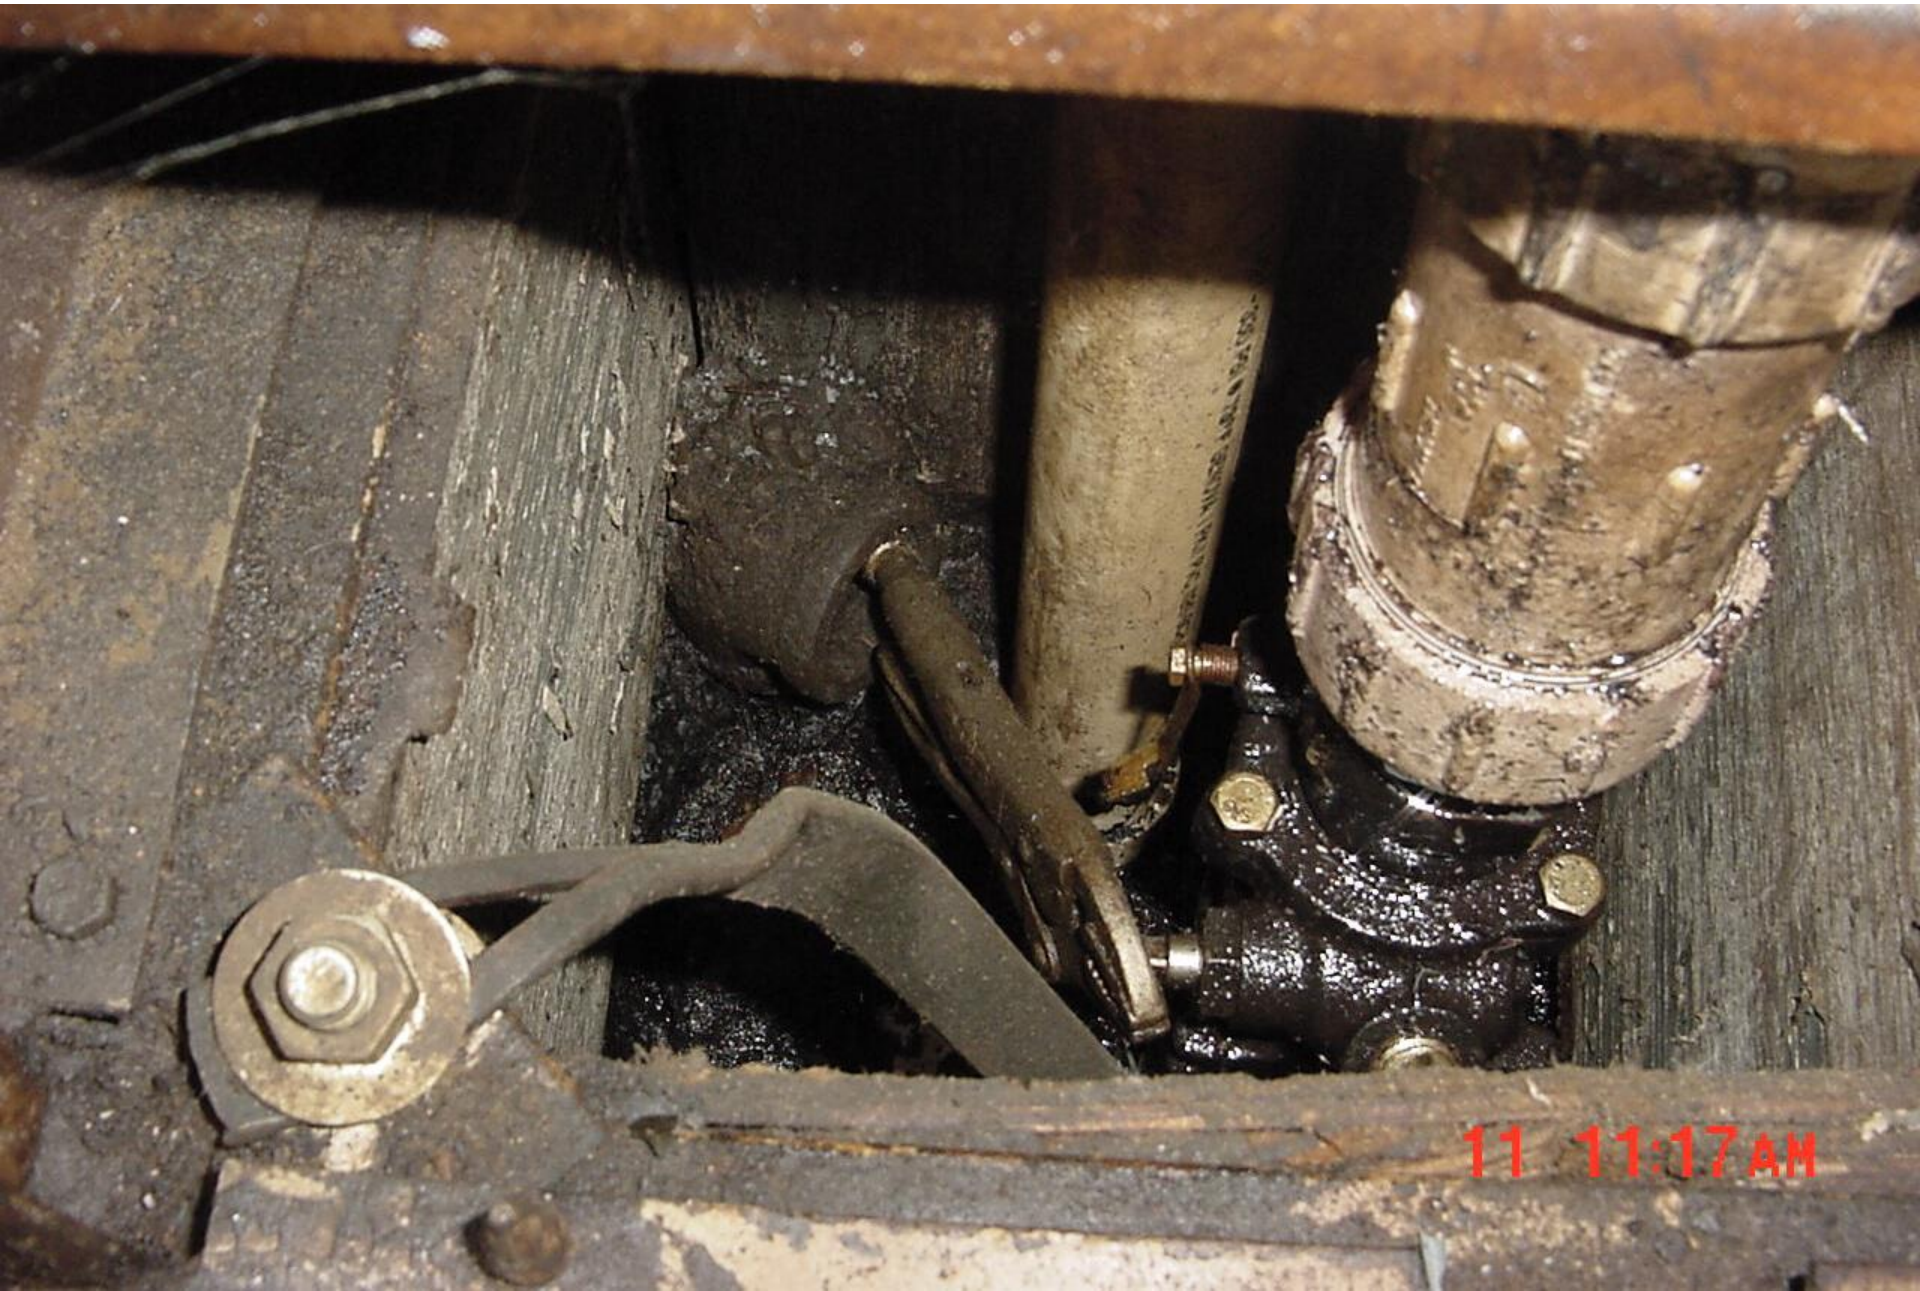
Shear valves required with a pressurized system

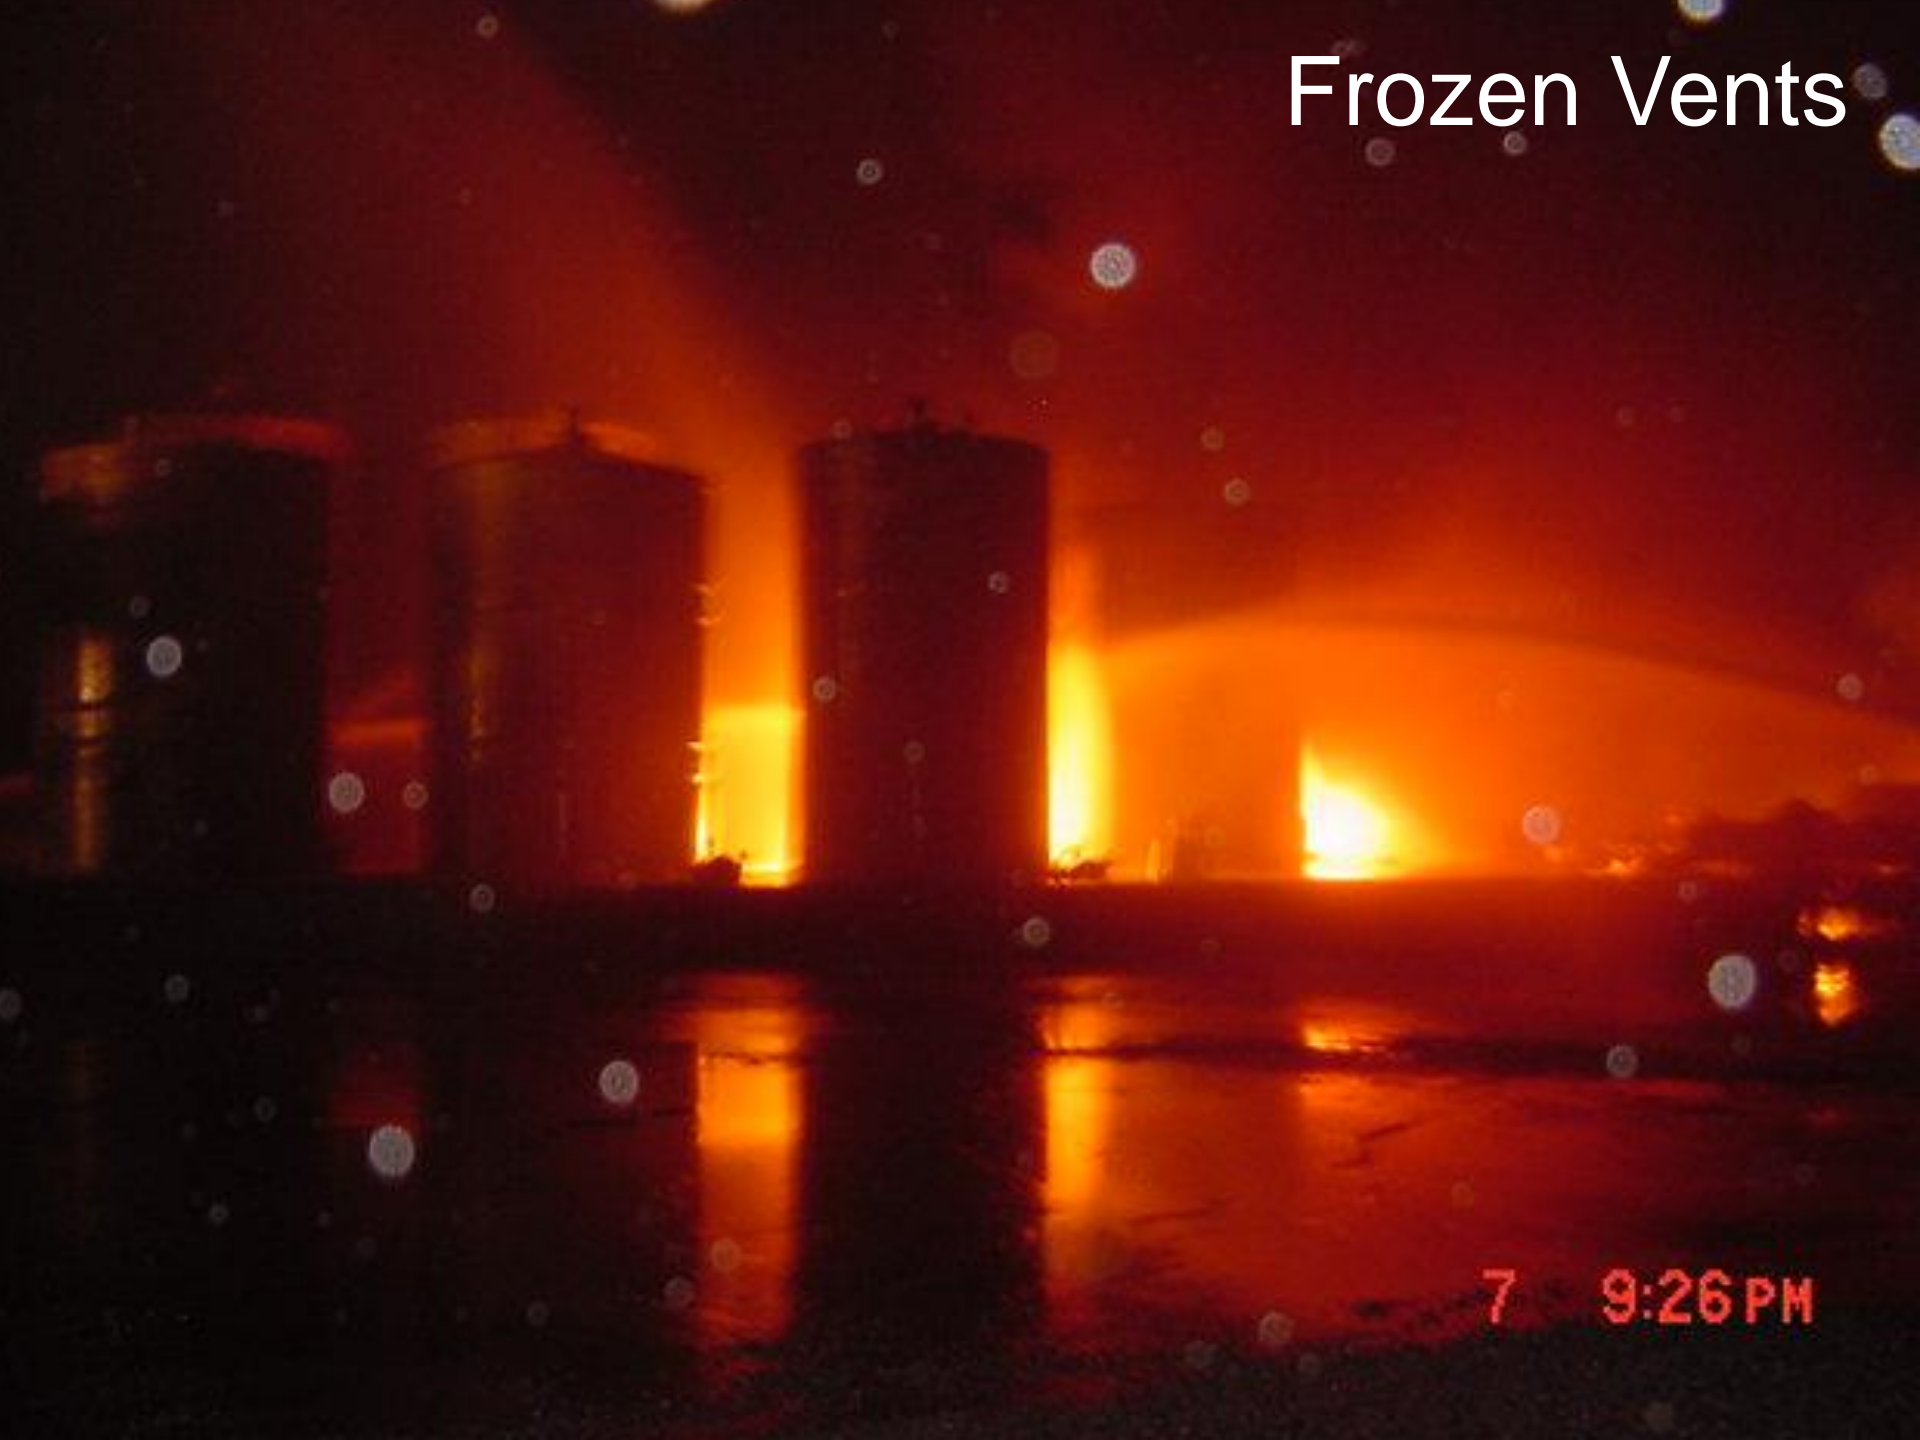
Frozen Vents

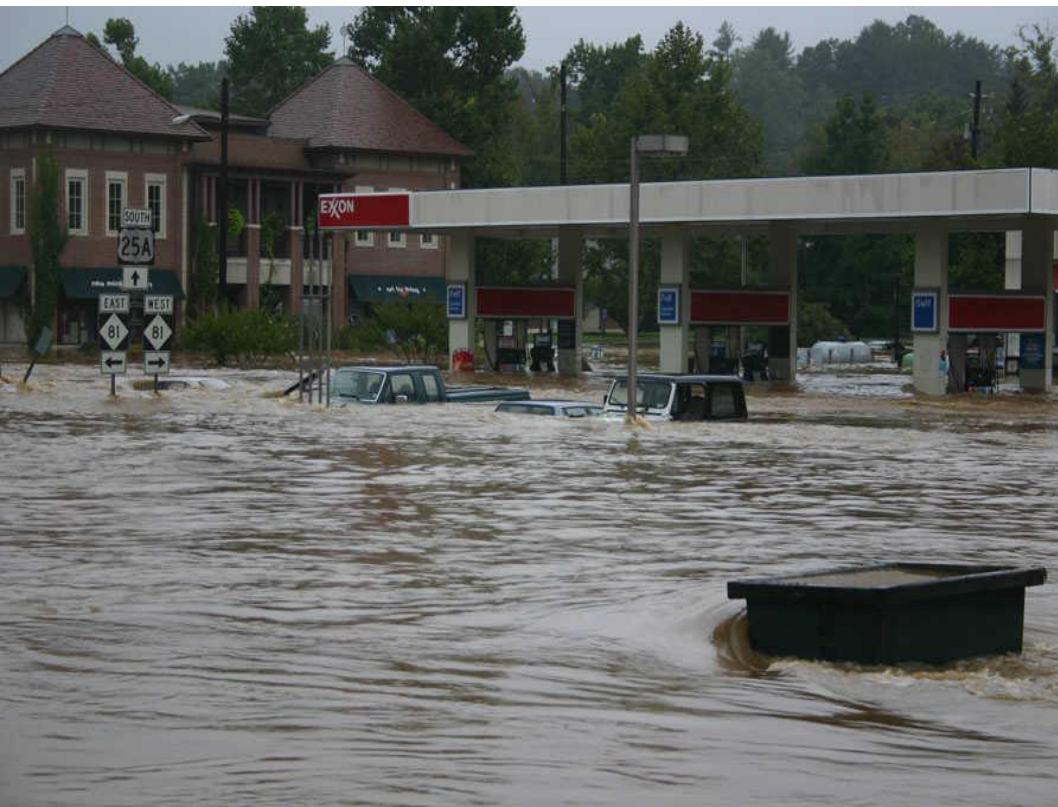
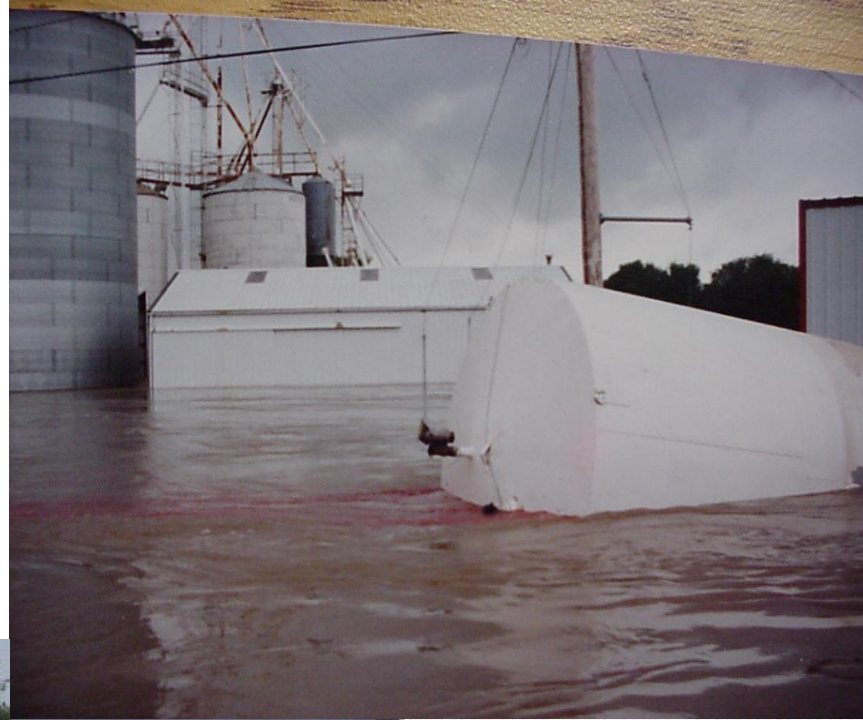
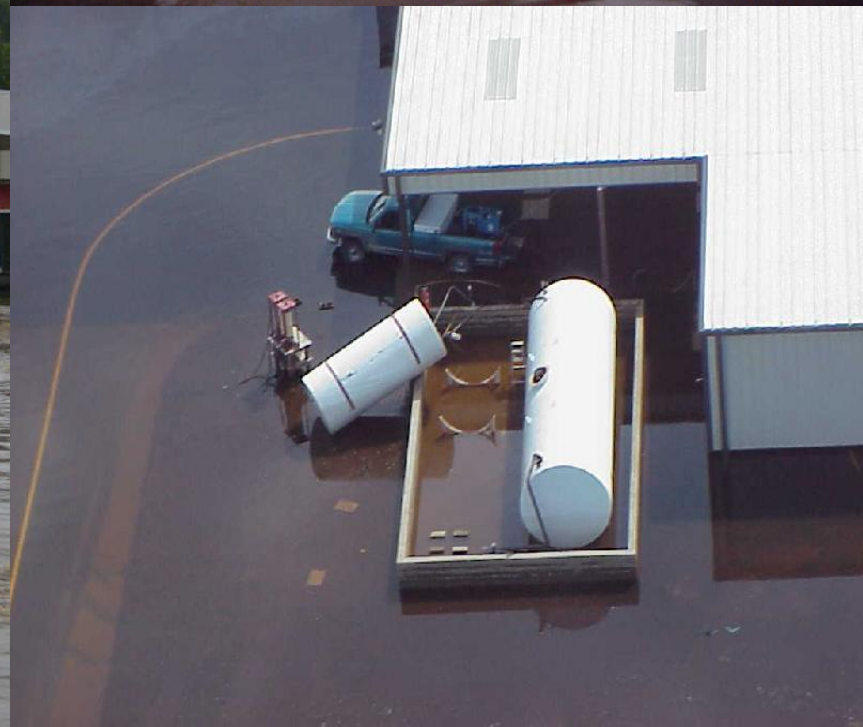
Flooding from Heavy Rainfall

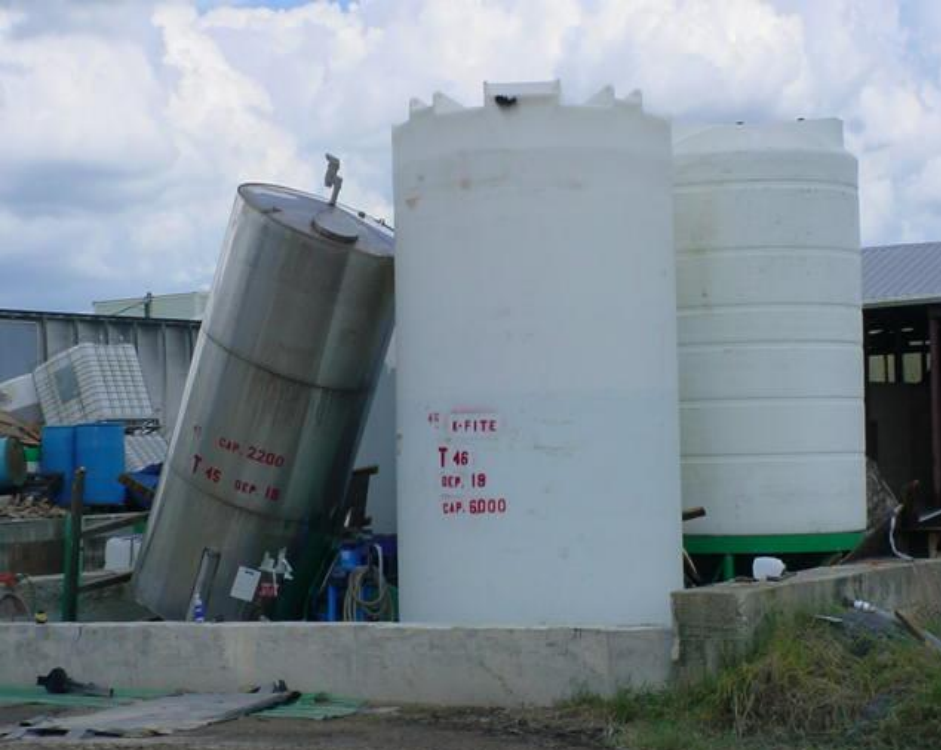
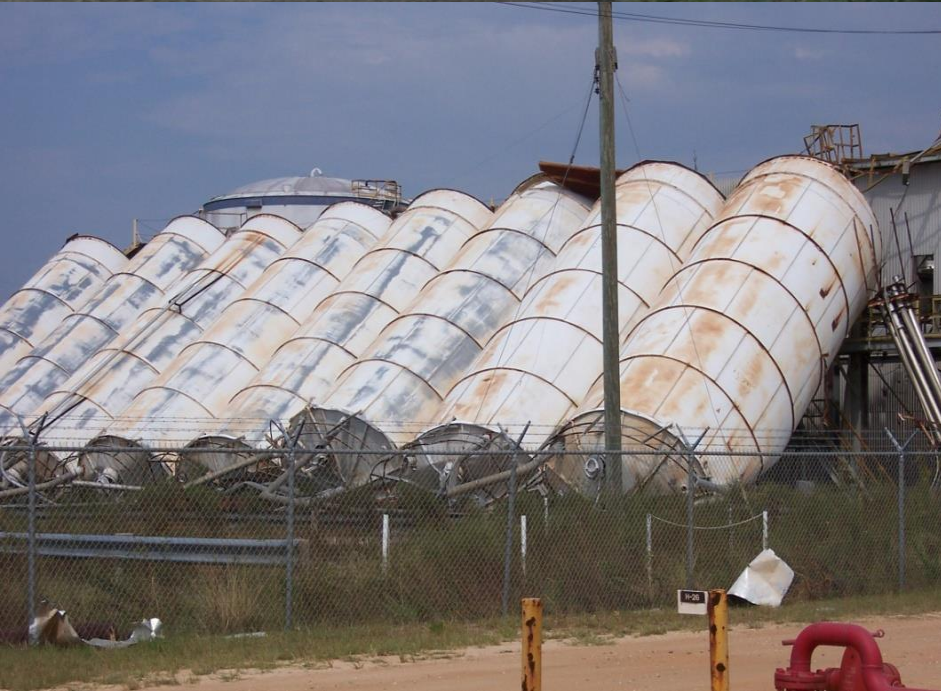
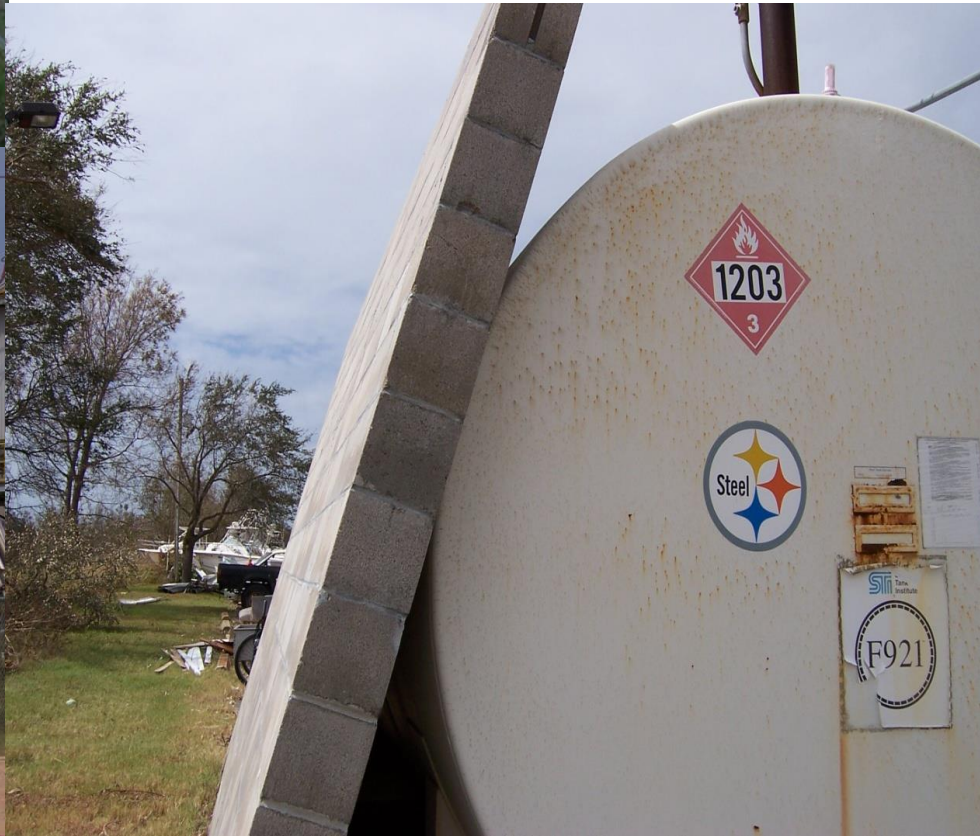
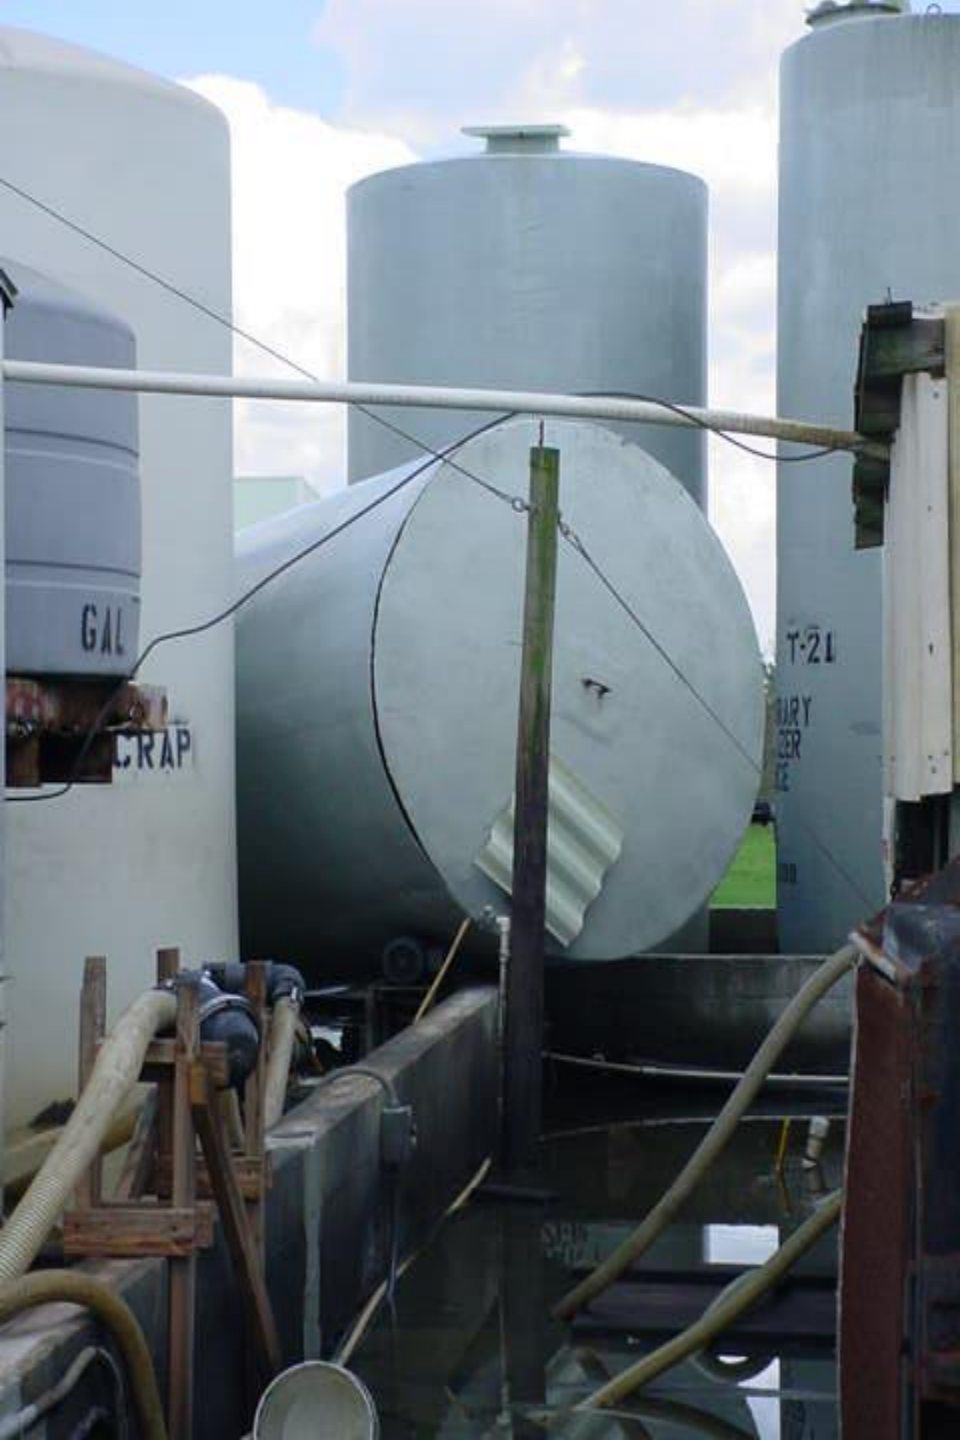
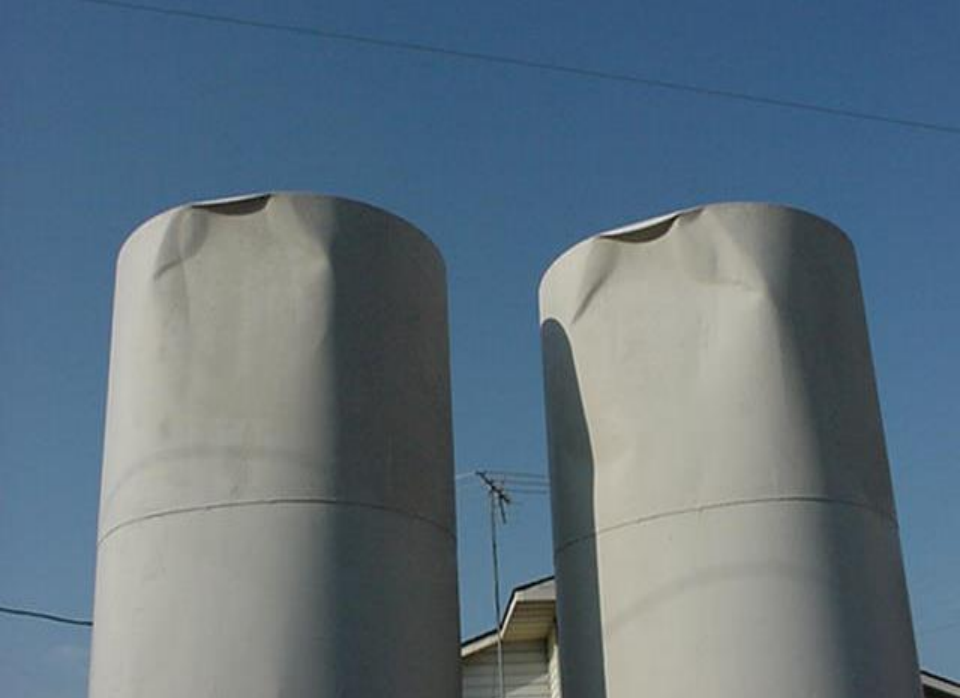
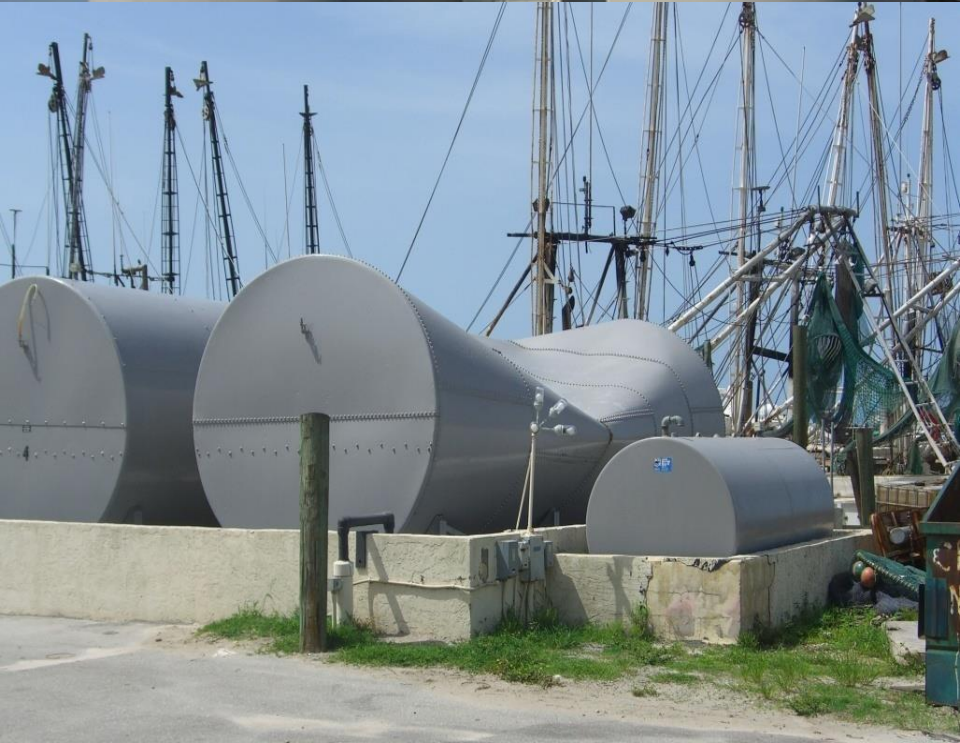
Wind Damage

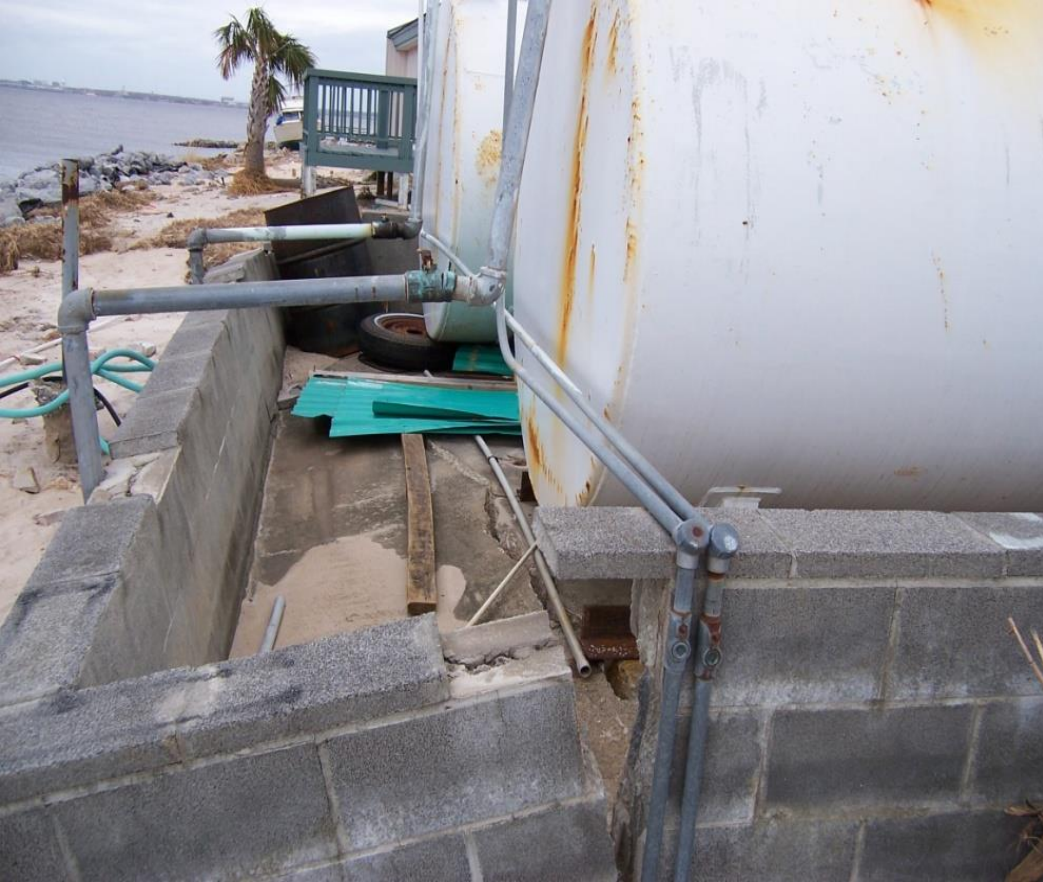
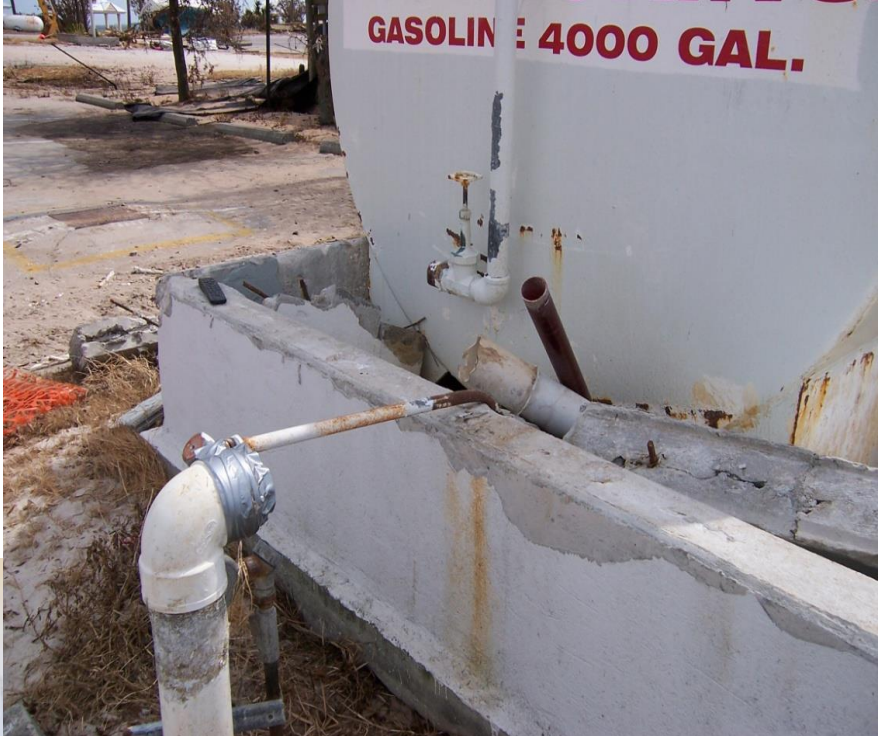
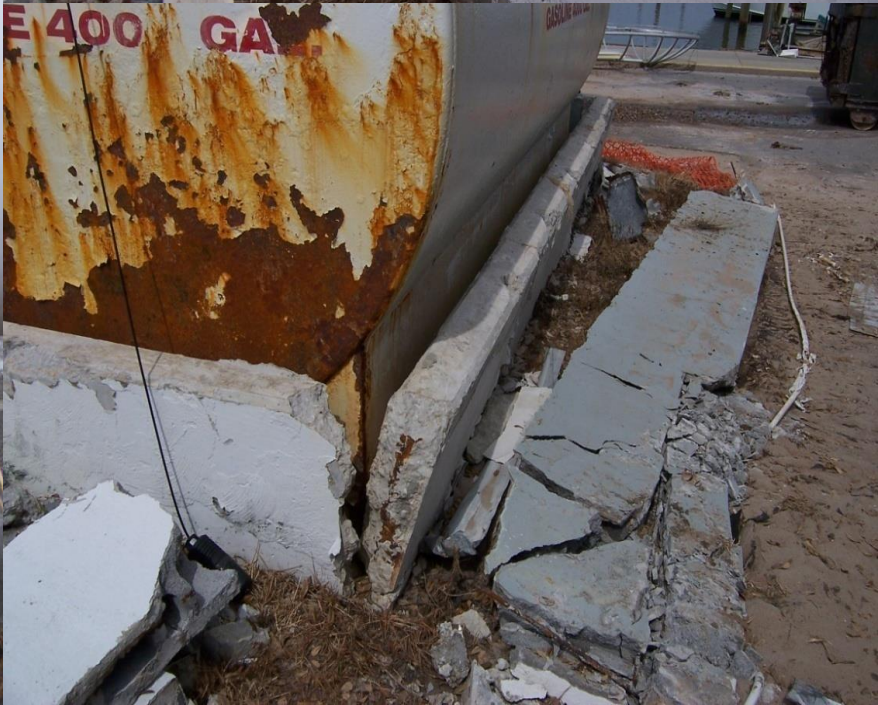
Storm Surge Dike-field Damage
