# MISSOURI ABOVEGROUND STORAGE TANK INSPECTIONS AND REGULATIONS

MISSOURI DEPARTMENT OF  
AGRICULTURE

Weights, Measures &  
Consumer Protection  
Petroleum/Propane/Nh3

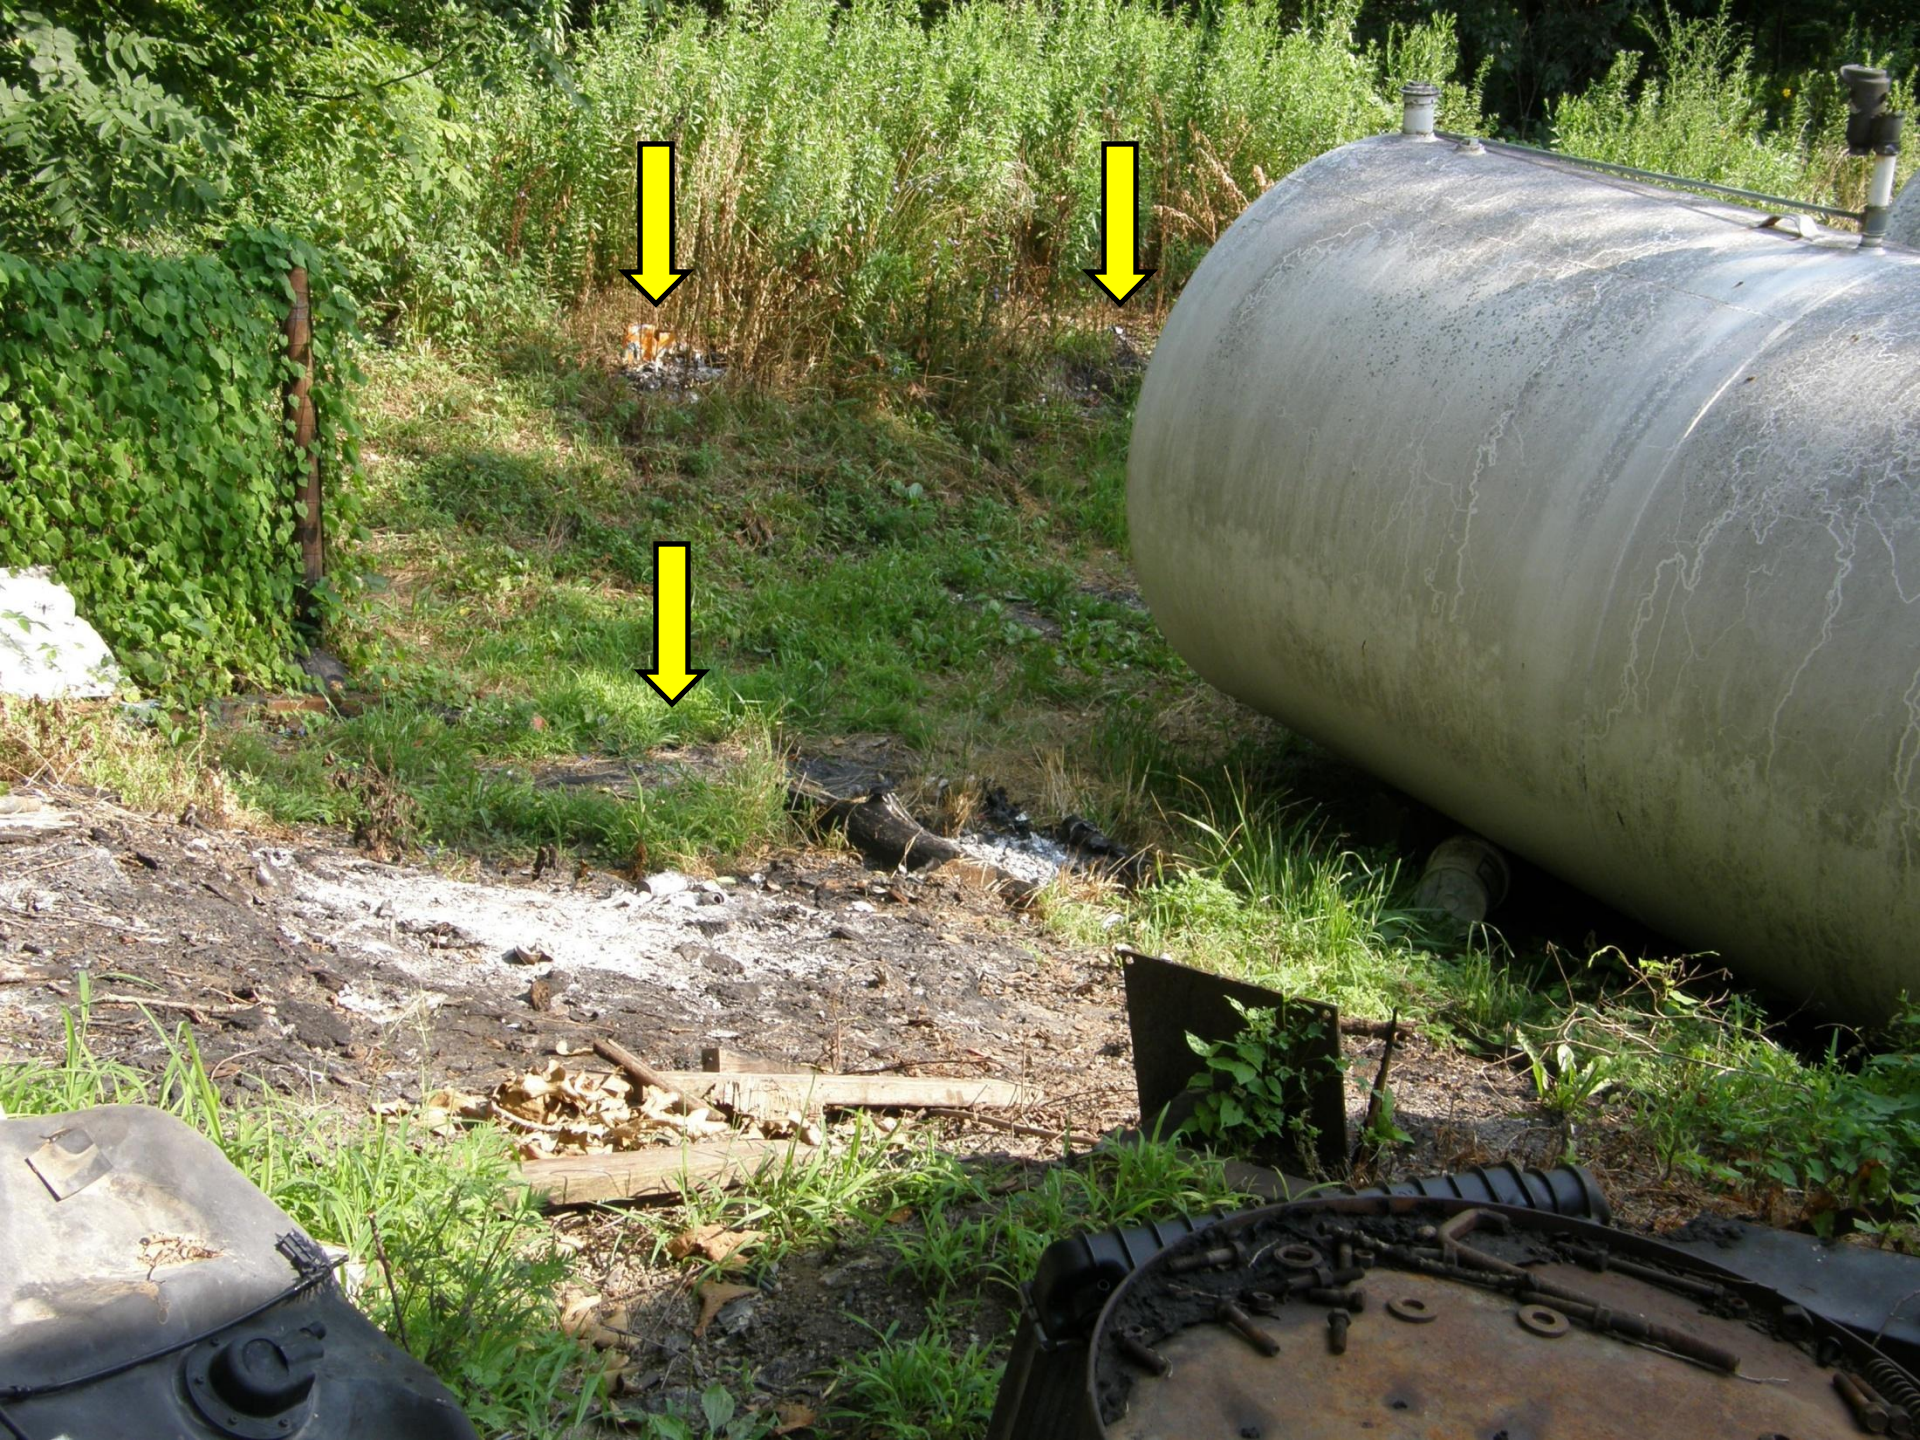
Yes, that really is where he was burning his old tires and trash!

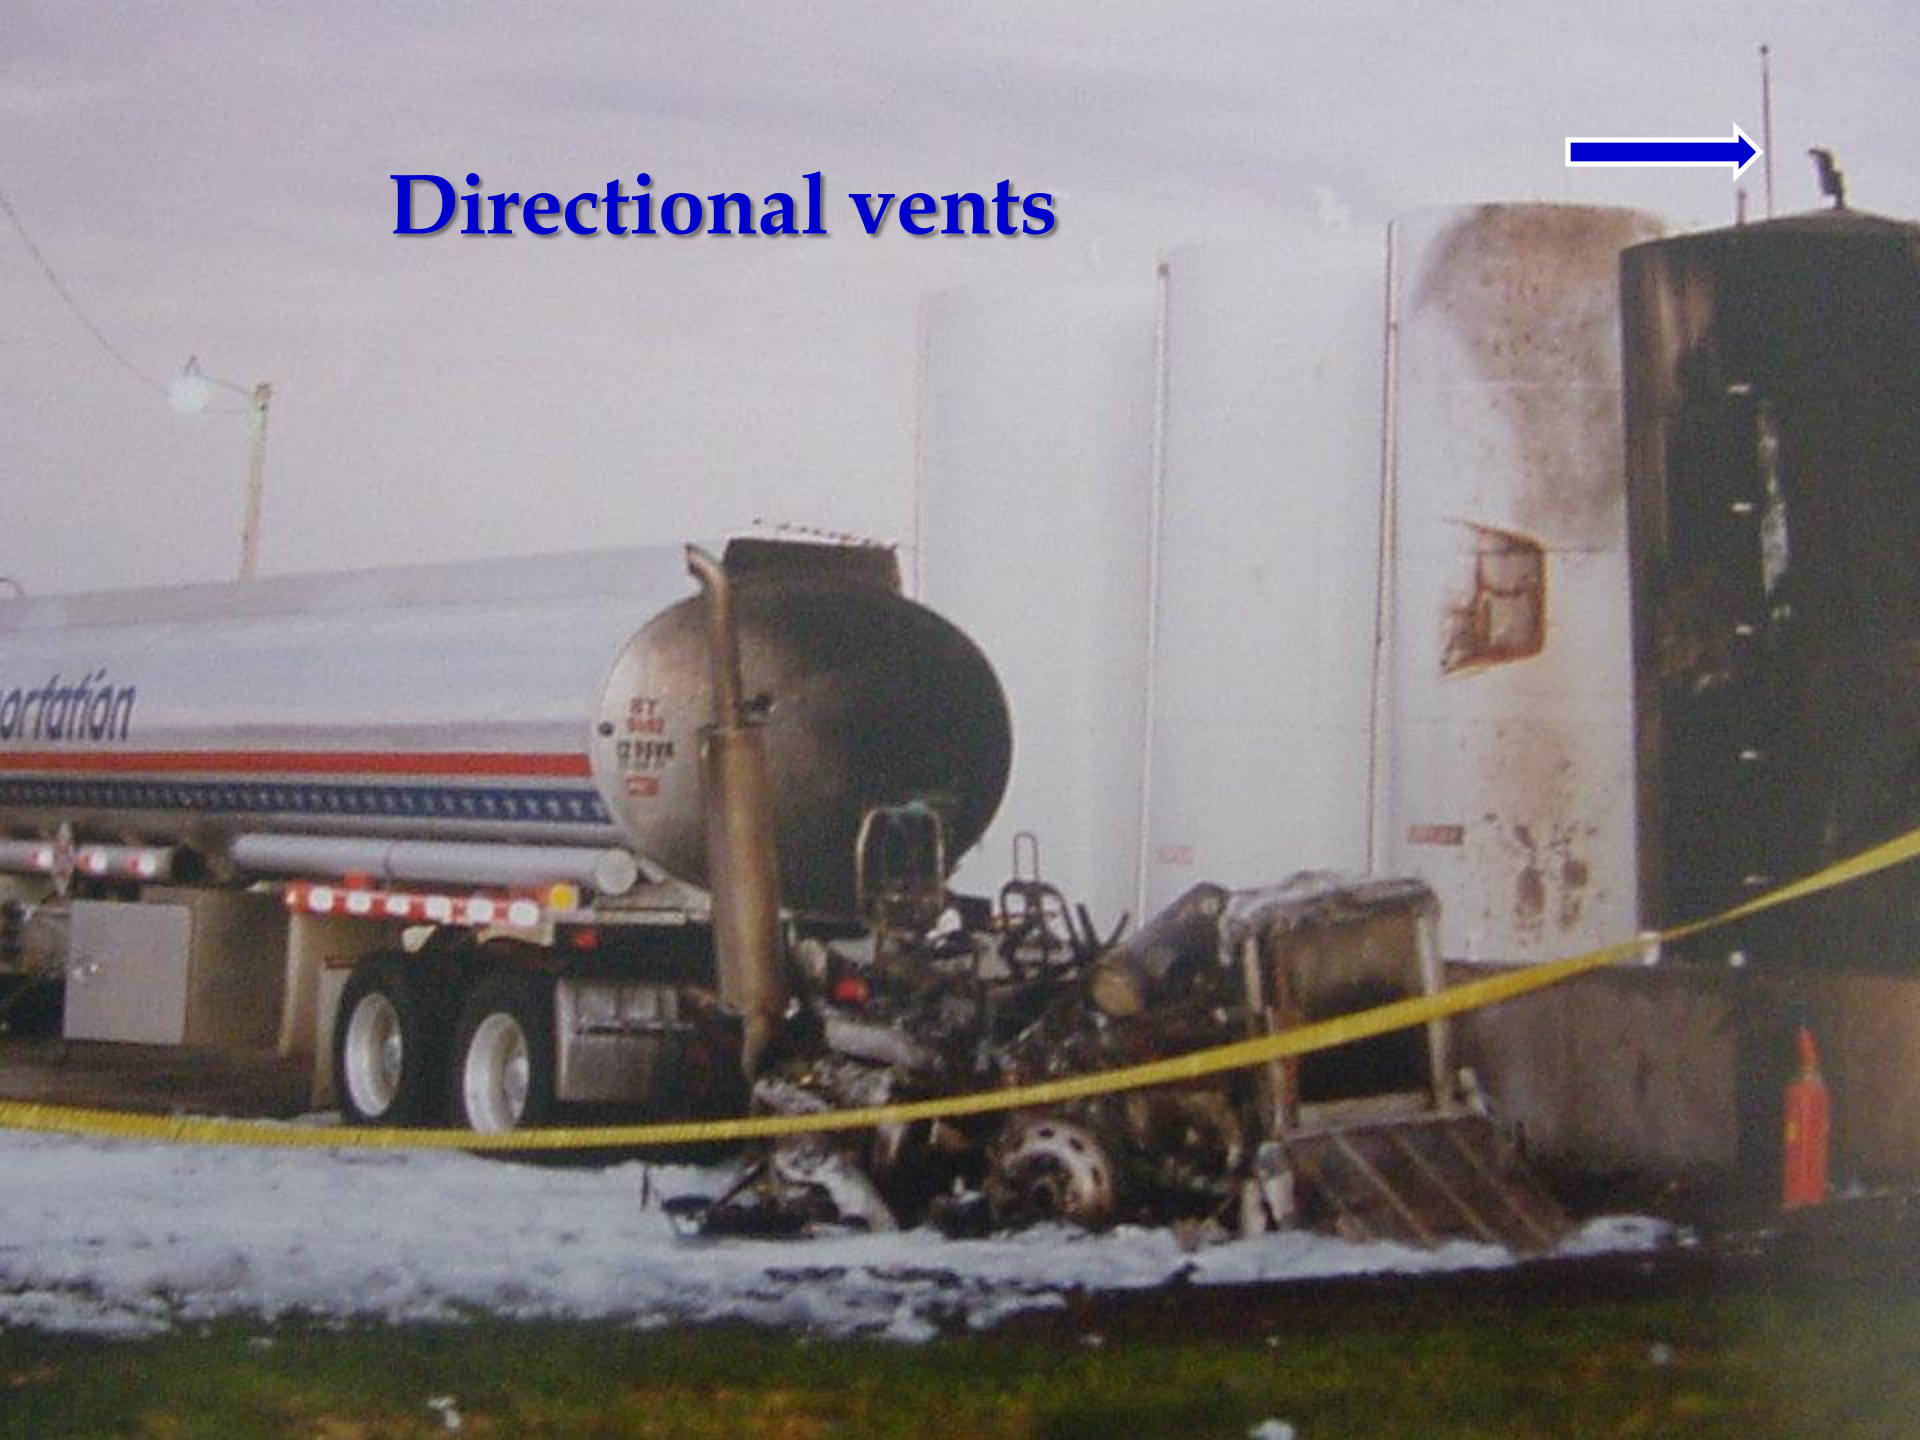
# Directional vents

Directional vents must discharge away from ignition sources. This includes the transport delivery area

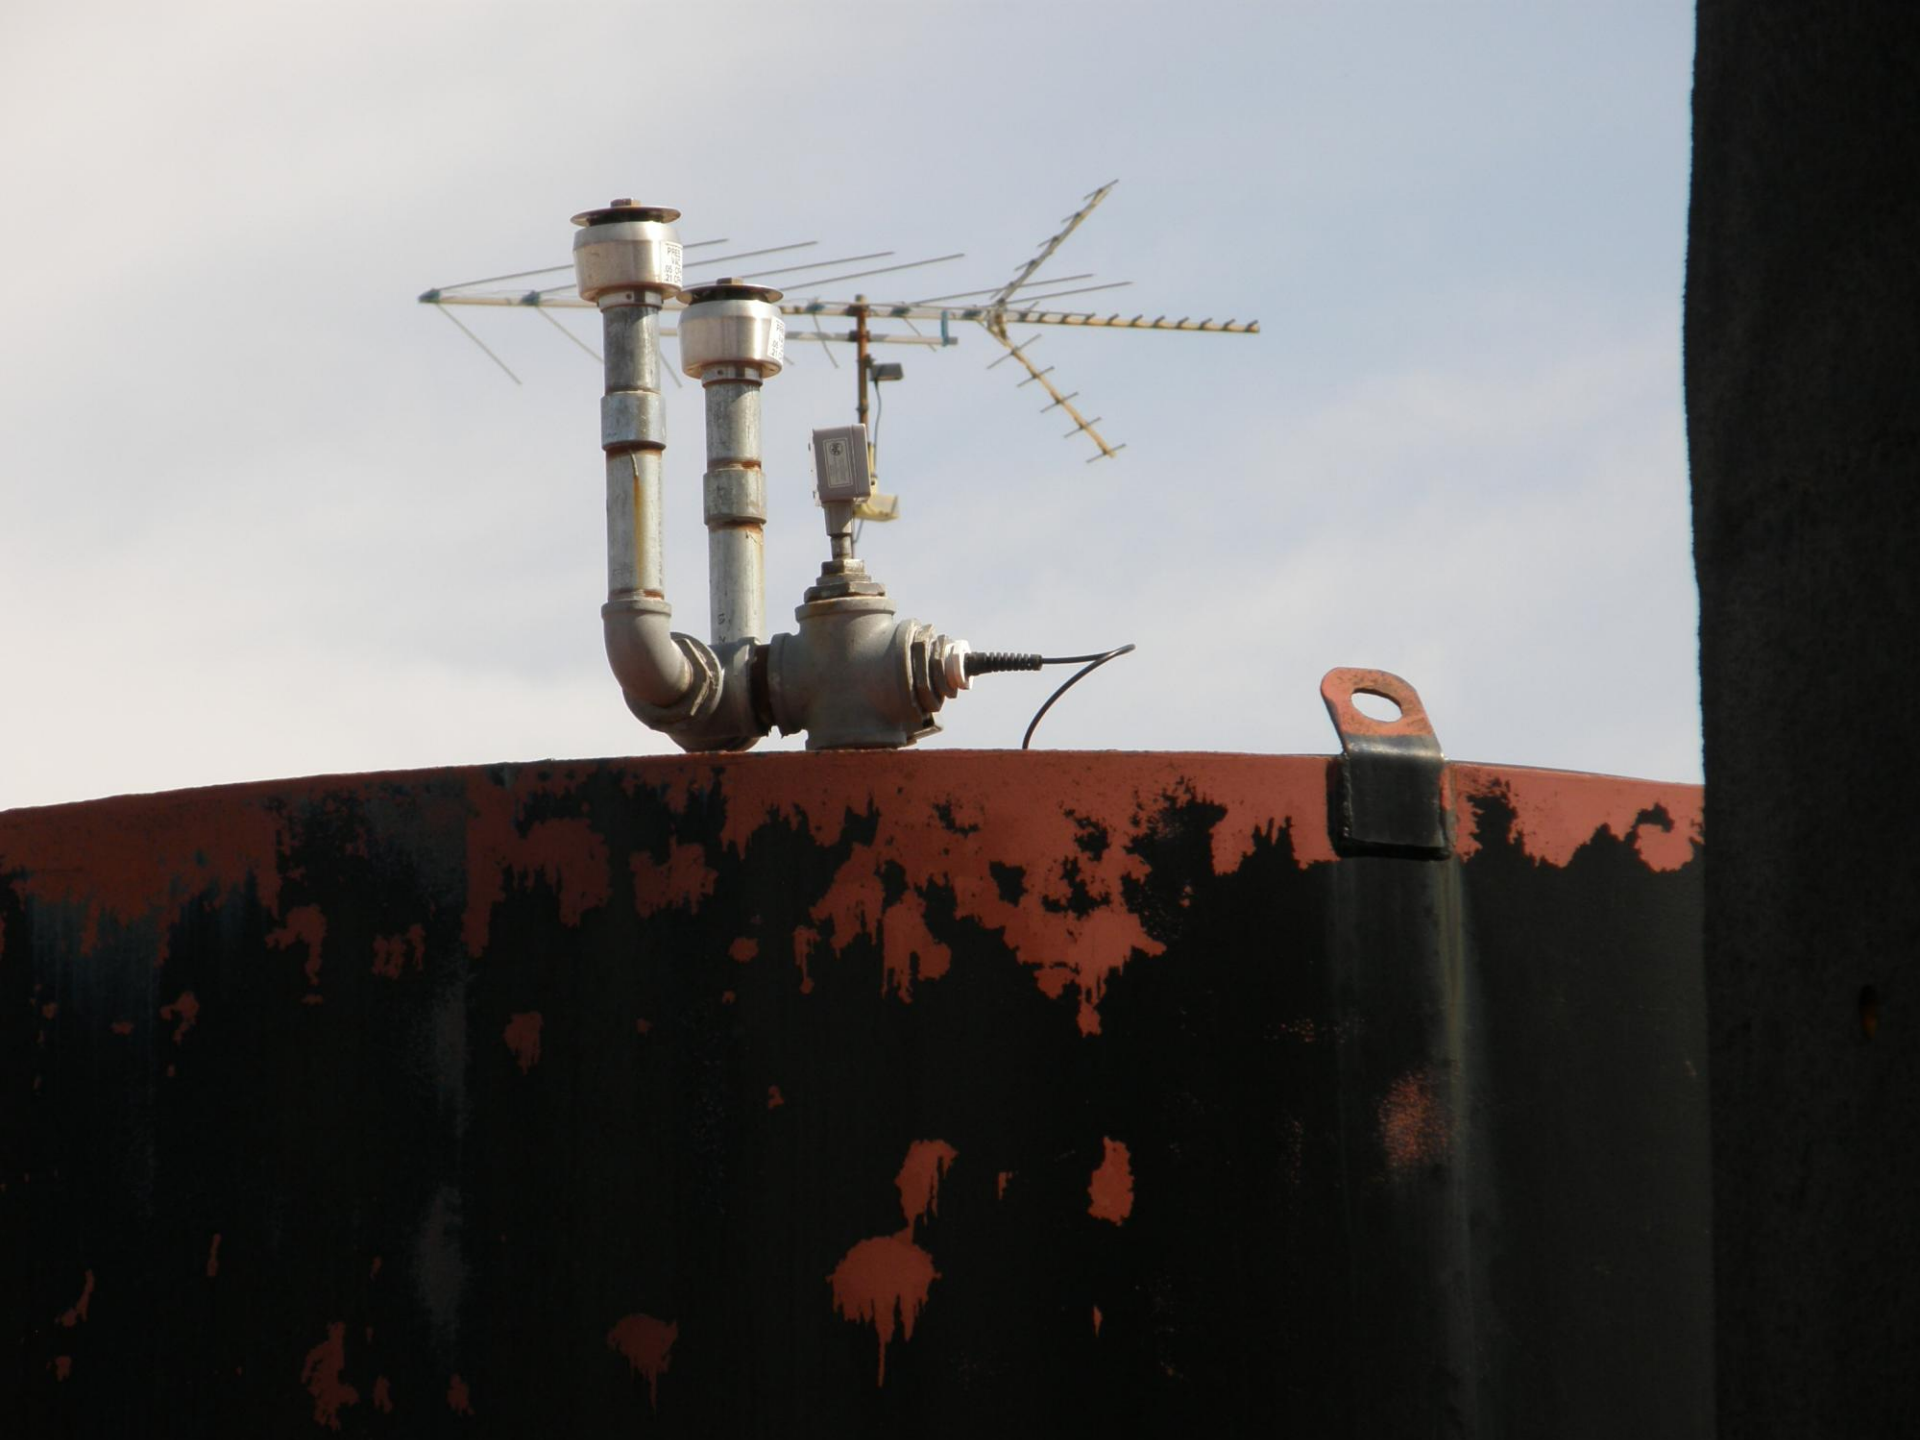
**Bull horn twin  
stack**

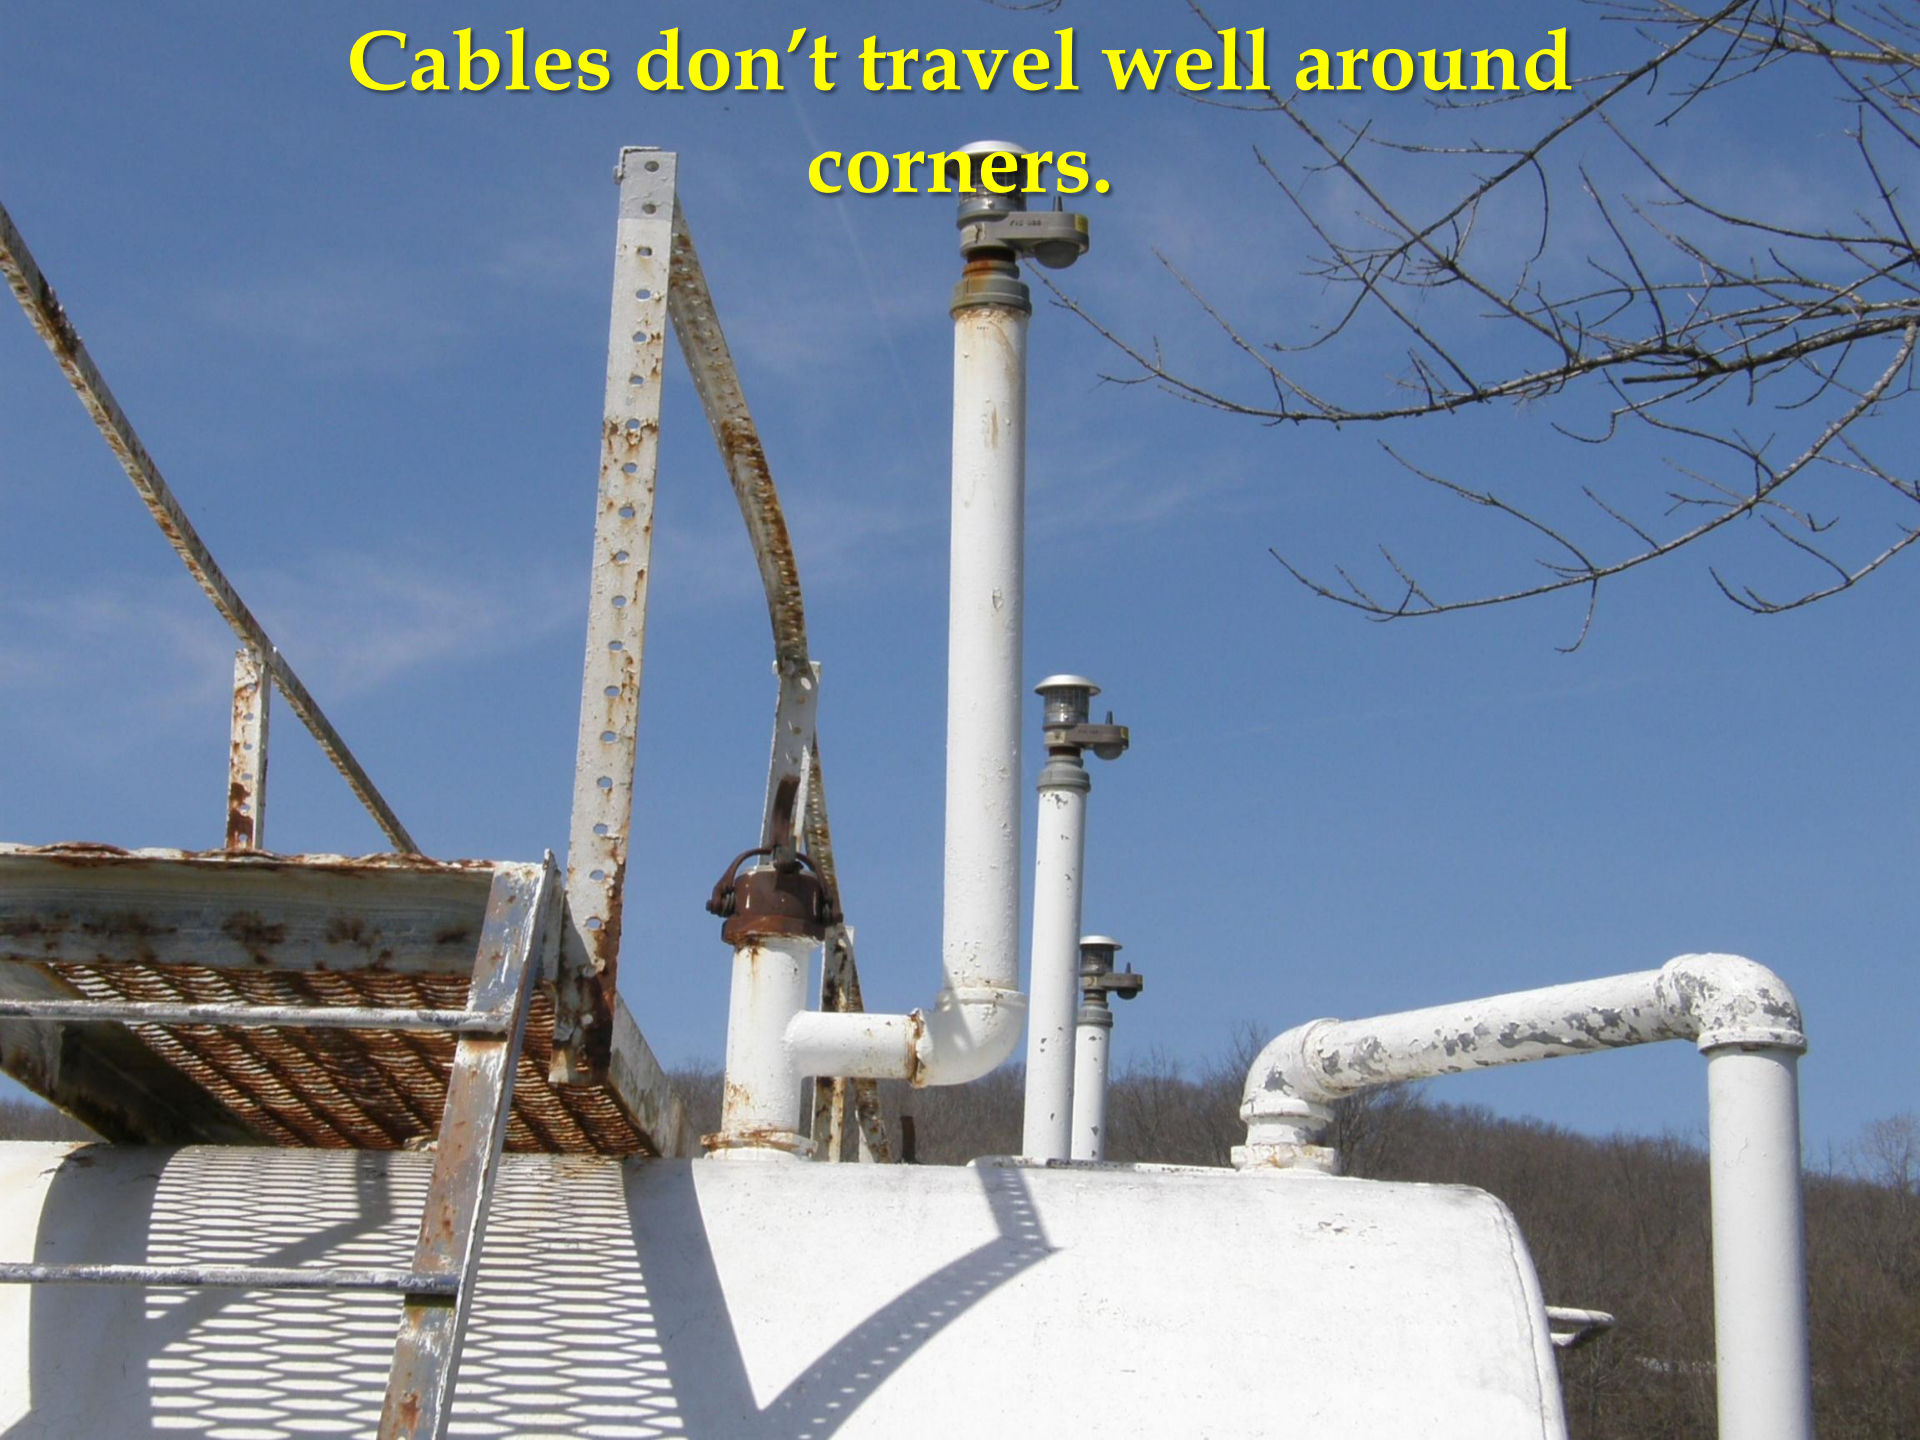
**Cables don't travel well around corners.**

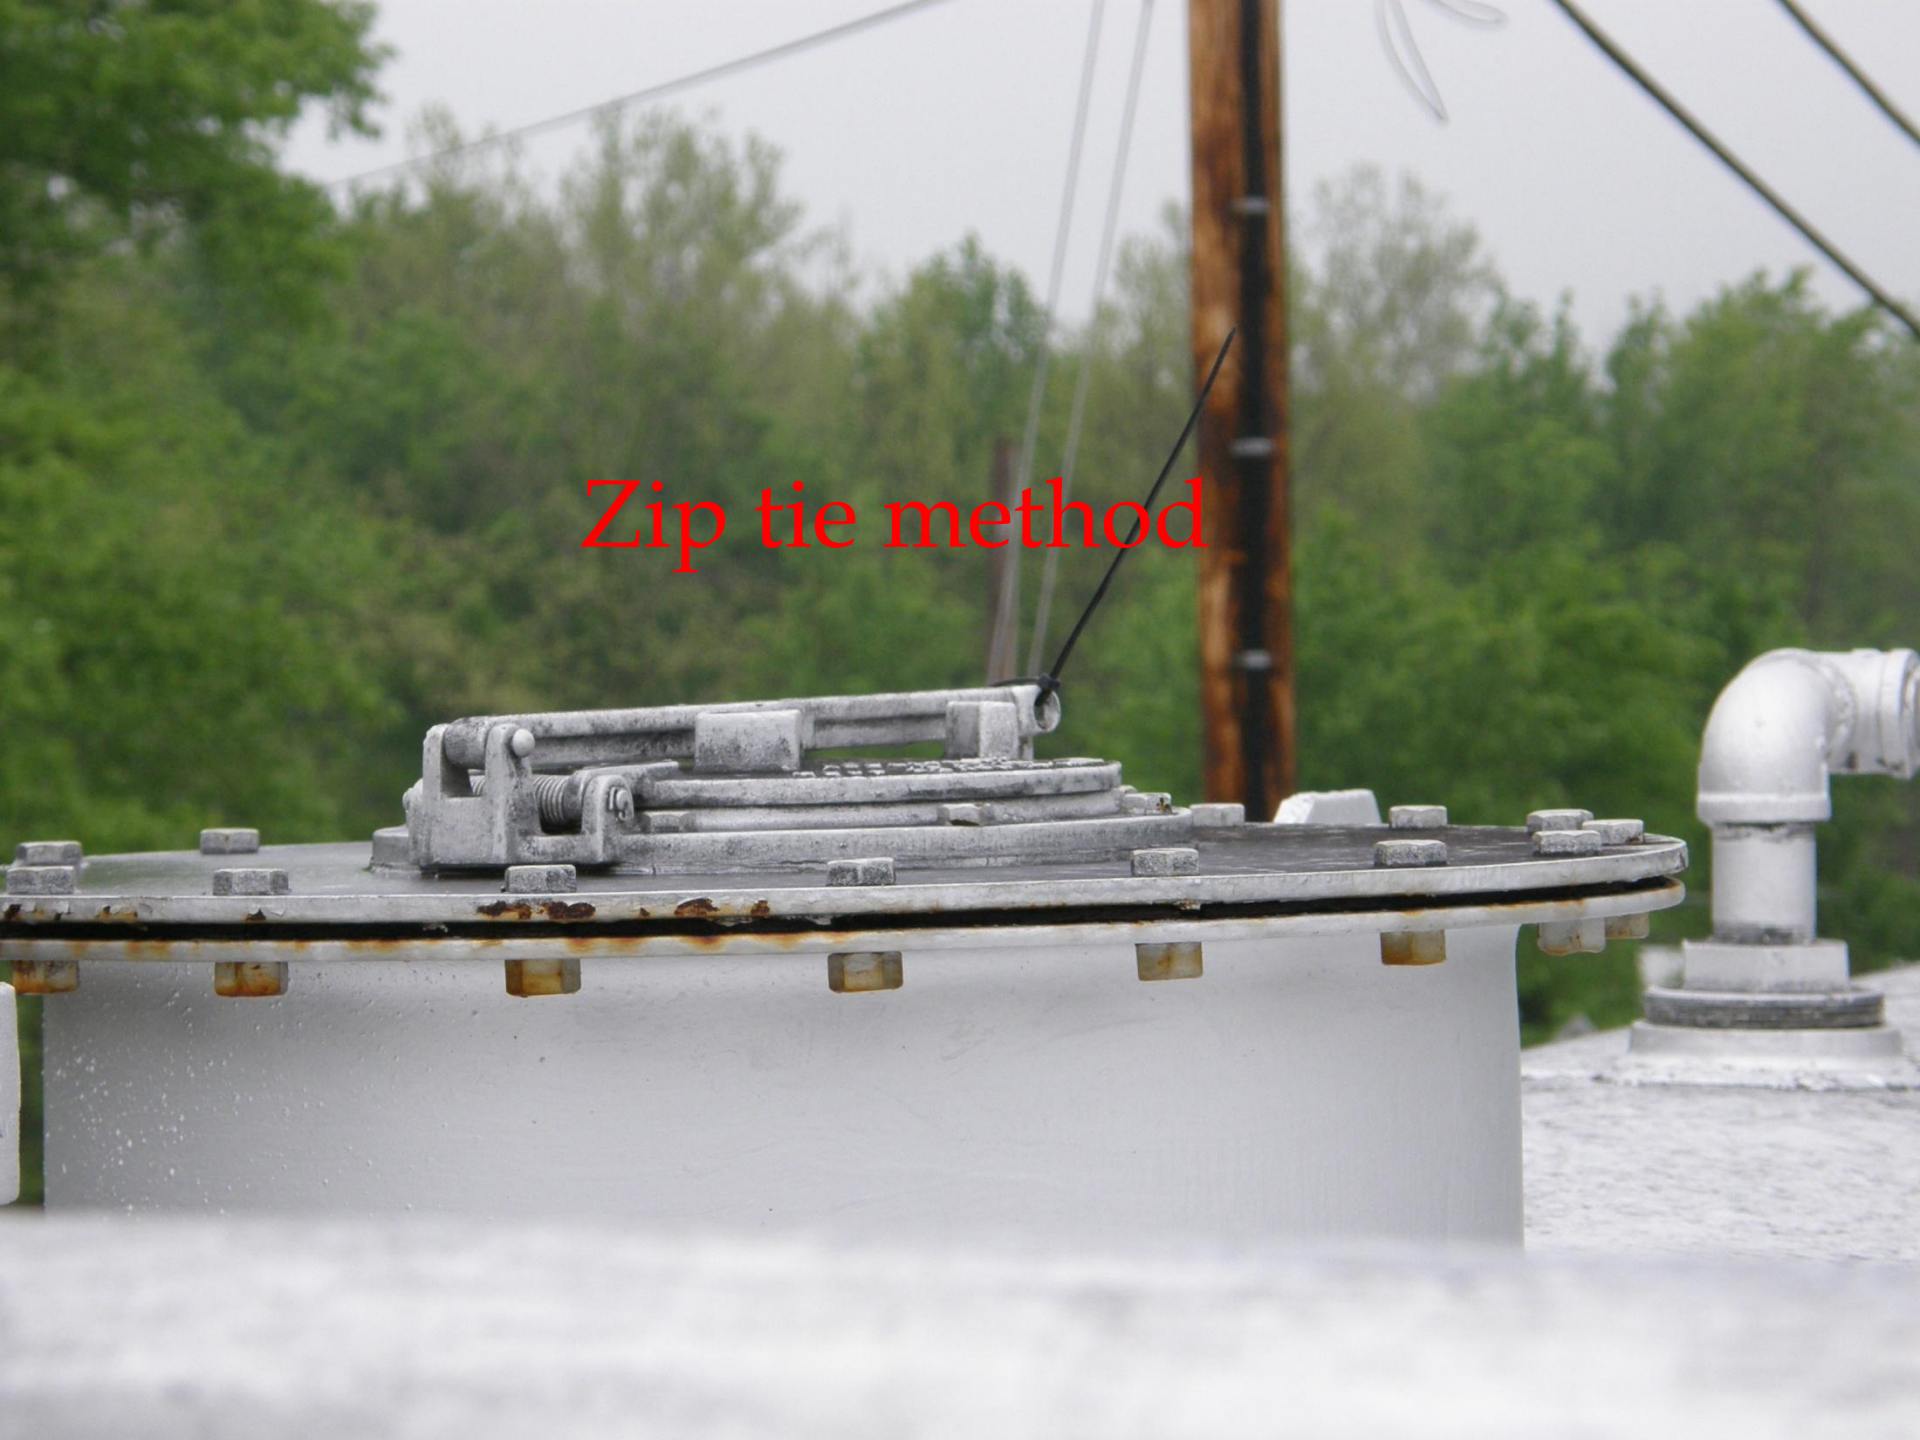
Zip tie method

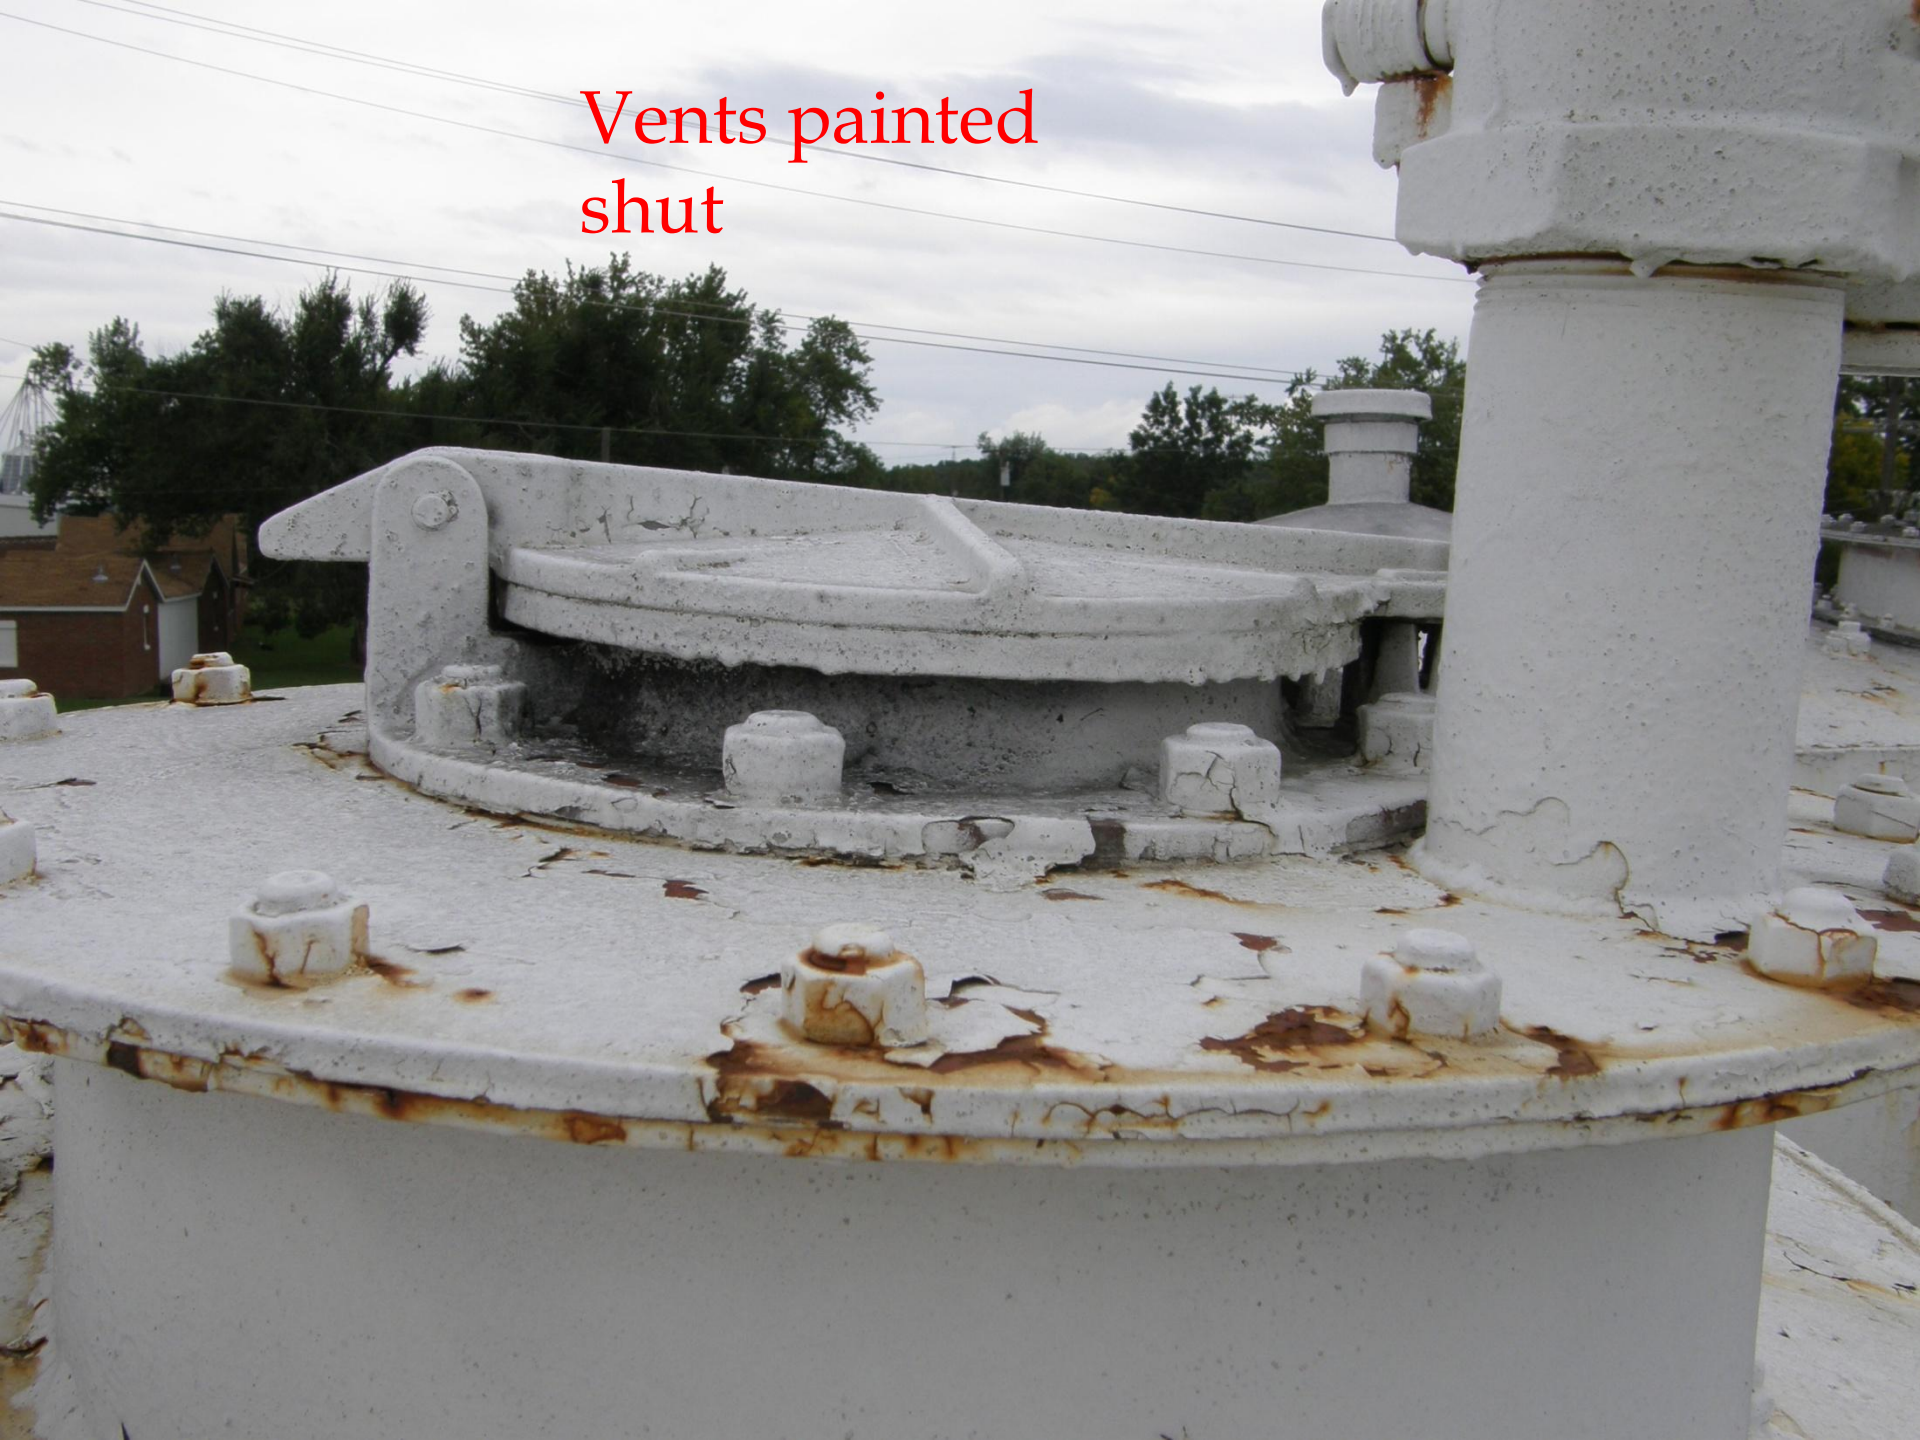
Vents painted  
shut

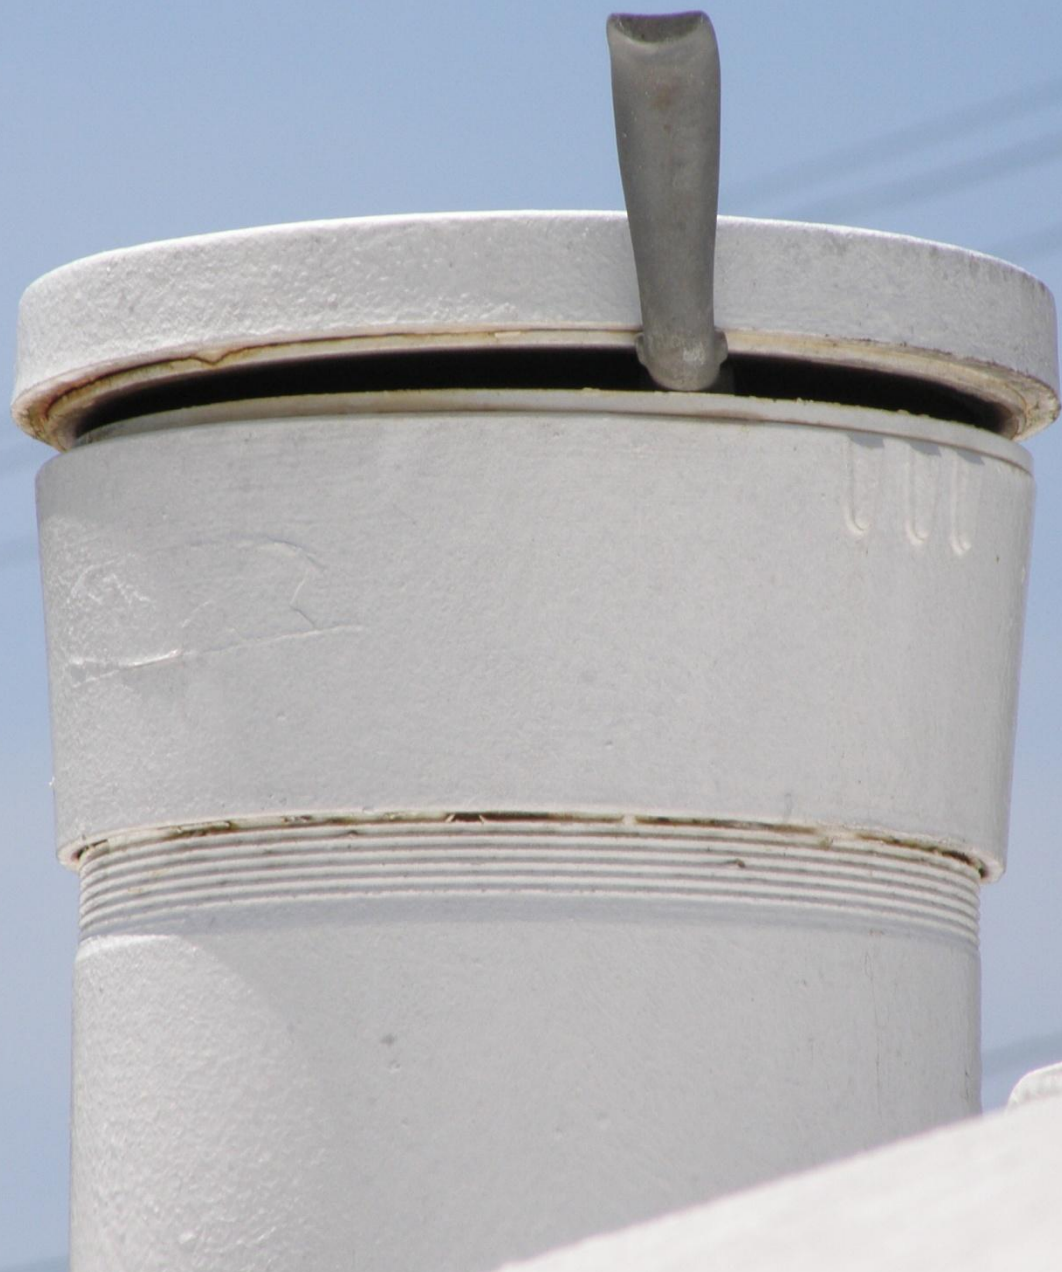
**Shim can affect the operation of the vent and allow fugitive emissions.**

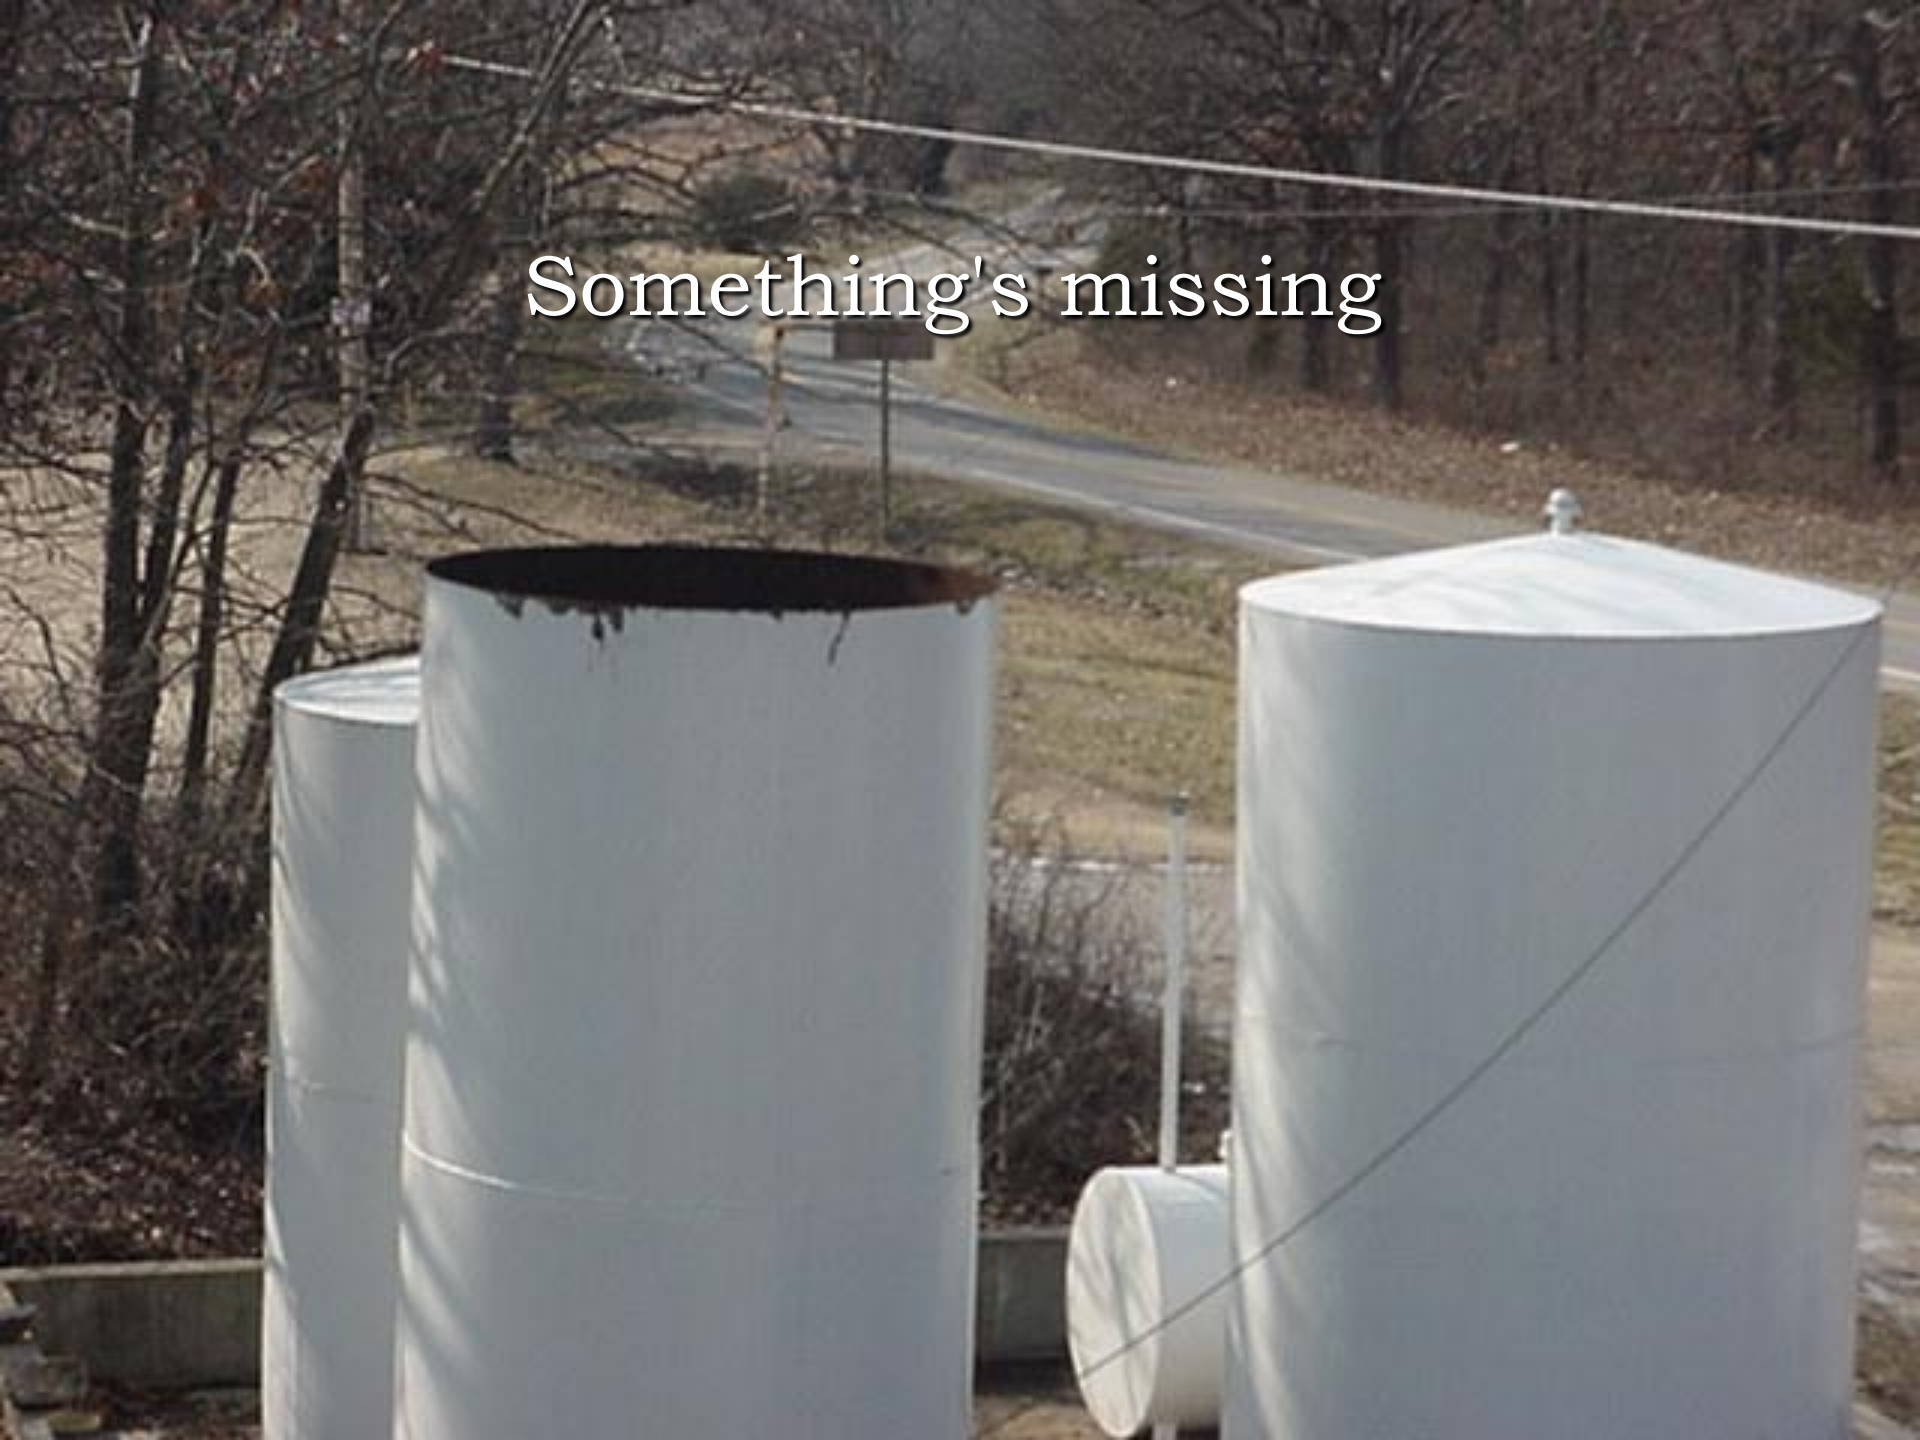
Something's missing
