# MISSOURI ABOVEGROUND STORAGE TANK INSPECTIONS AND REGULATIONS

MISSOURI DEPARTMENT OF  
AGRICULTURE

Weights, Measures &  
Consumer Protection  
Petroleum/Propane/Nh3

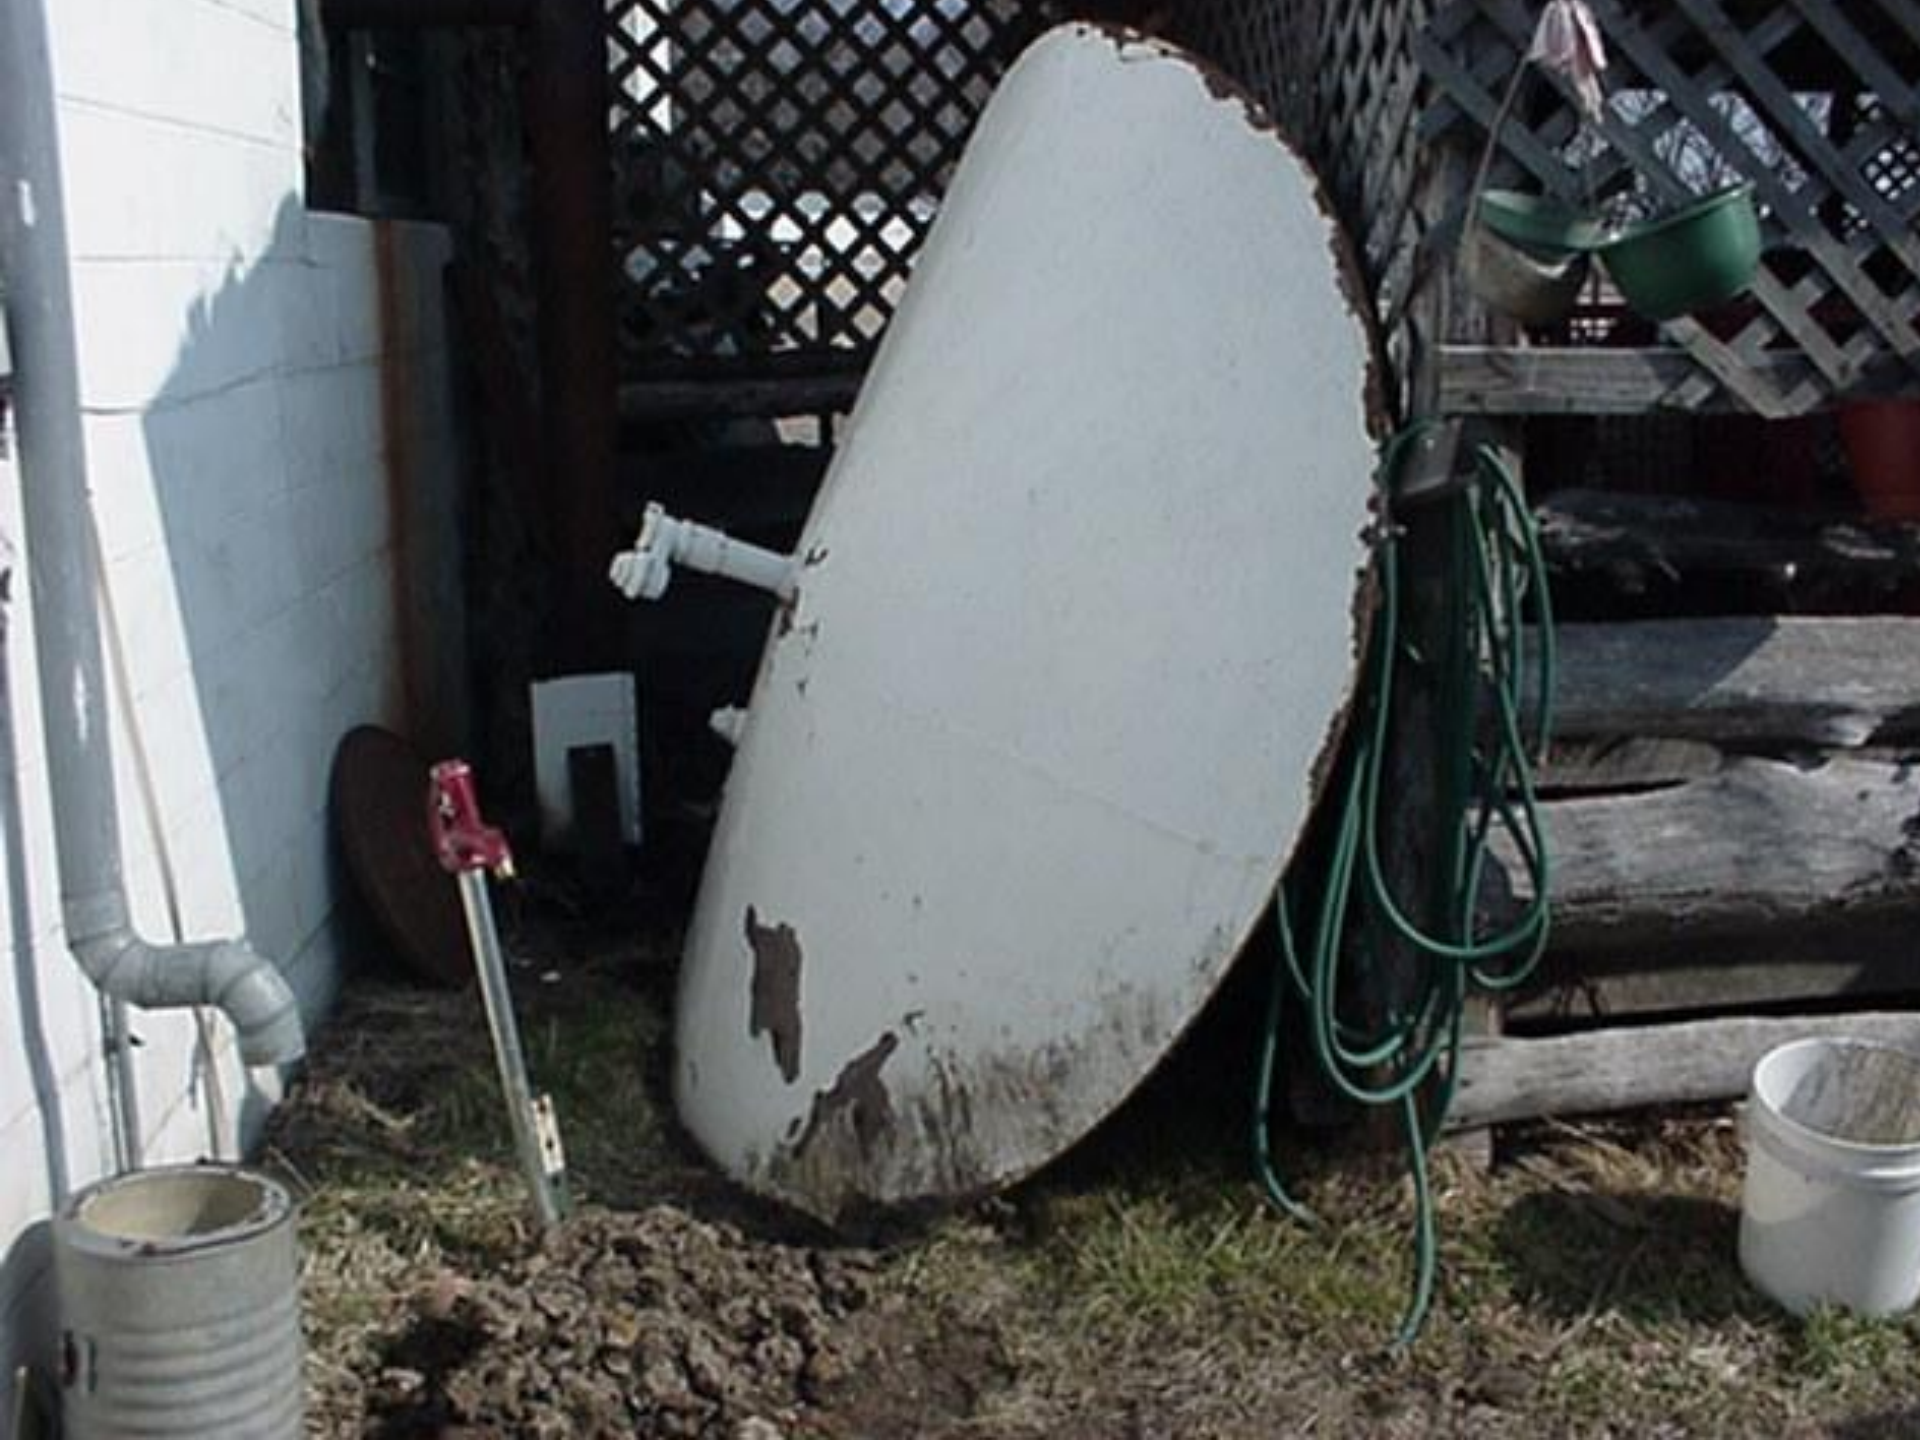
**Weak Roof-to-Shell**

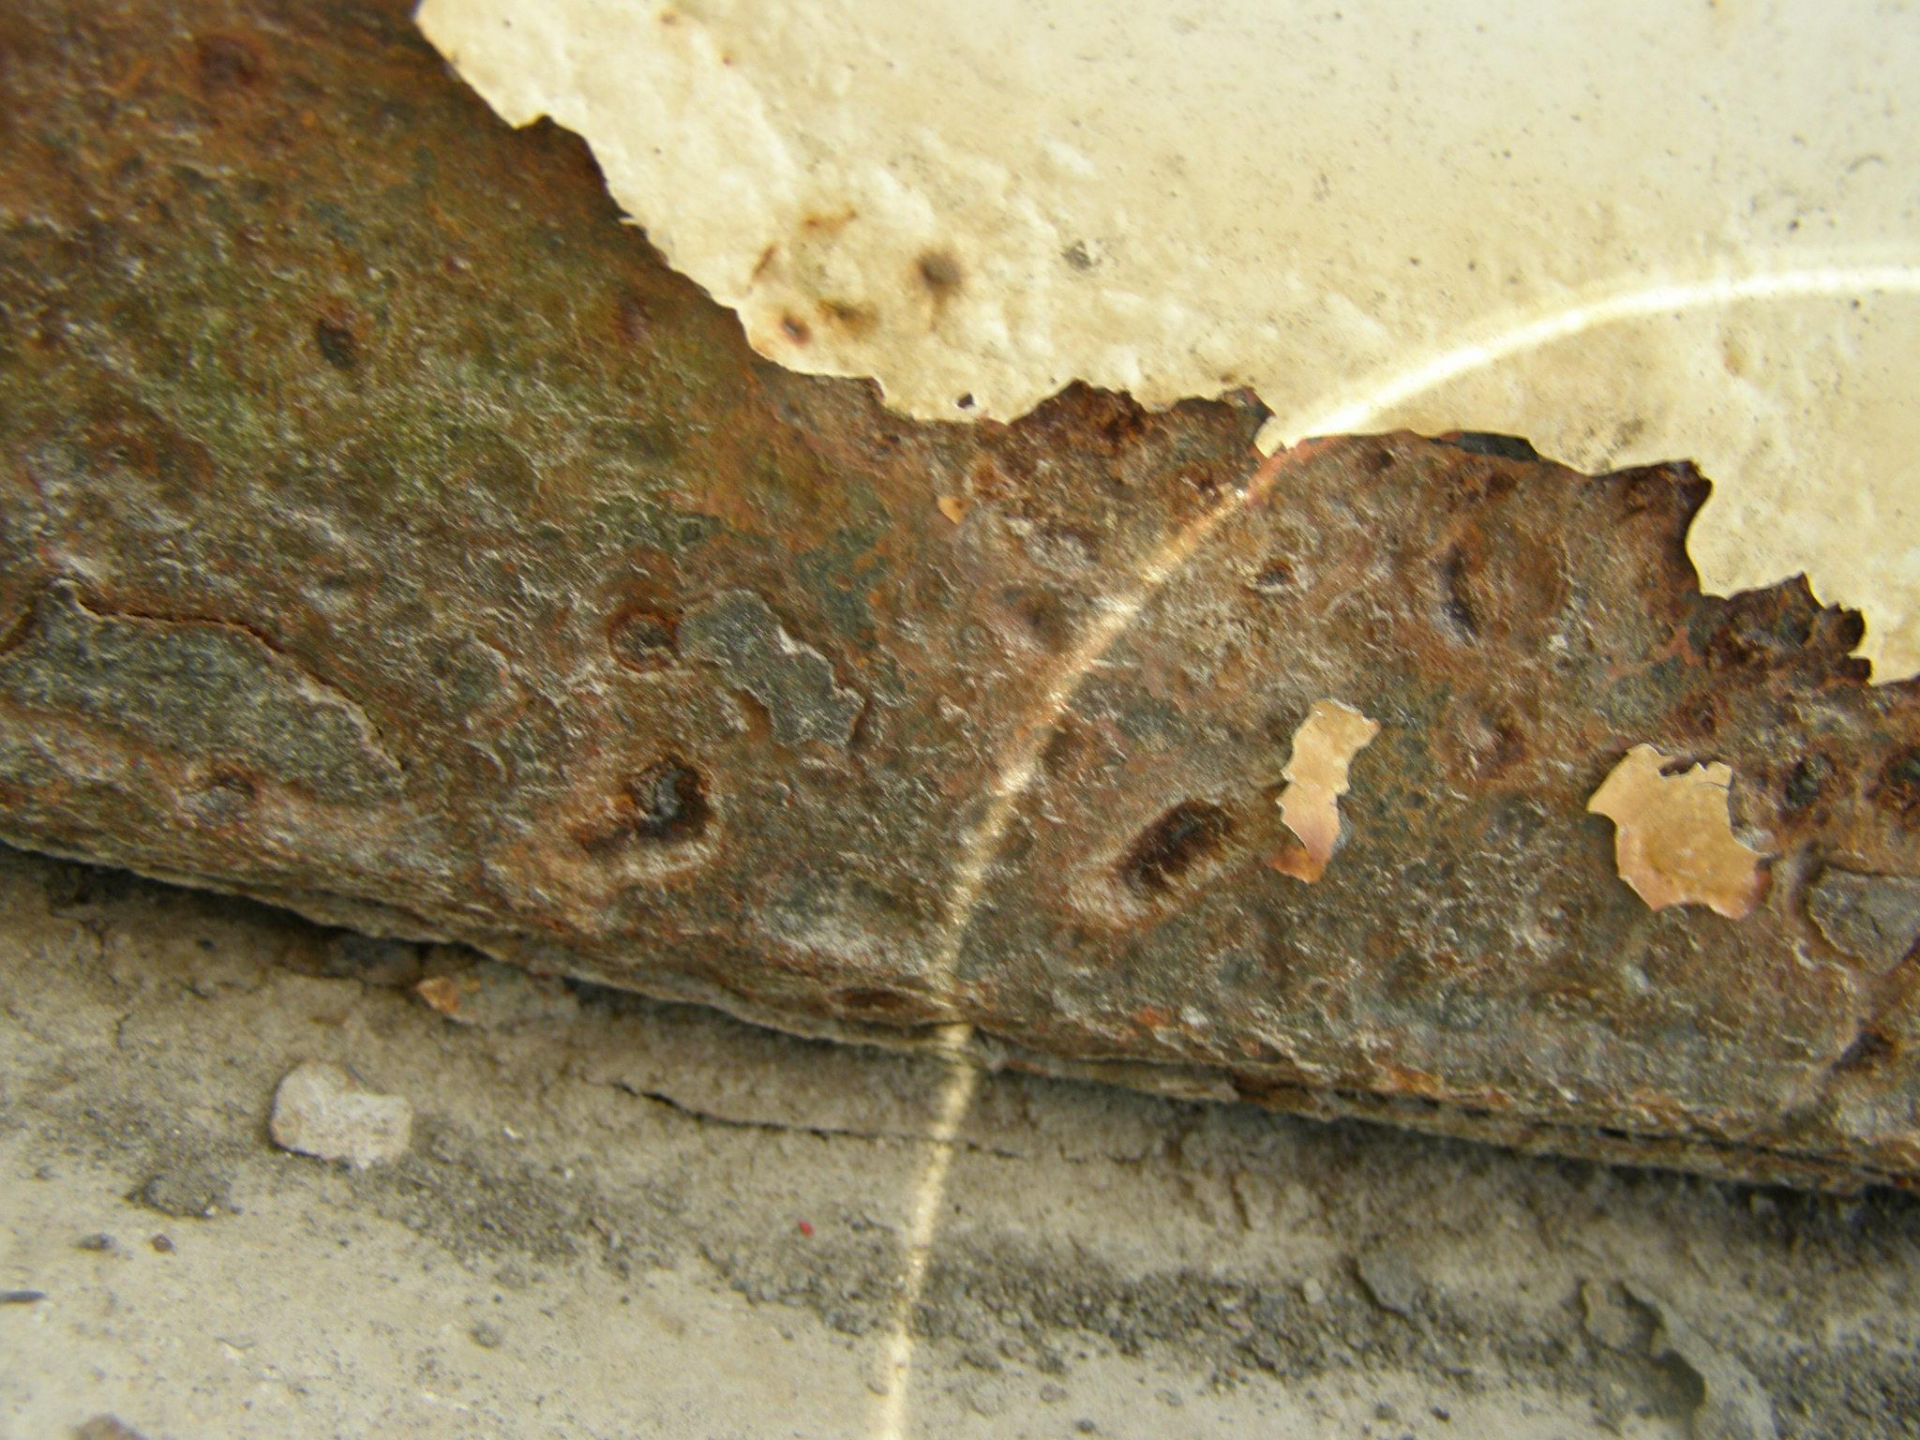
**Corrosion and  
pitting**

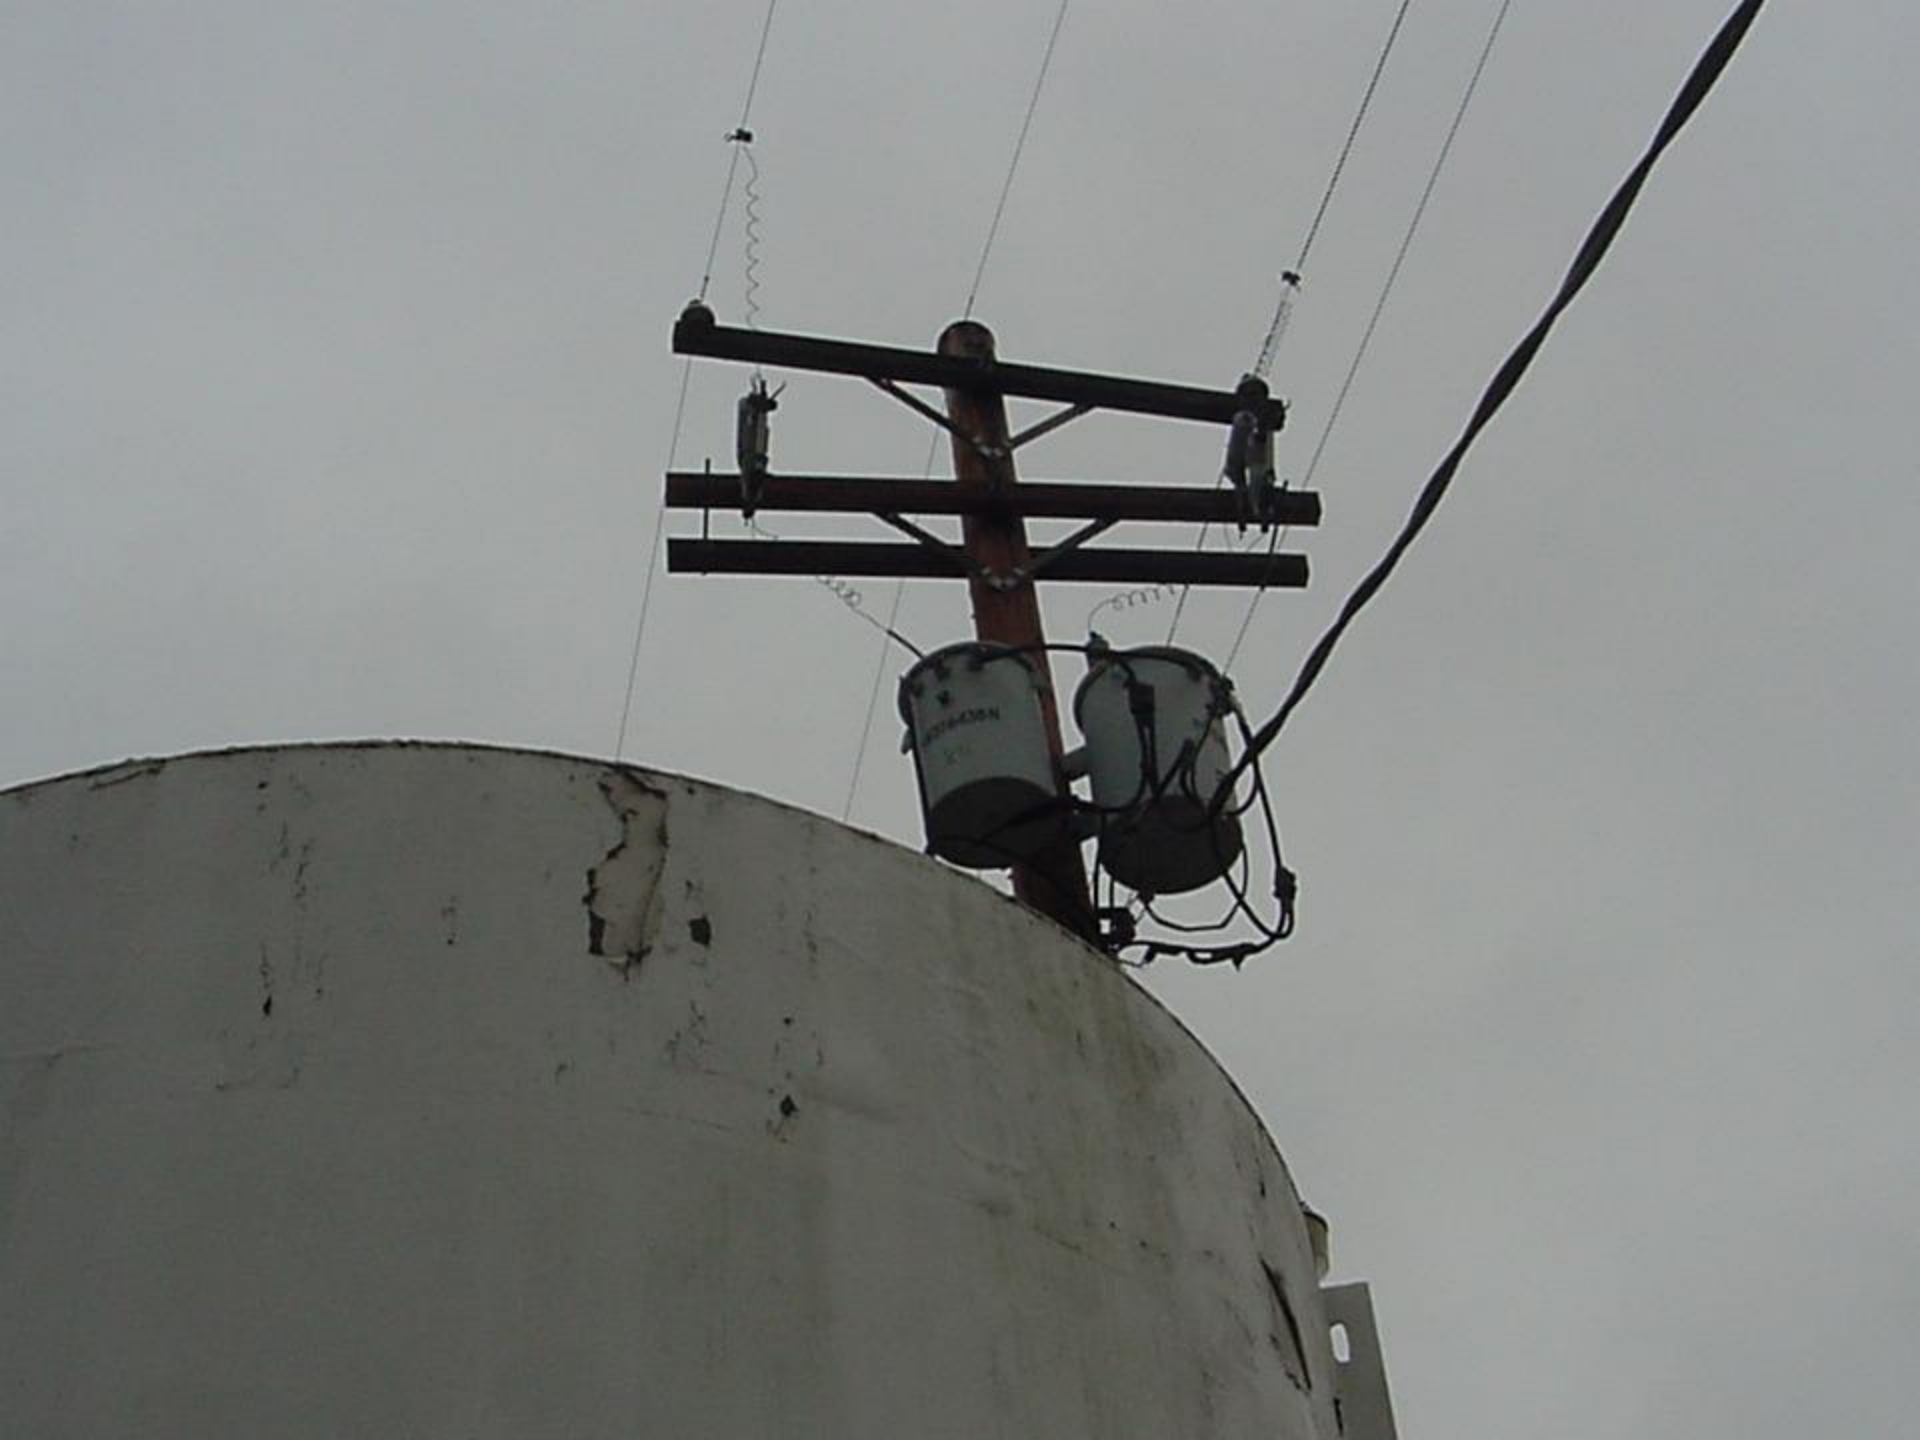
There must be a 10 ft horizontal separation, especially in this instance where the lines are stretched toward the tank.

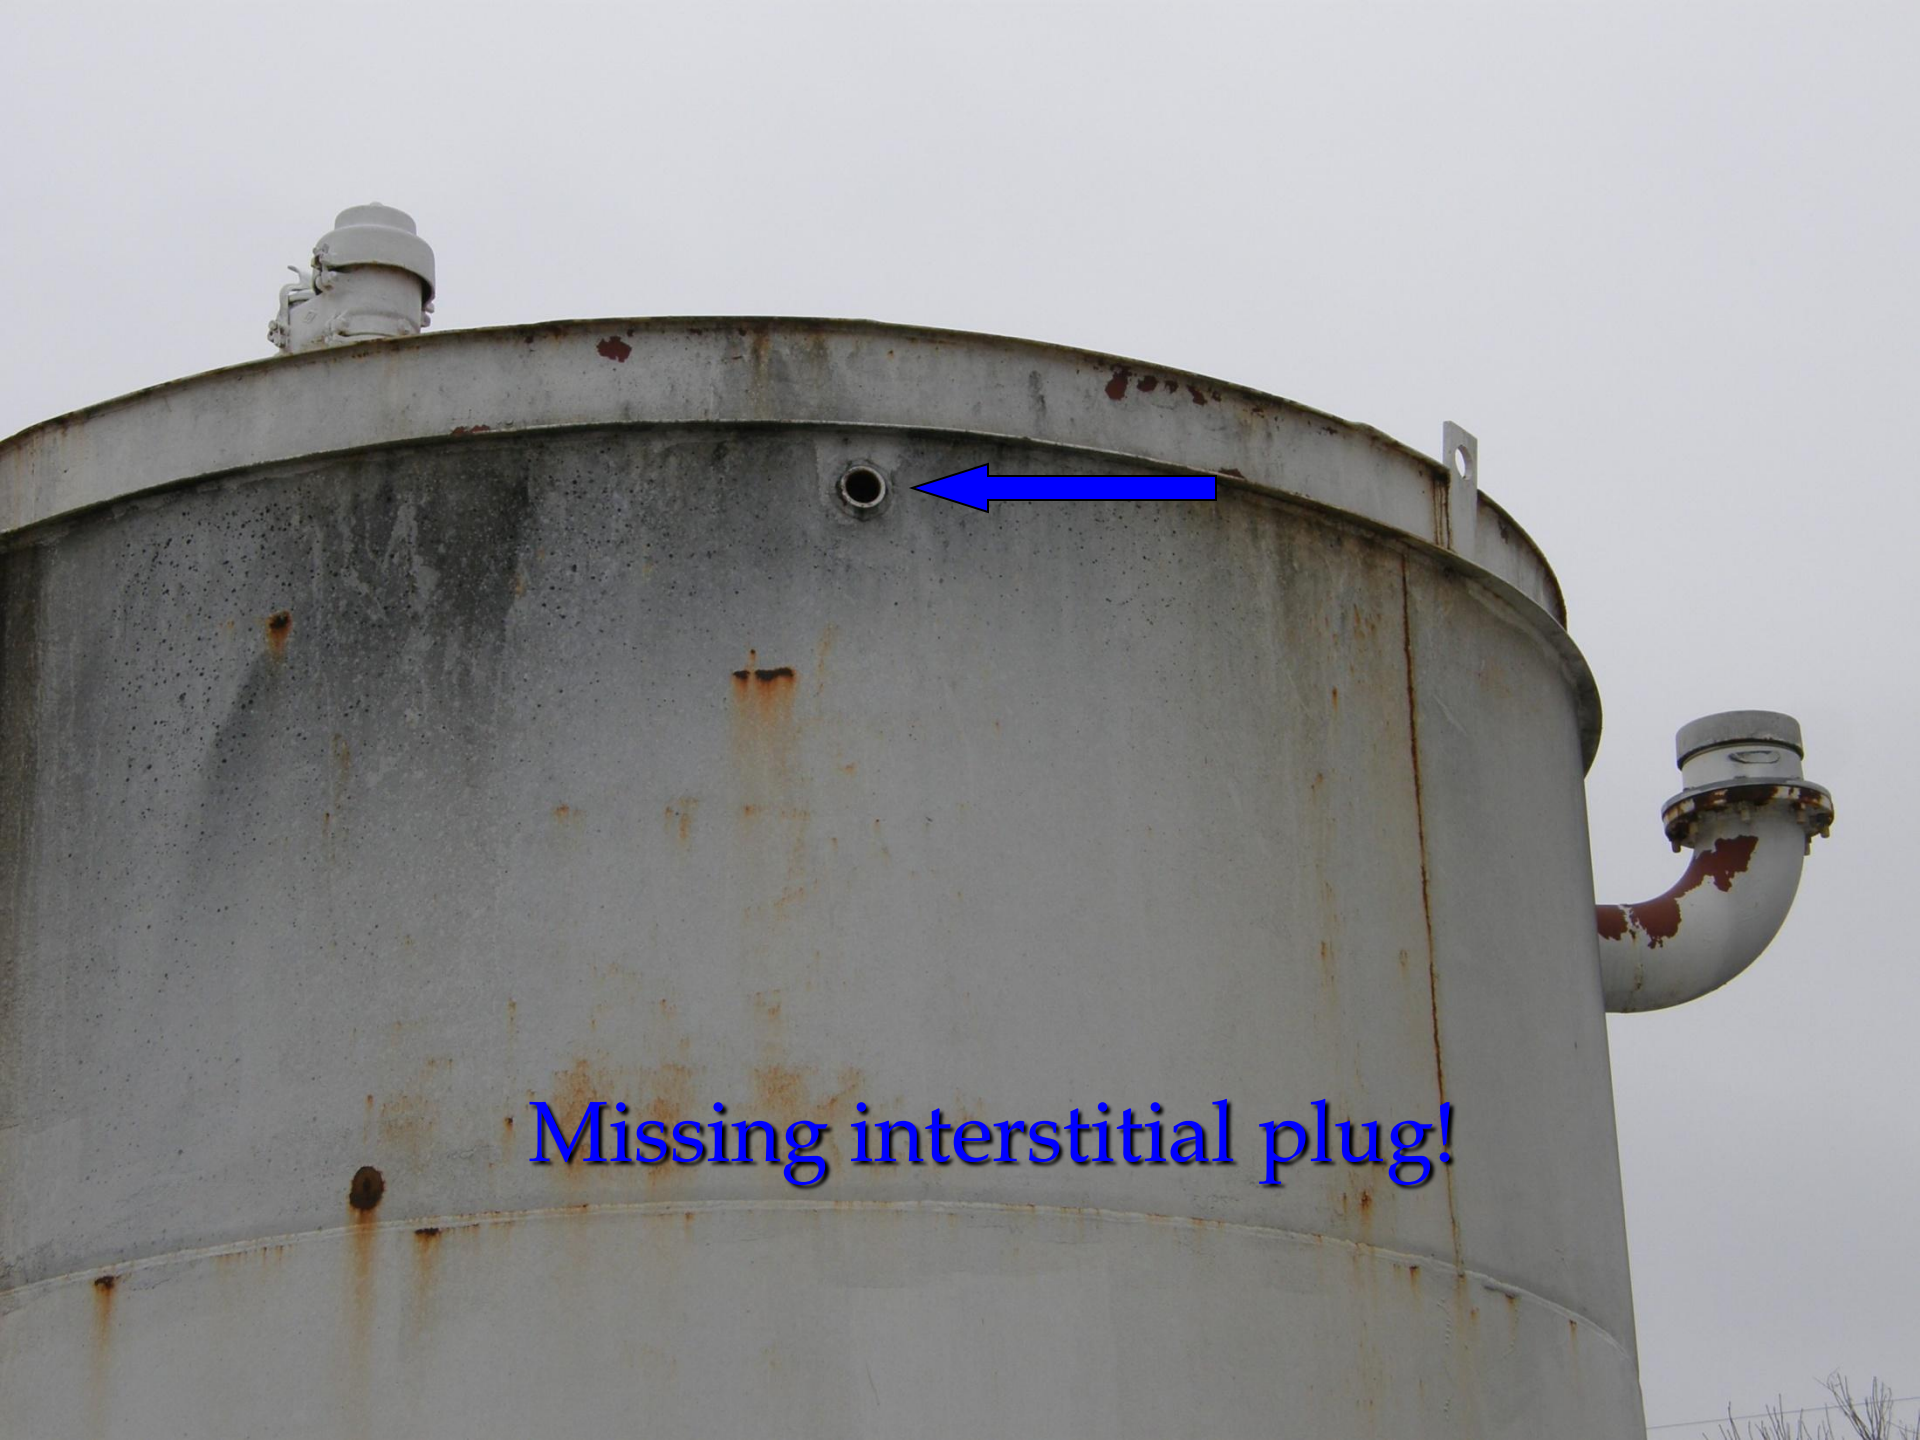
Missing interstitial plug!

Interstice not sealed
