Emerging Solutions for Biofuel-Induced Corrosion for ASTs & USTs

Real world problems caused by the use of Ethanol, Bio-diesel, and Ultra-Low Sulfur Diesel, and a look at possible solutions

Marshall T. Mott-Smith, President, Mott-Smith Consulting Group, LLC

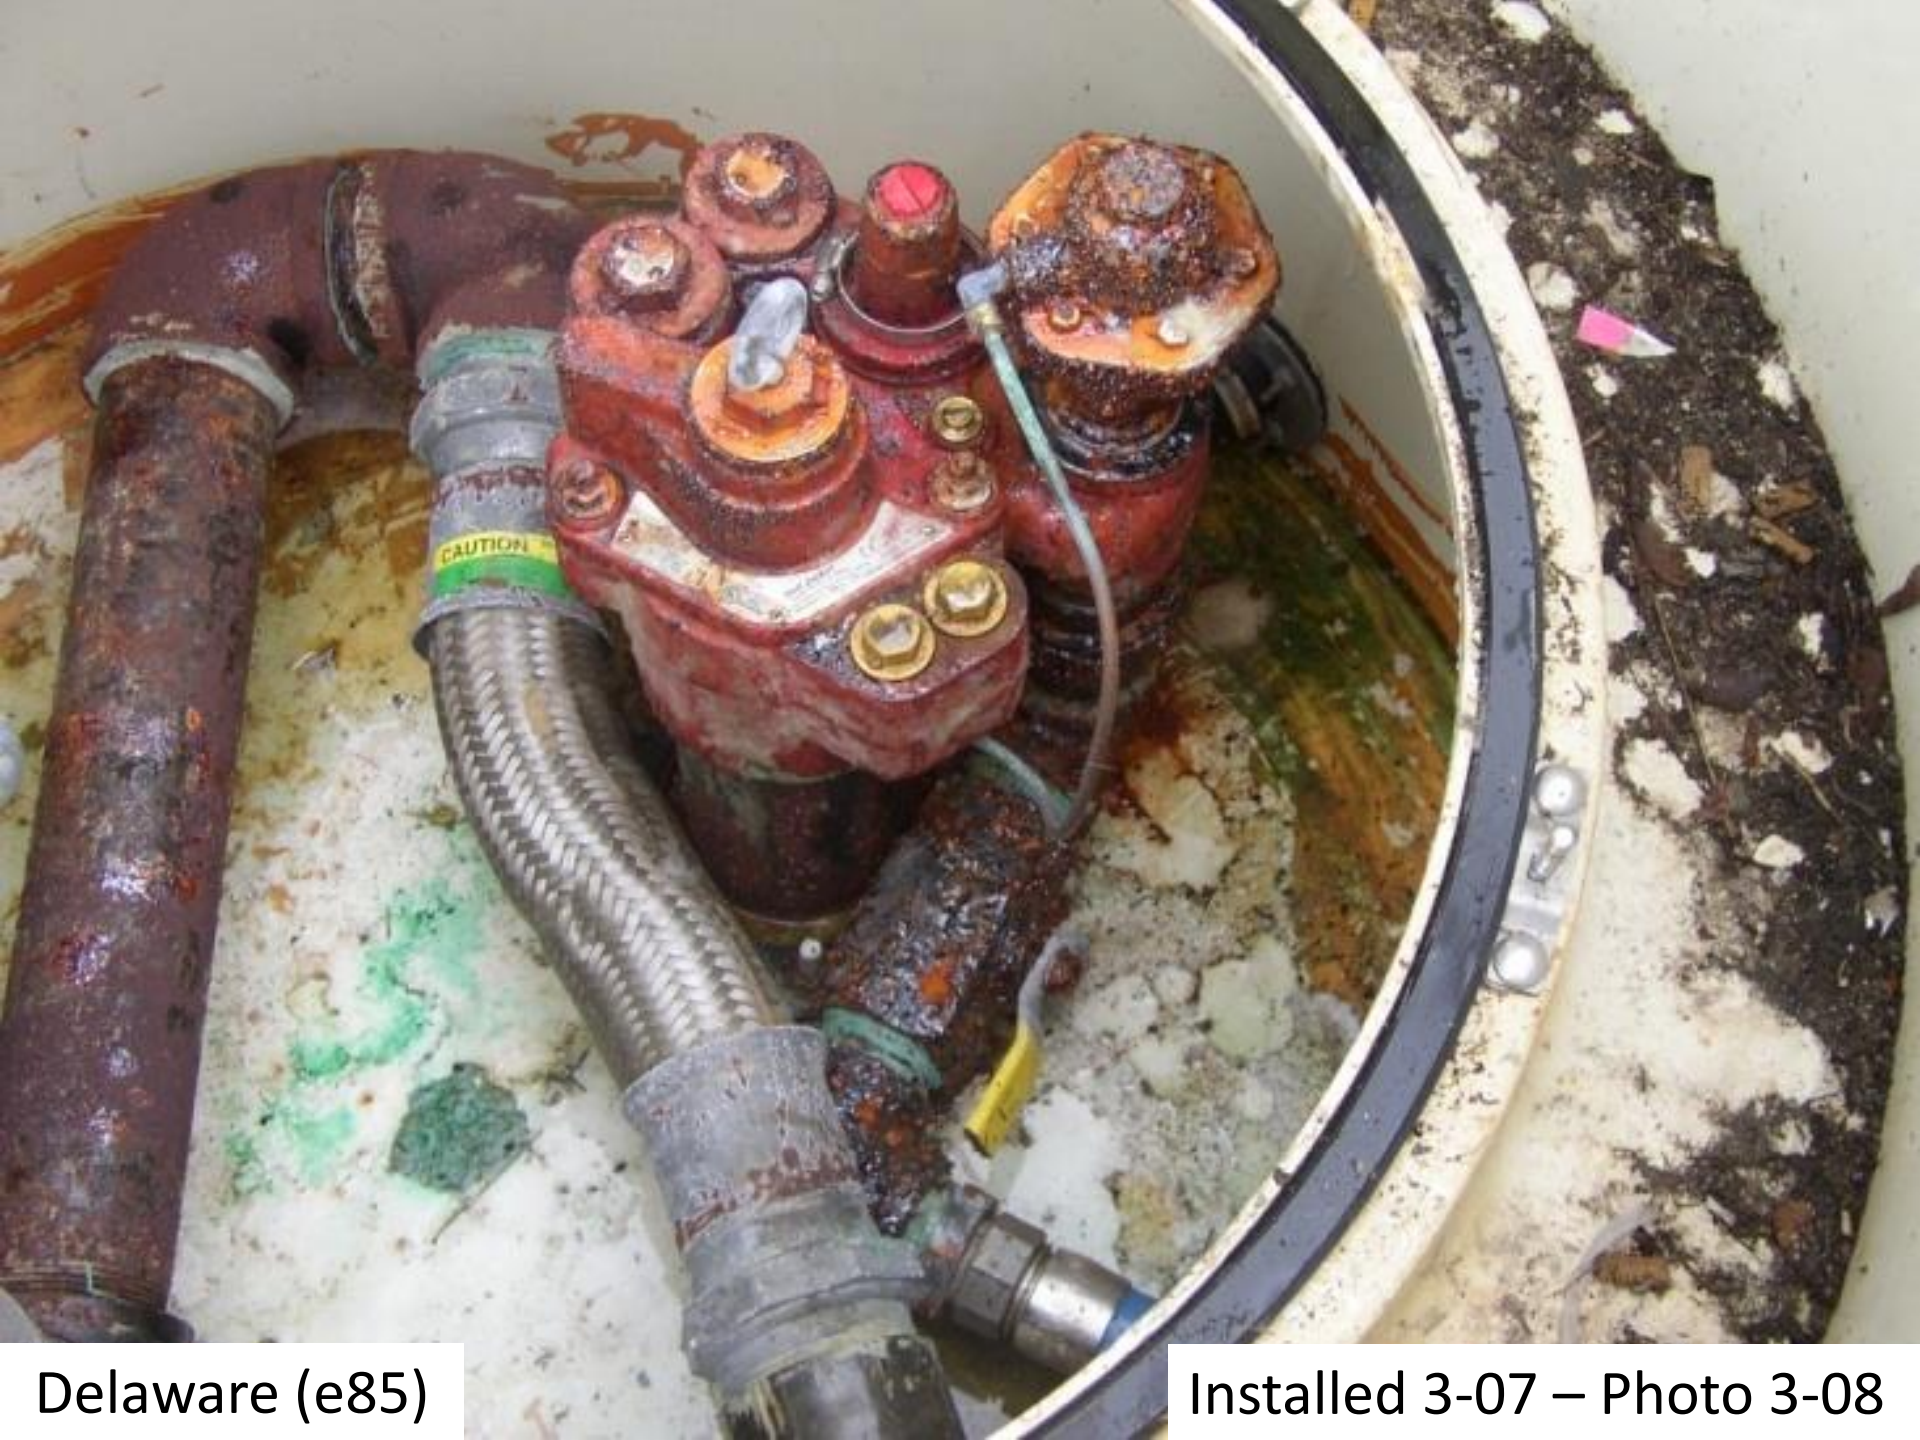
Delaware (e85)

Installed 3-07 – Photo 3-08

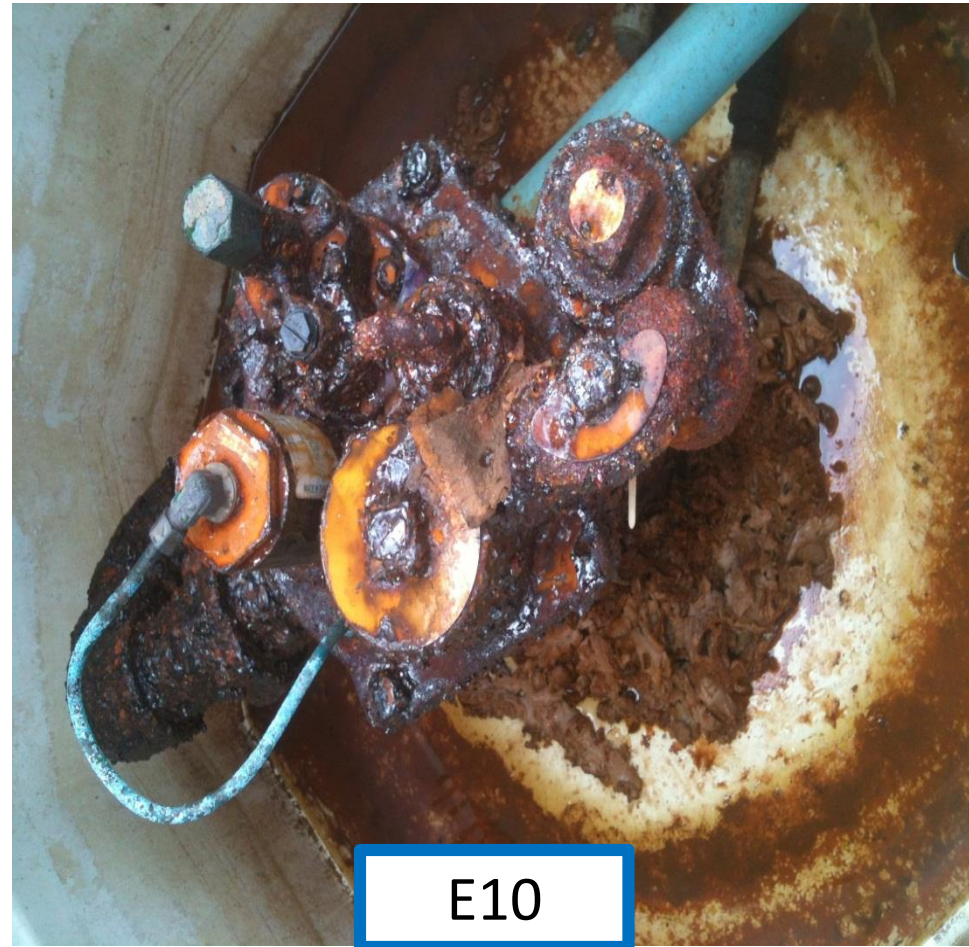
Mississippi

Installed 8-07 - Photos 3-12

Same Facility - Same Equipment – Same Day- Different Sumps

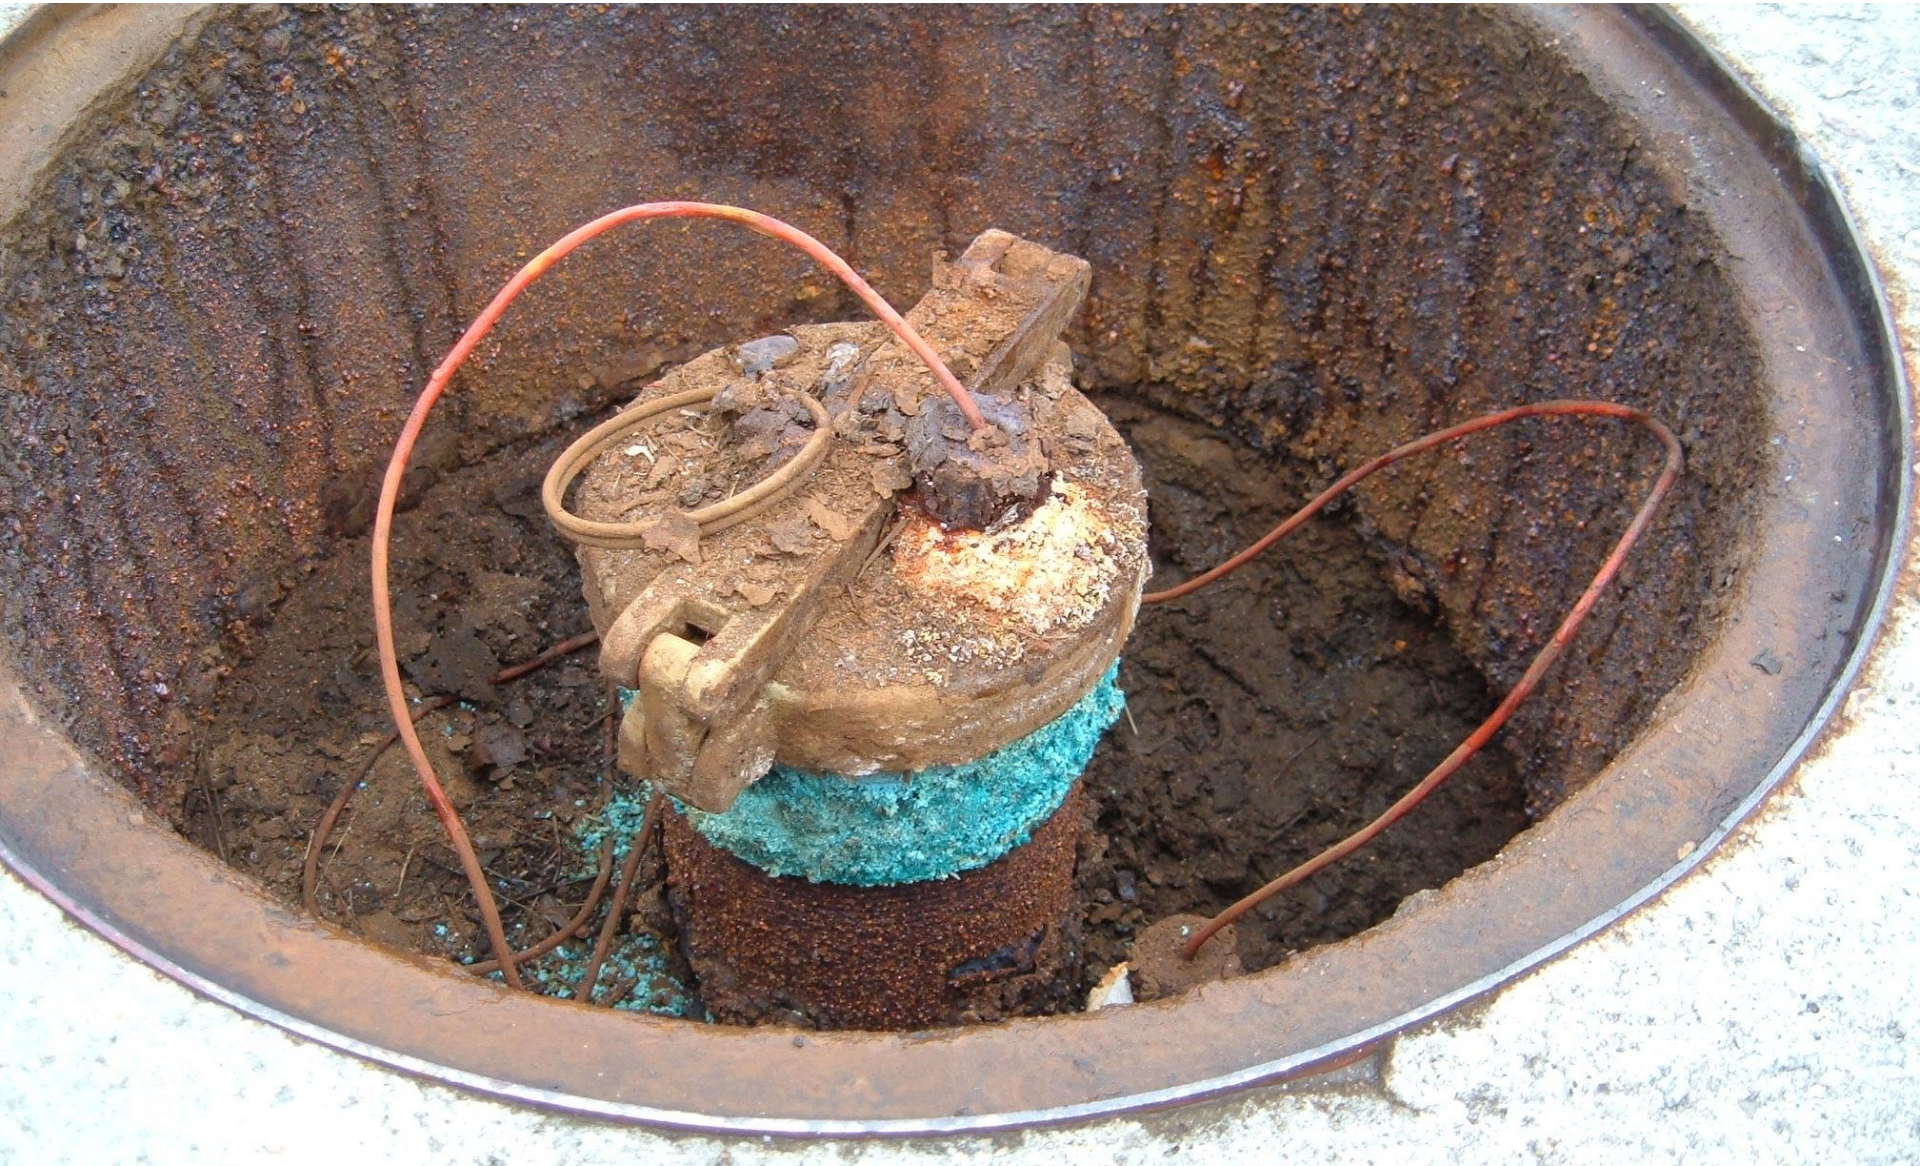
Other Problem Areas – ATG Equipment

Evidence of vapor leaks

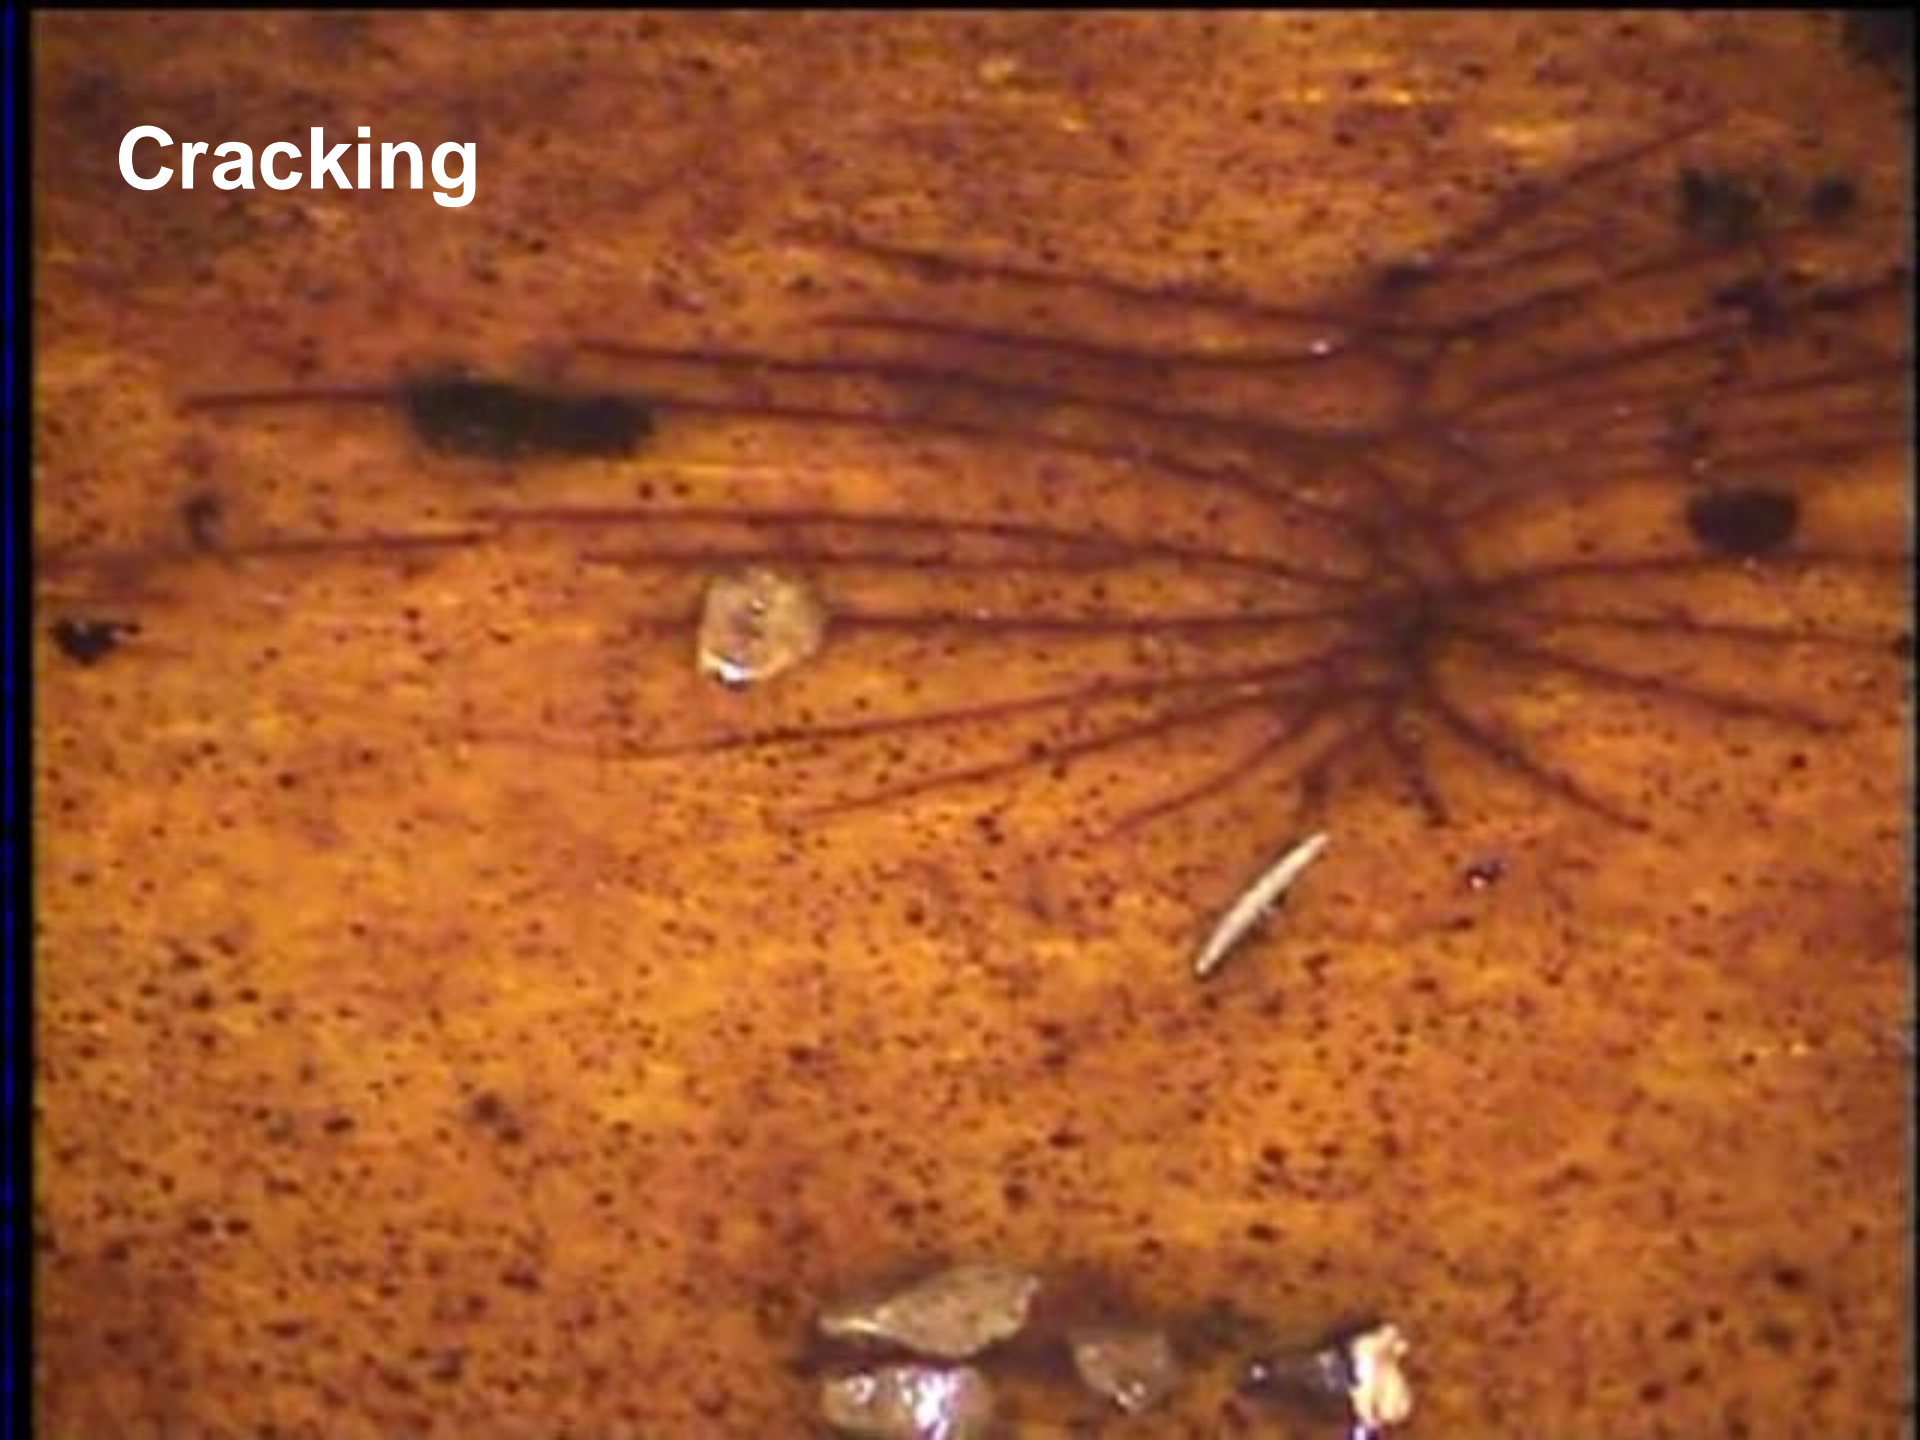
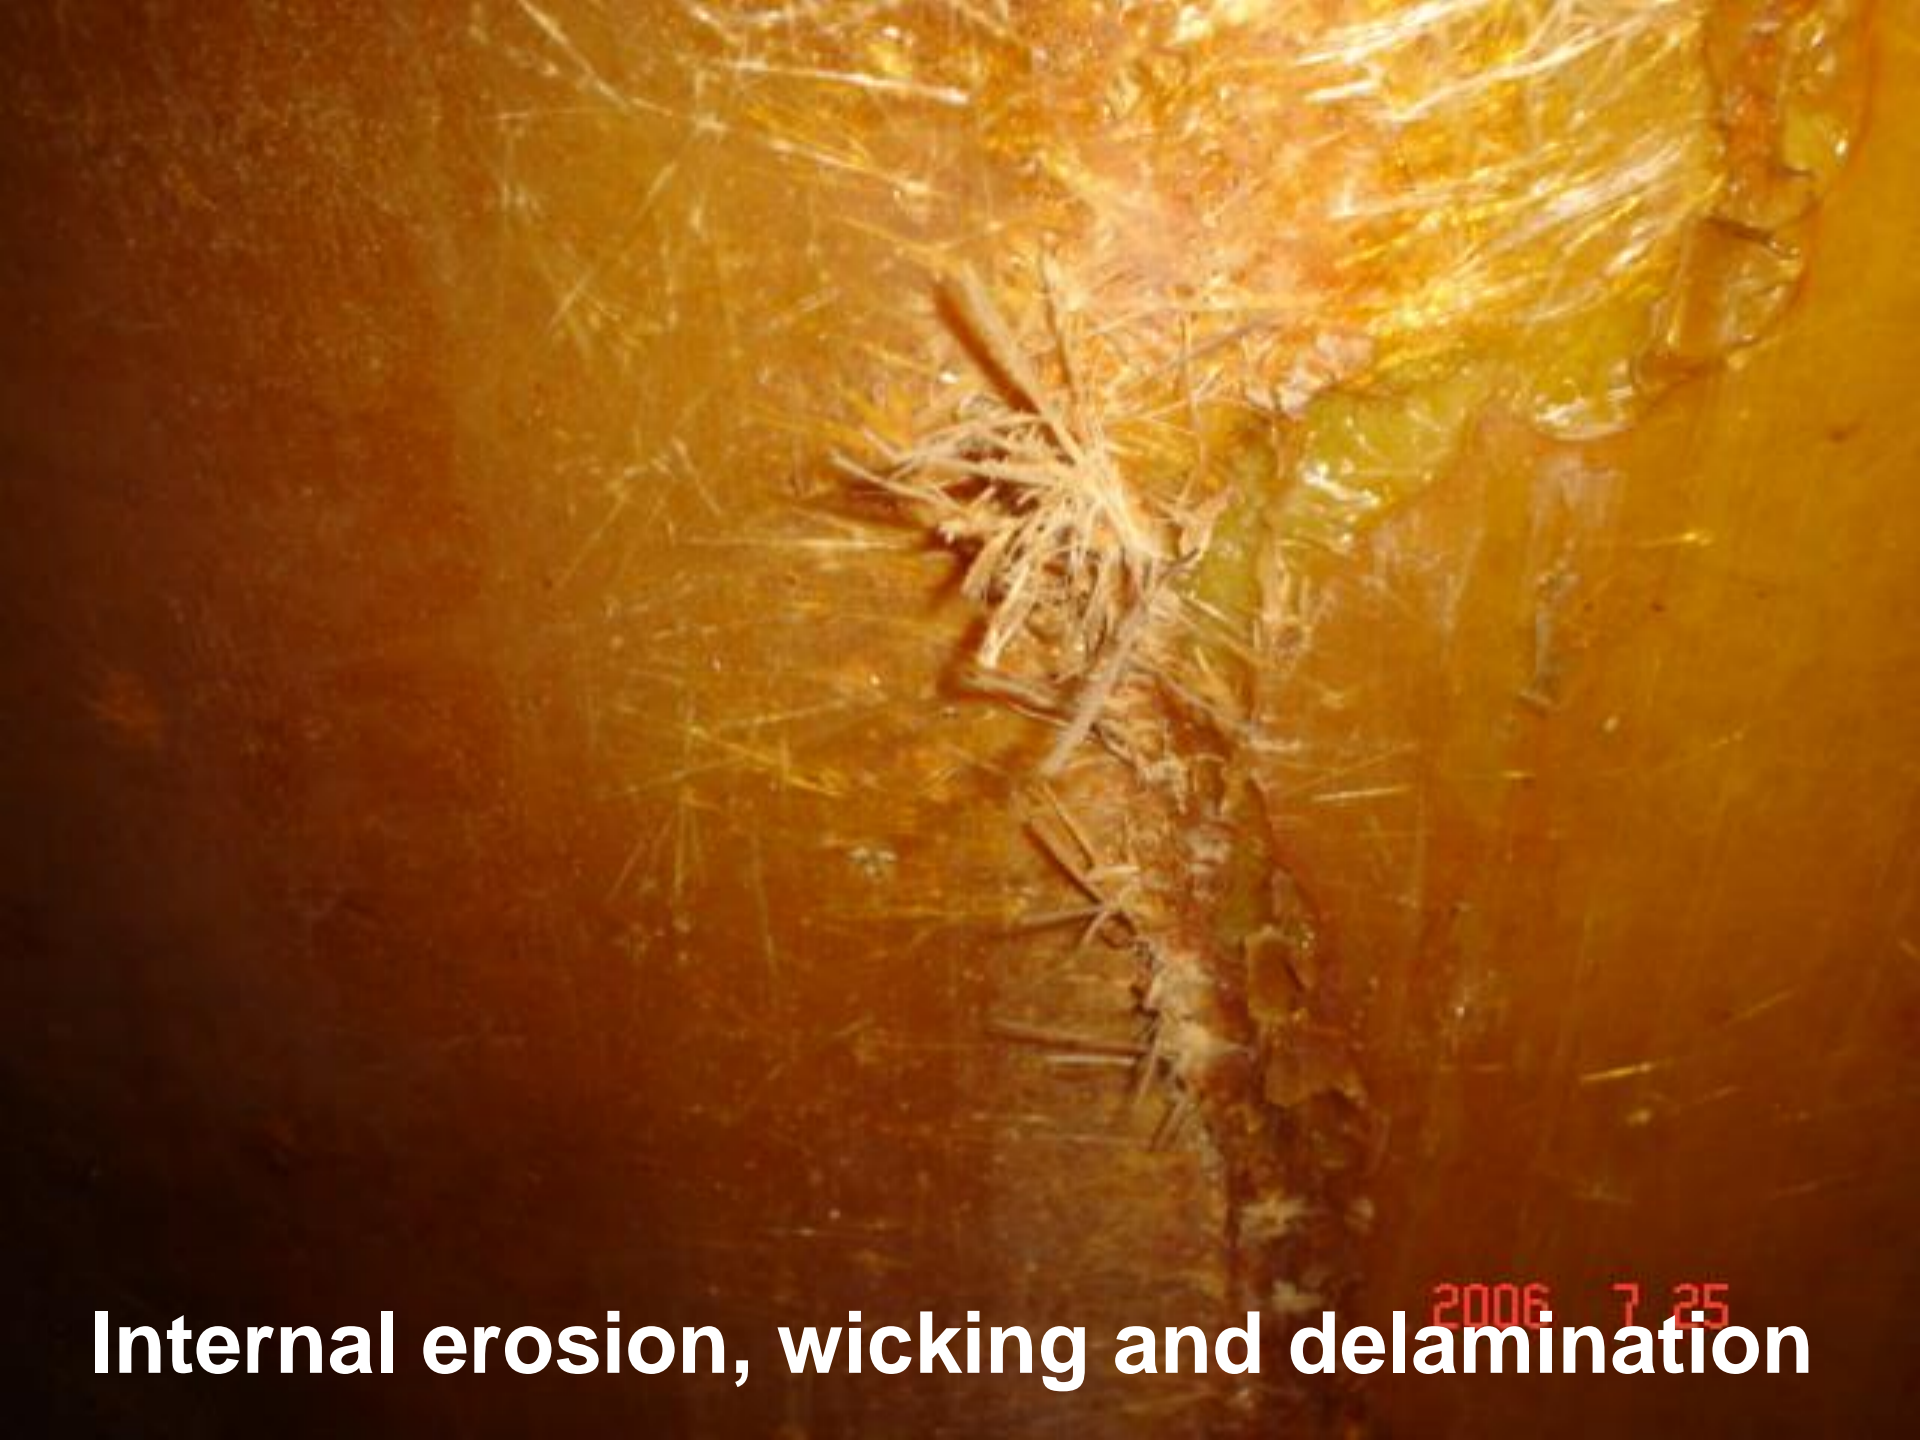
Internal erosion, wicking and delamination

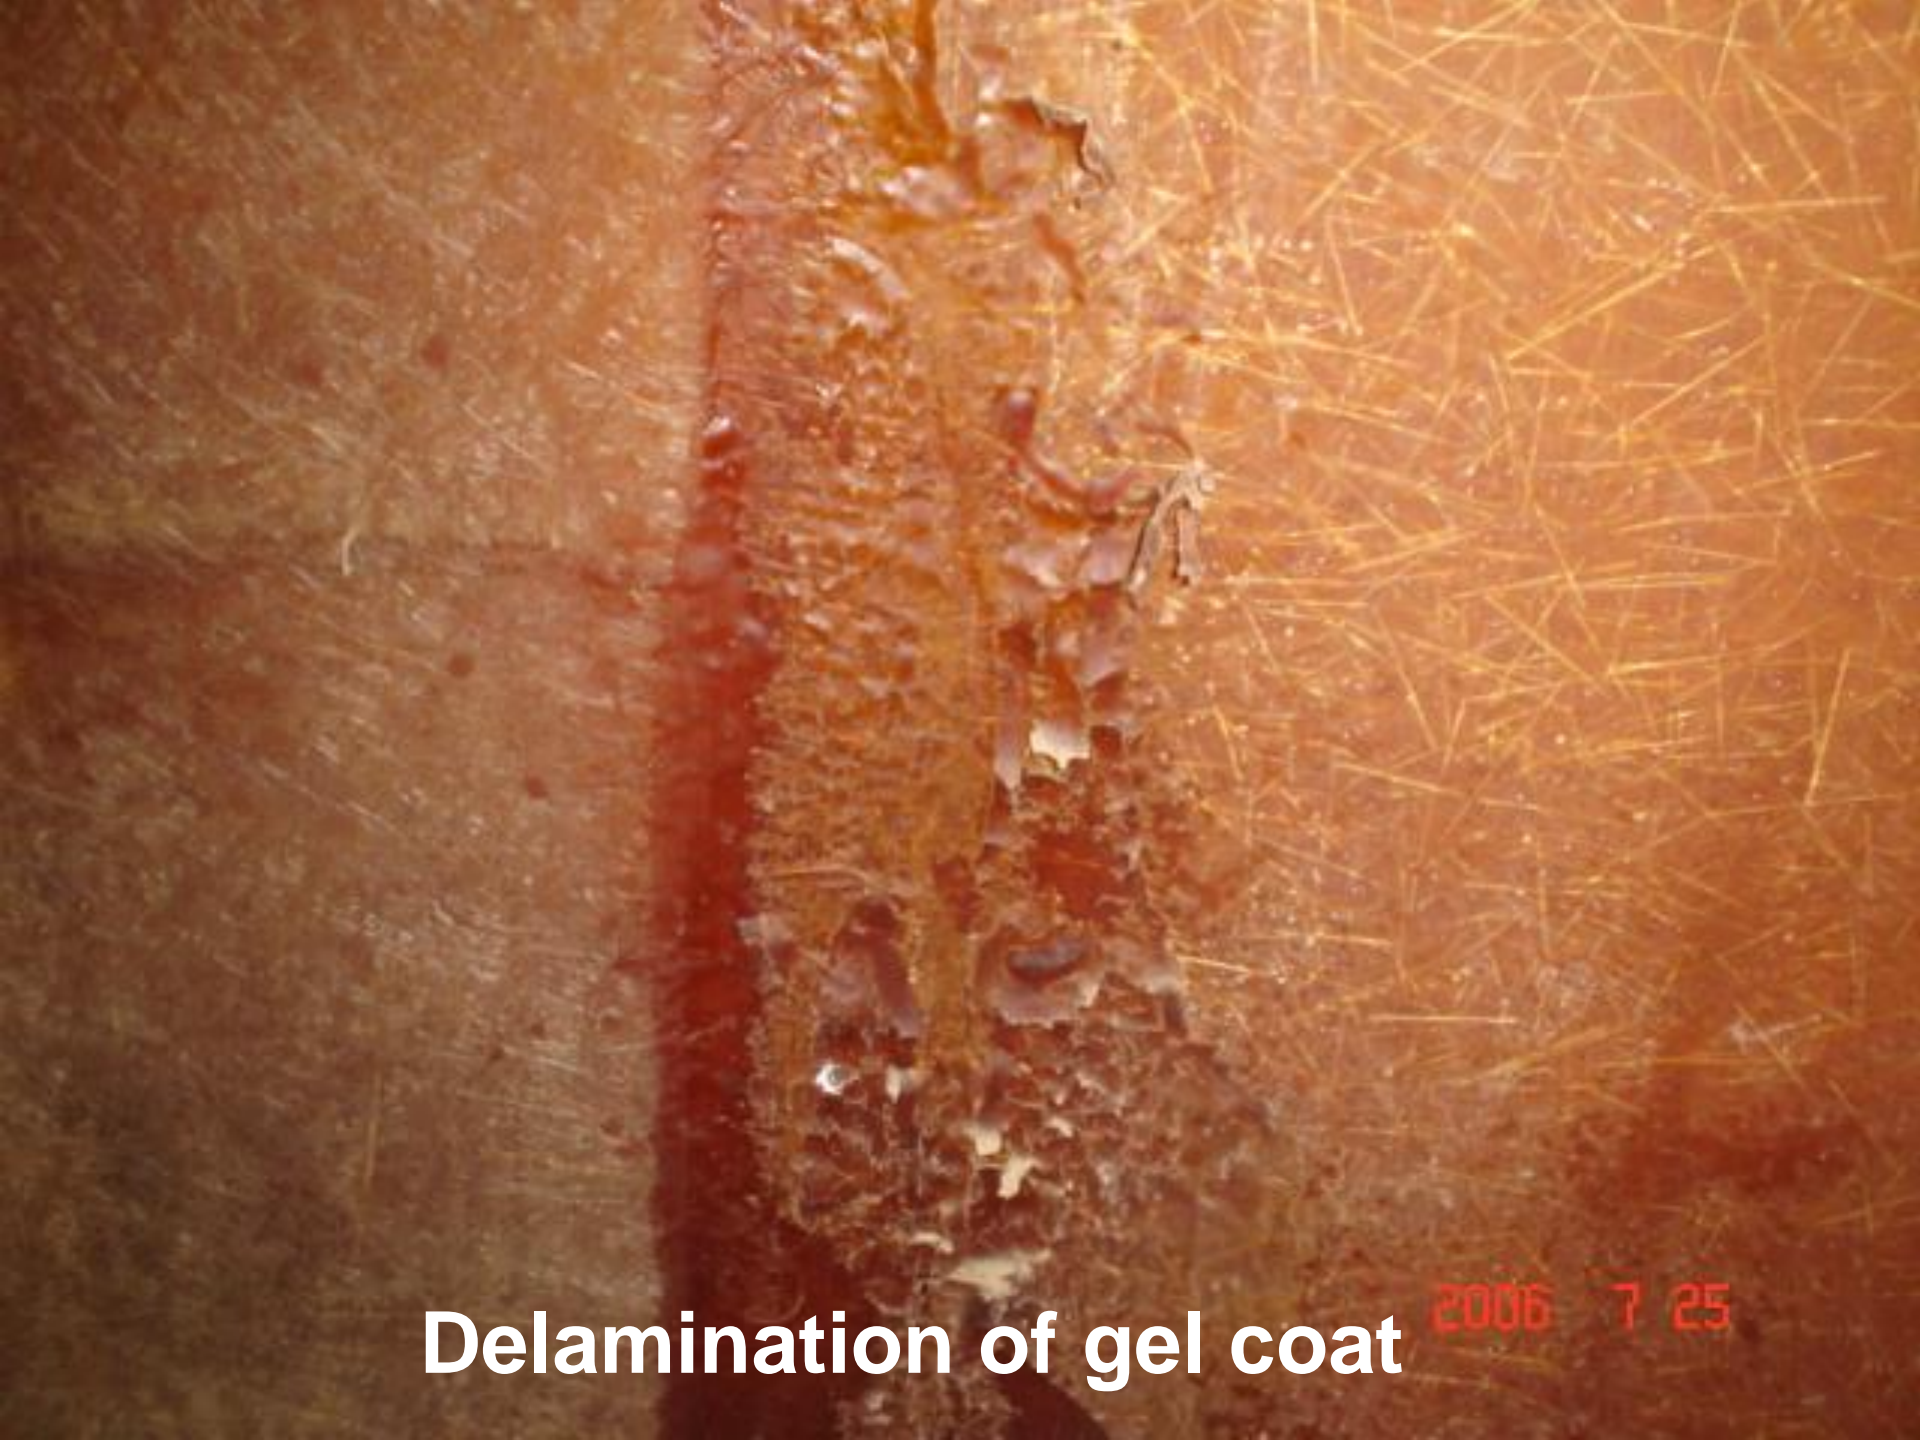
Delamination of gel coat

Blisters on sidewall

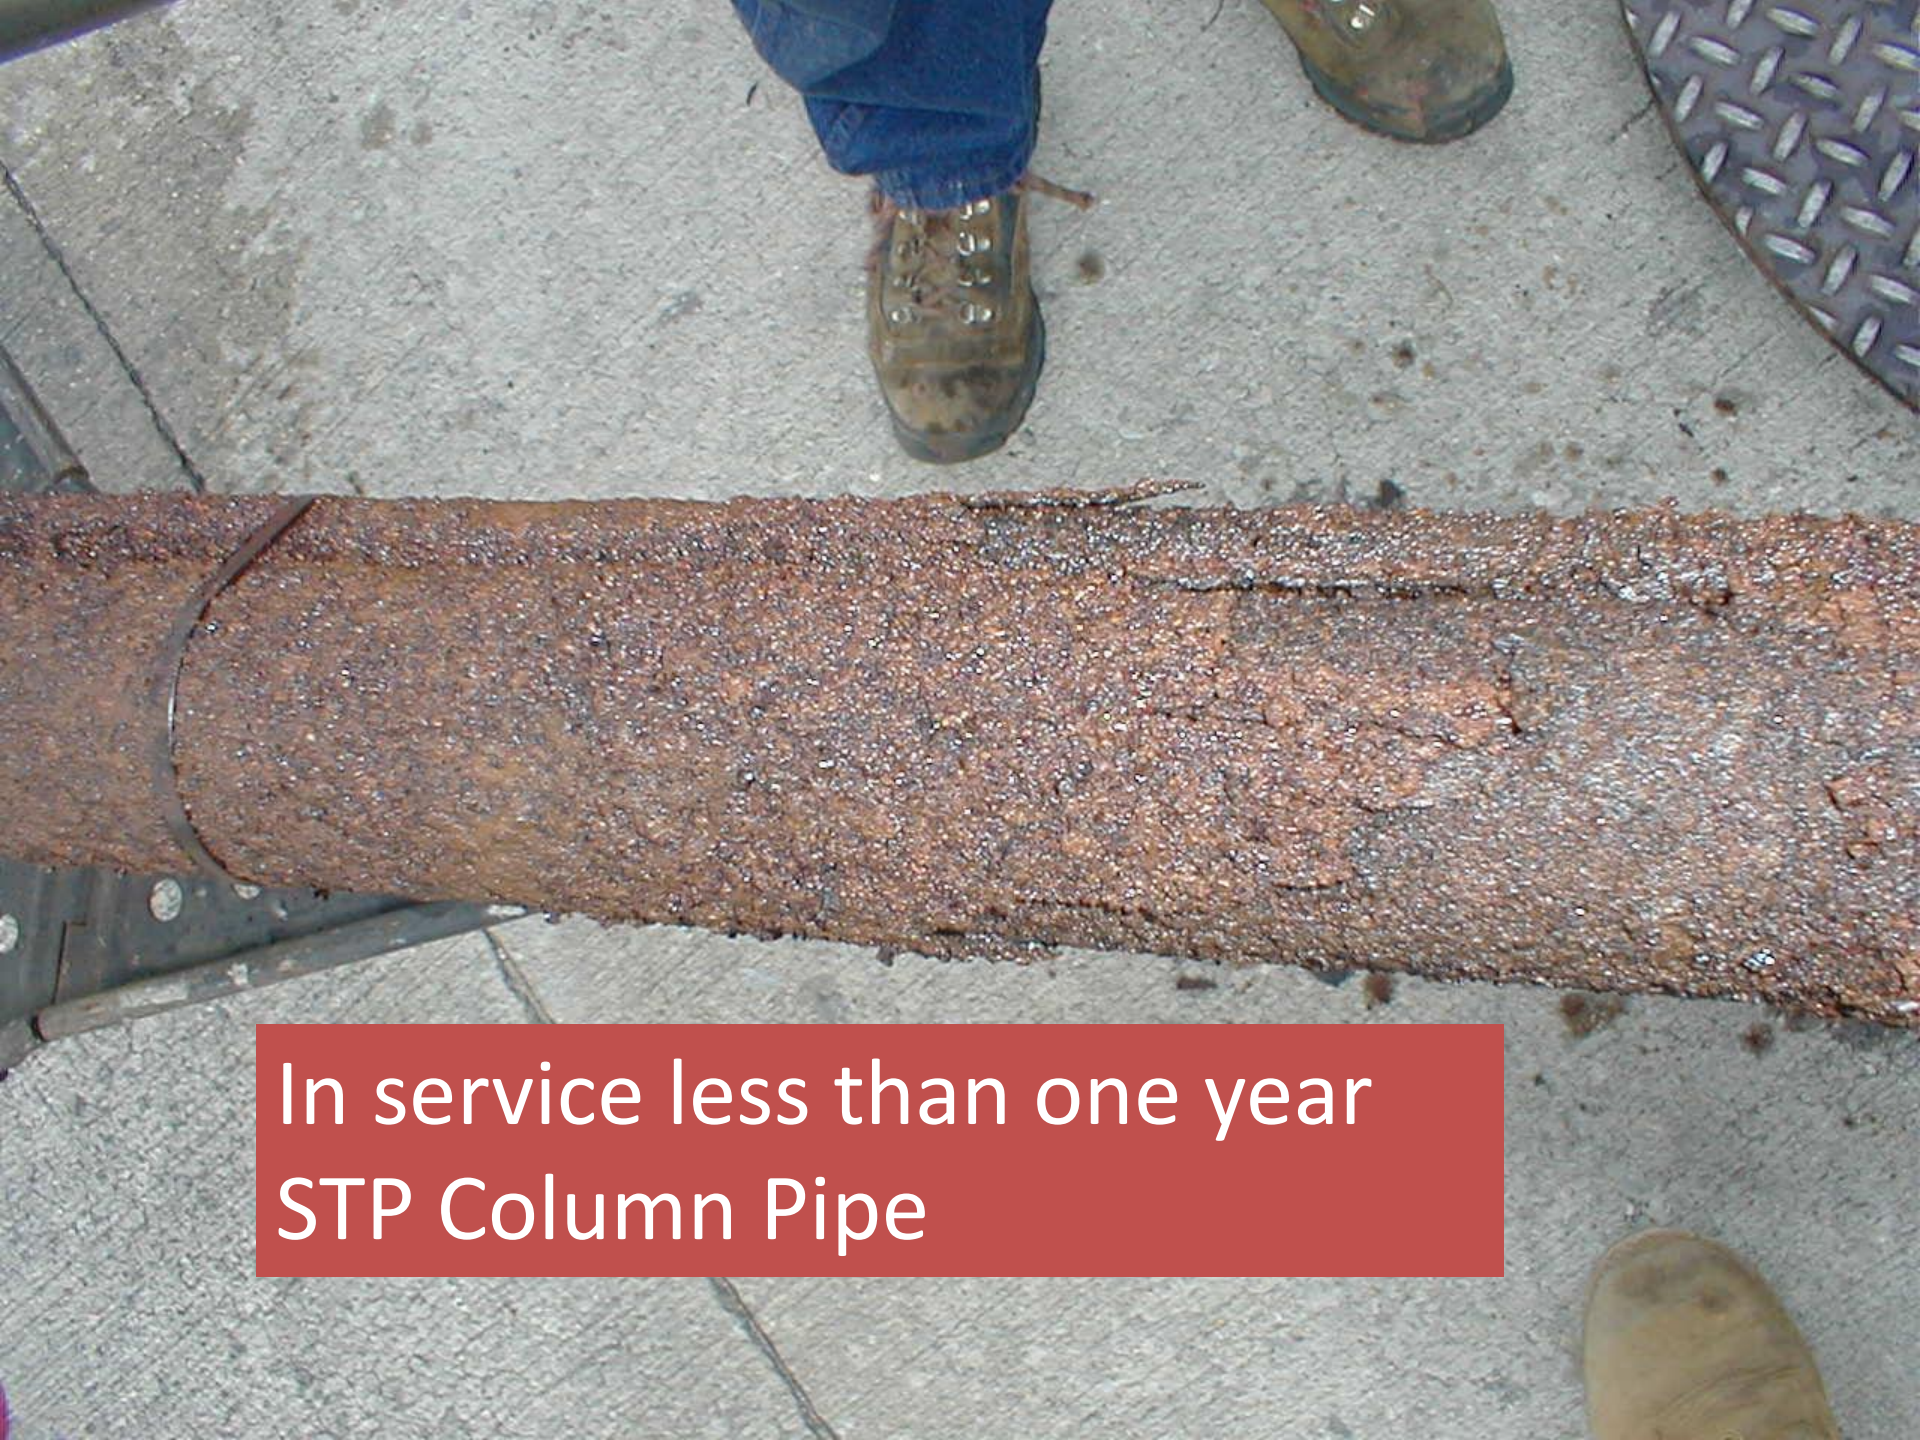
In service less than one year
STP Column Pipe
