Emerging Solutions for Biofuel-Induced Corrosion for ASTs & USTs

Real world problems caused by the use of Ethanol, Bio-diesel, and Ultra-Low Sulfur Diesel, and a look at possible solutions

Marshall T. Mott-Smith, President

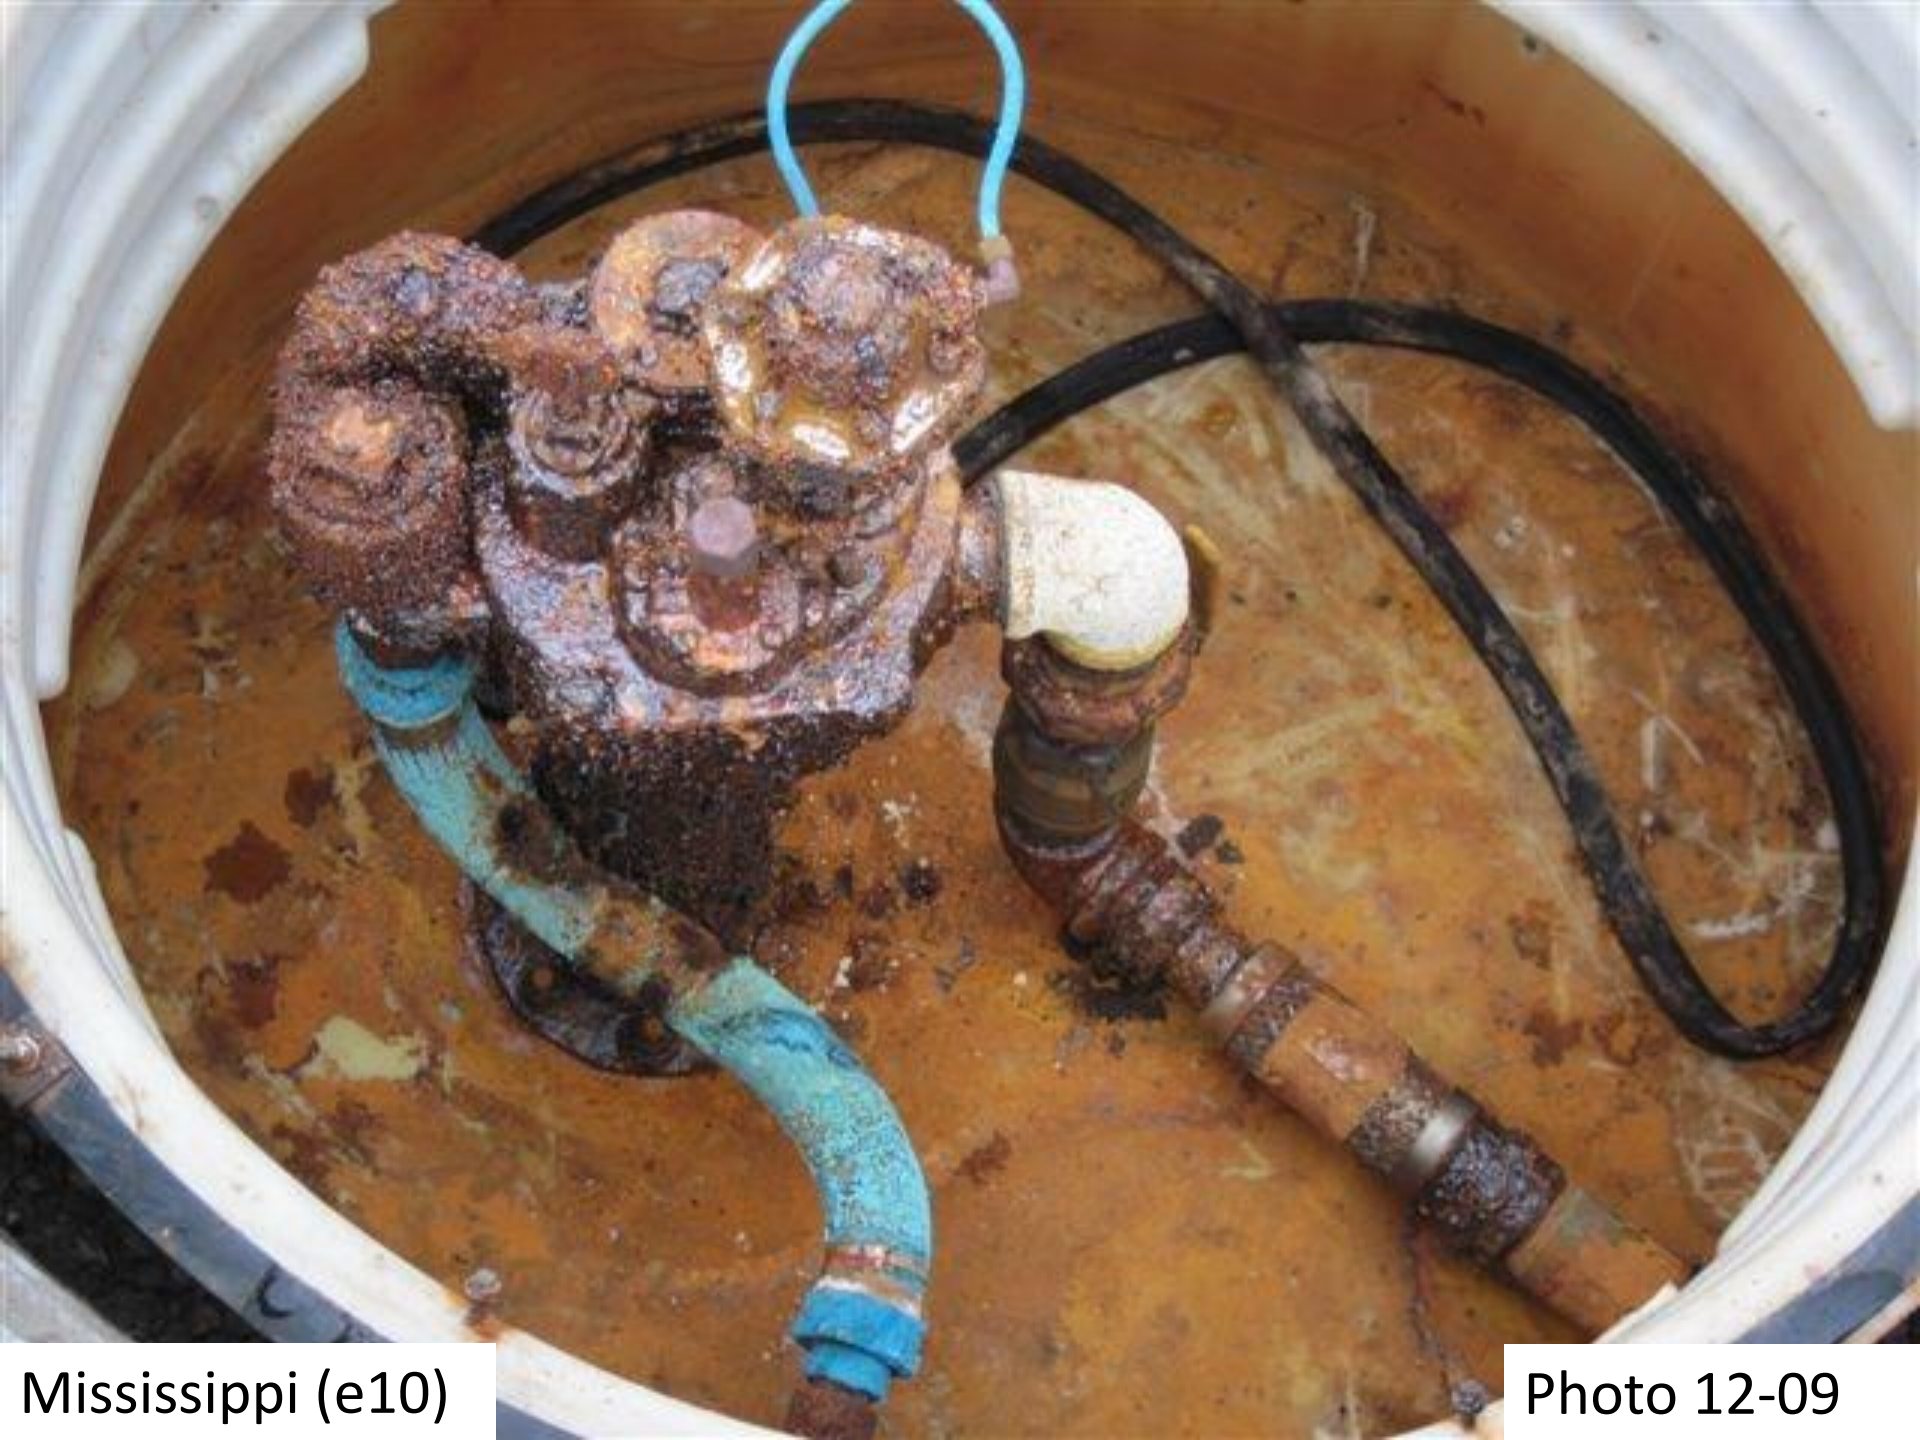
Photo 12-09

Mississippi (e10)

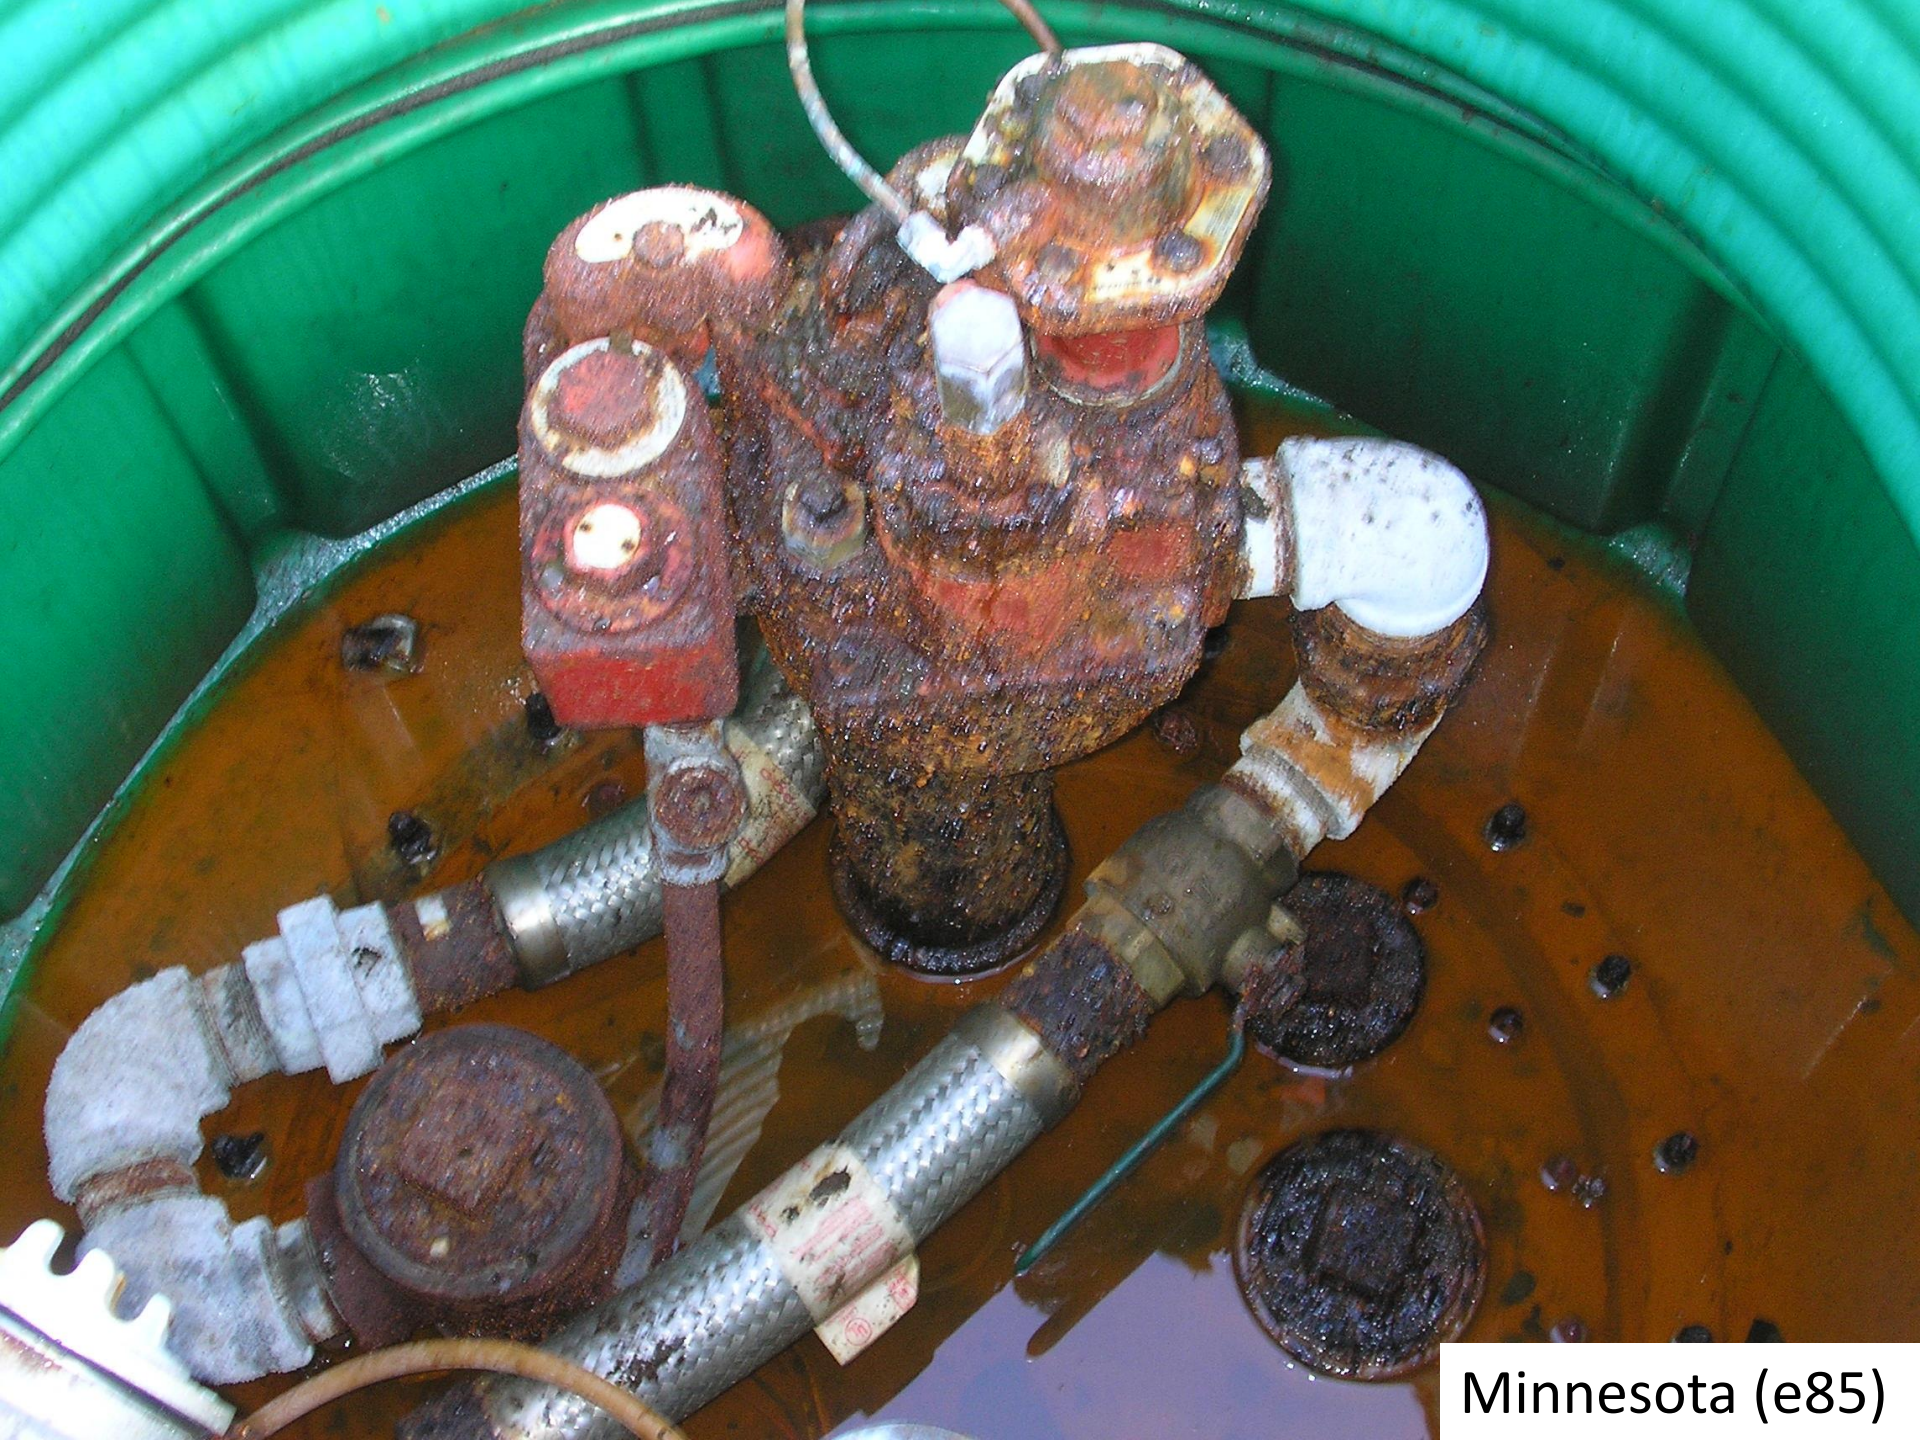
Installed 3-07 – Photo 3-08

Delaware (e85)

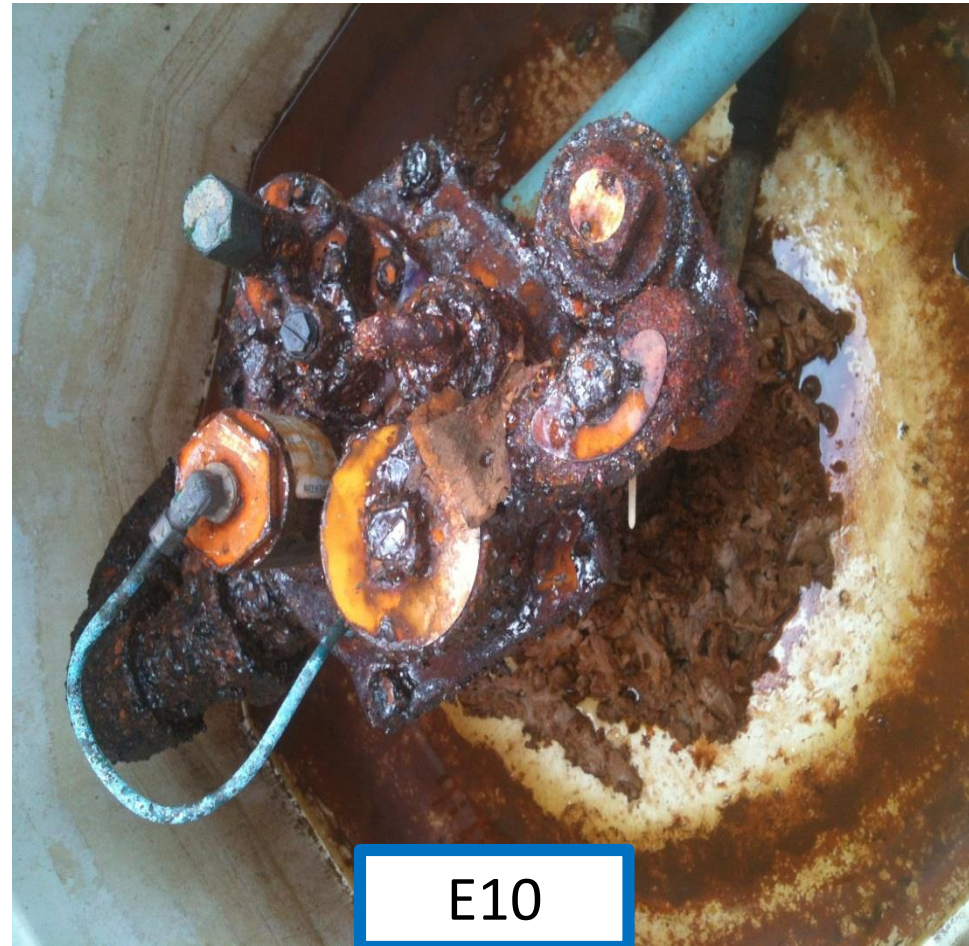
Installed 8-07 - Photos 3-12

E10

Same Facility - Same Equipment – Same Day- Different Sumps

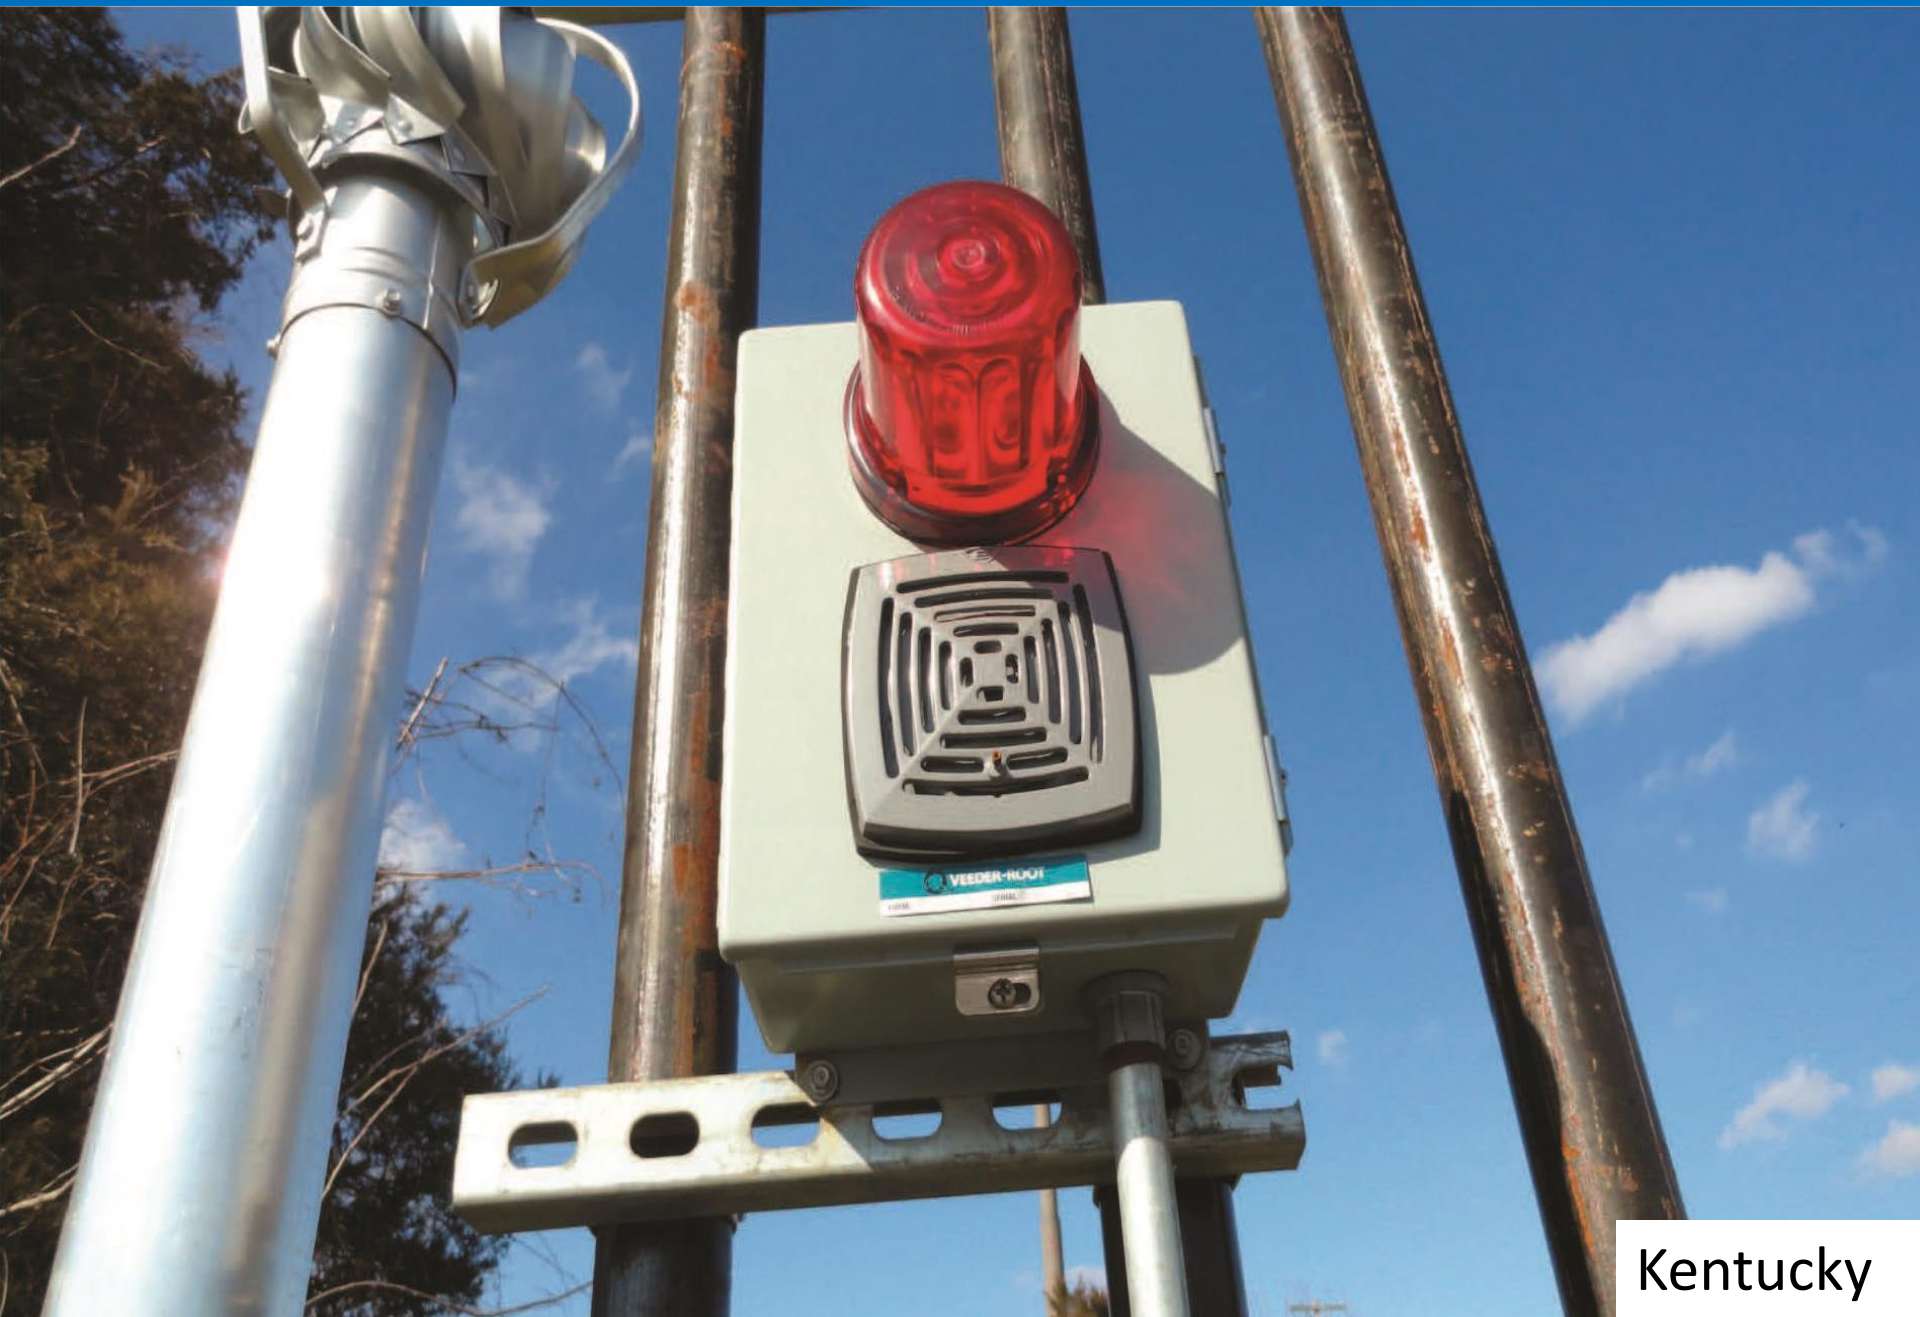
What's this "whirlybird" doing here with the tank vents?

Kentucky

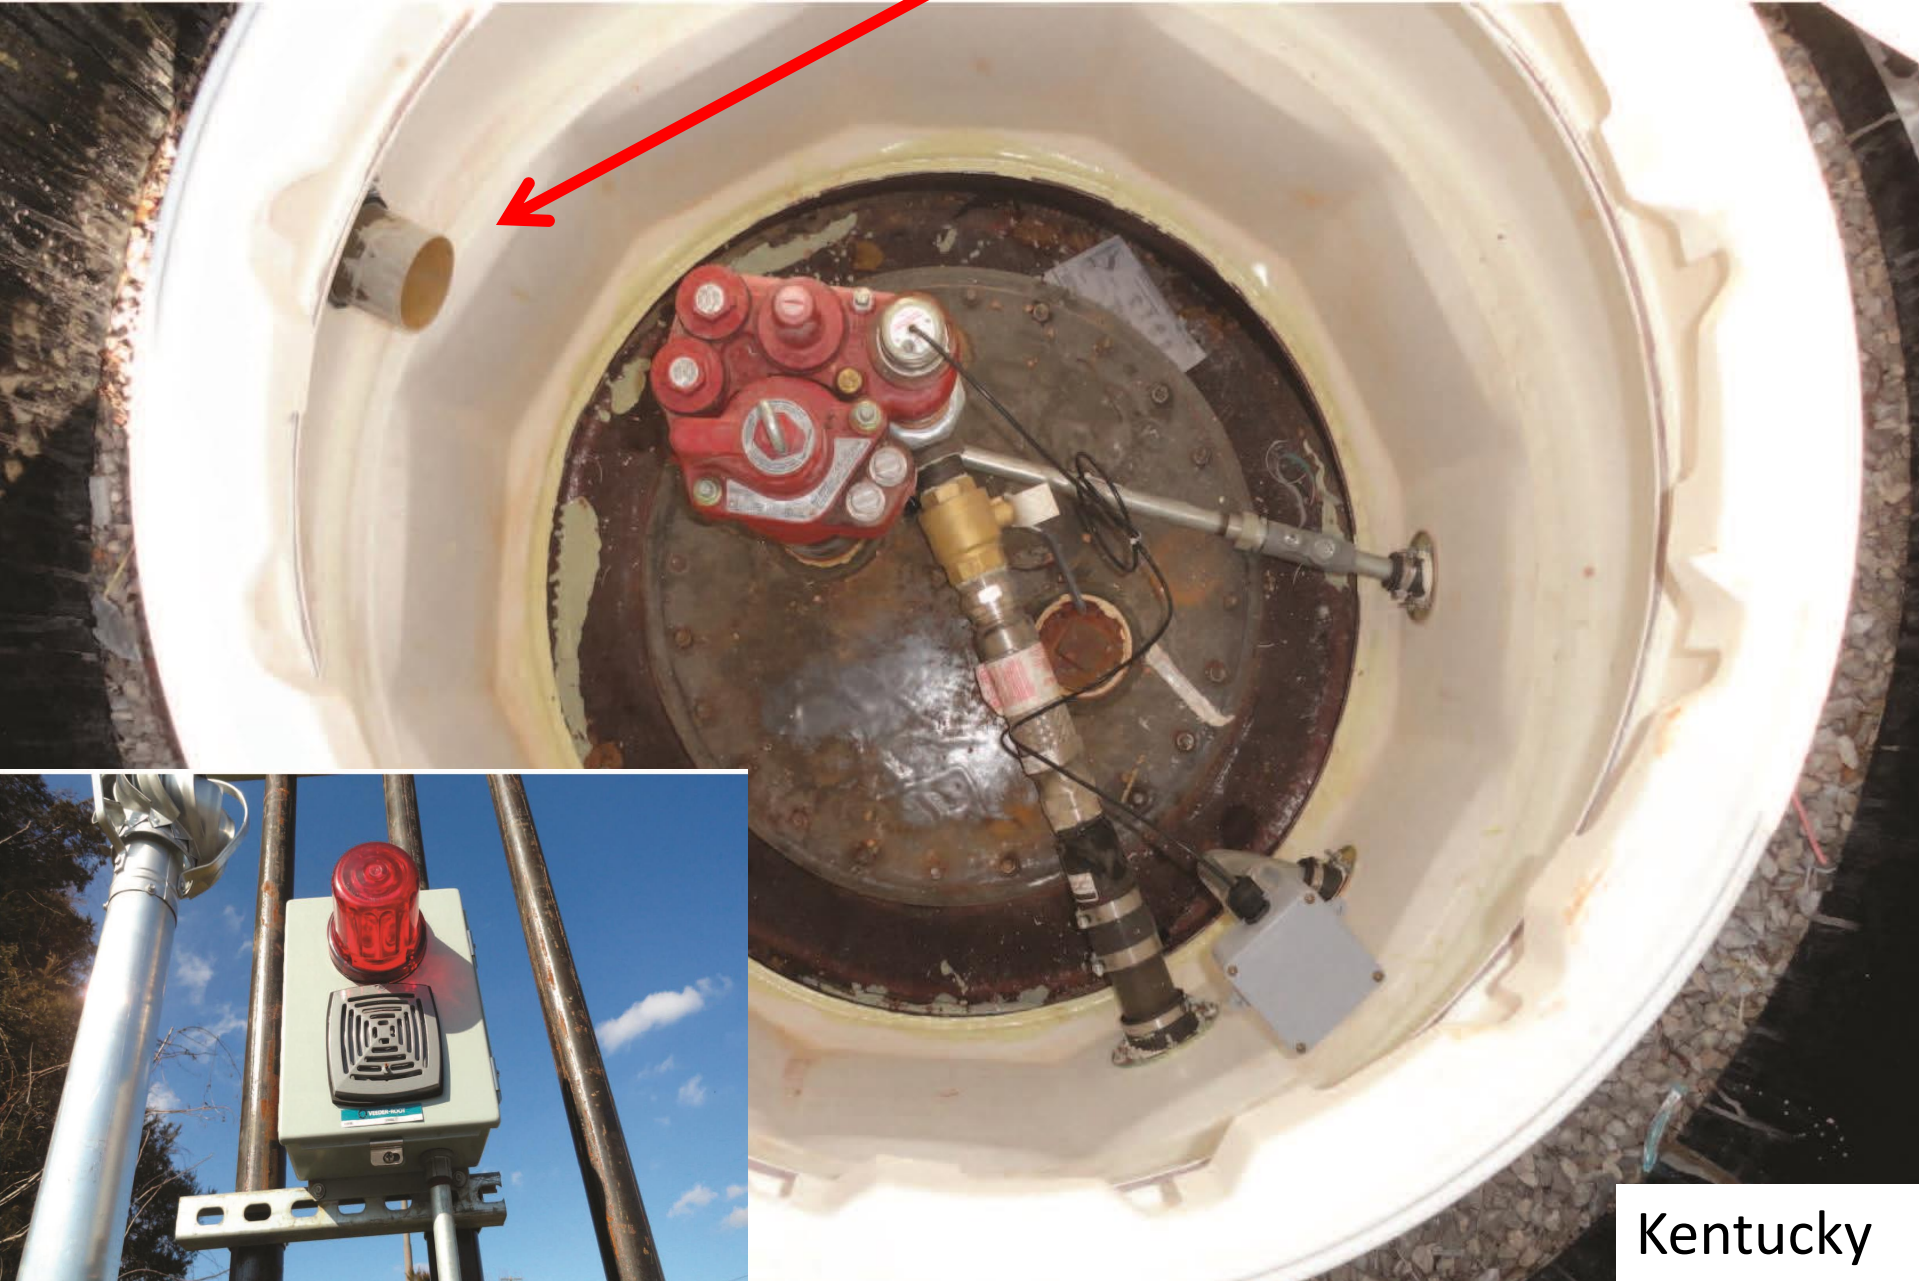
What's this open pipe doing here?

Kentucky

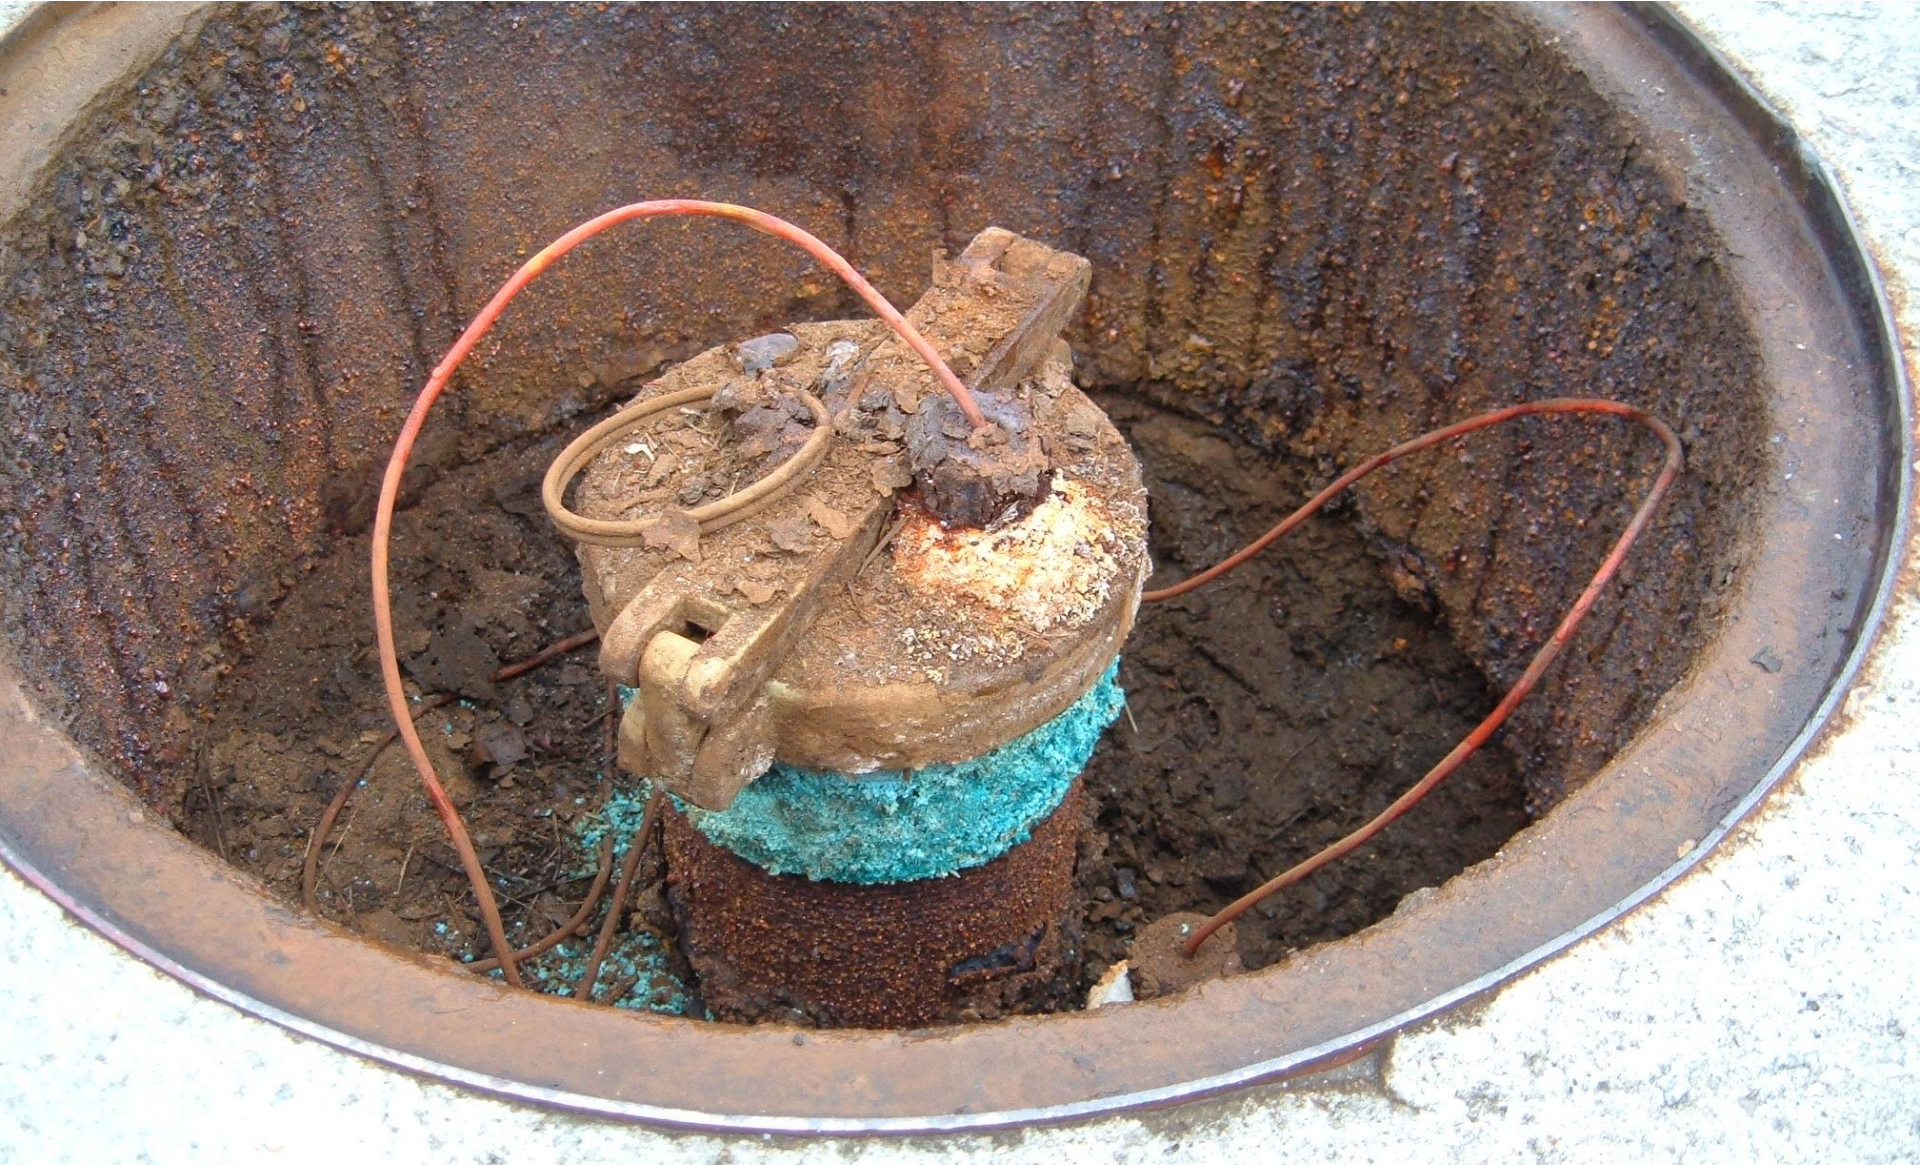
Other Problem Areas – ATG Equipment

Evidence of vapor leaks

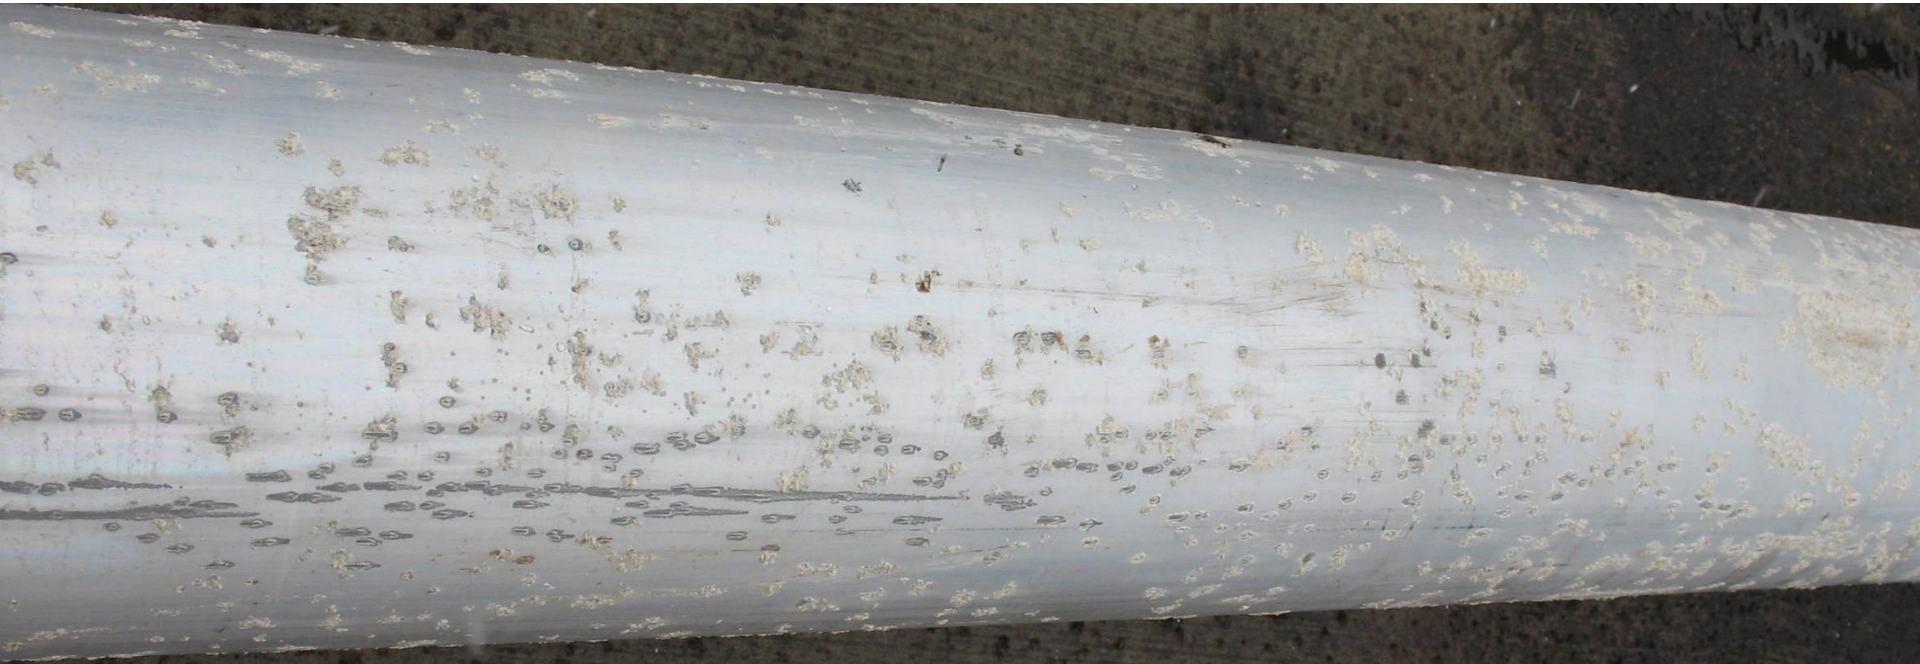
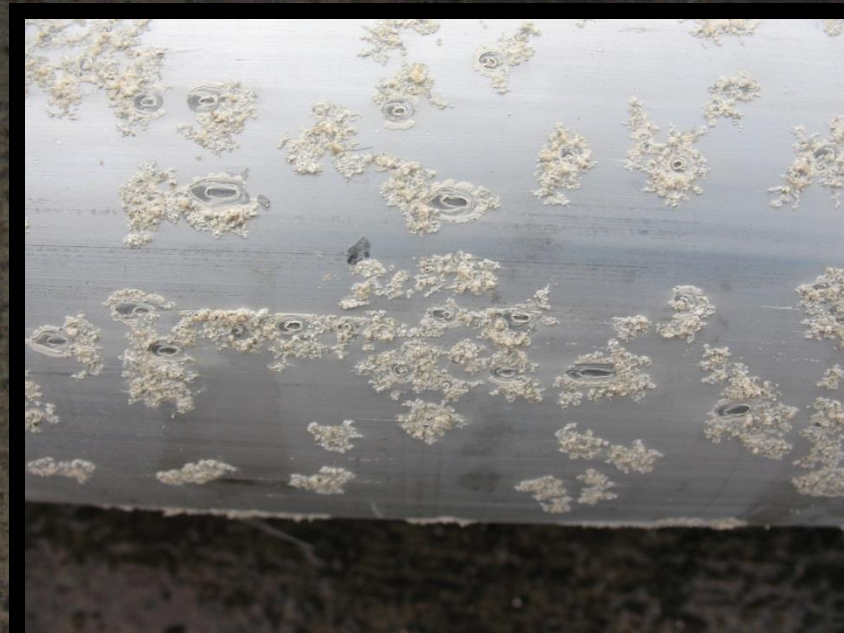
Corrosion on Aluminum Drop Tubes

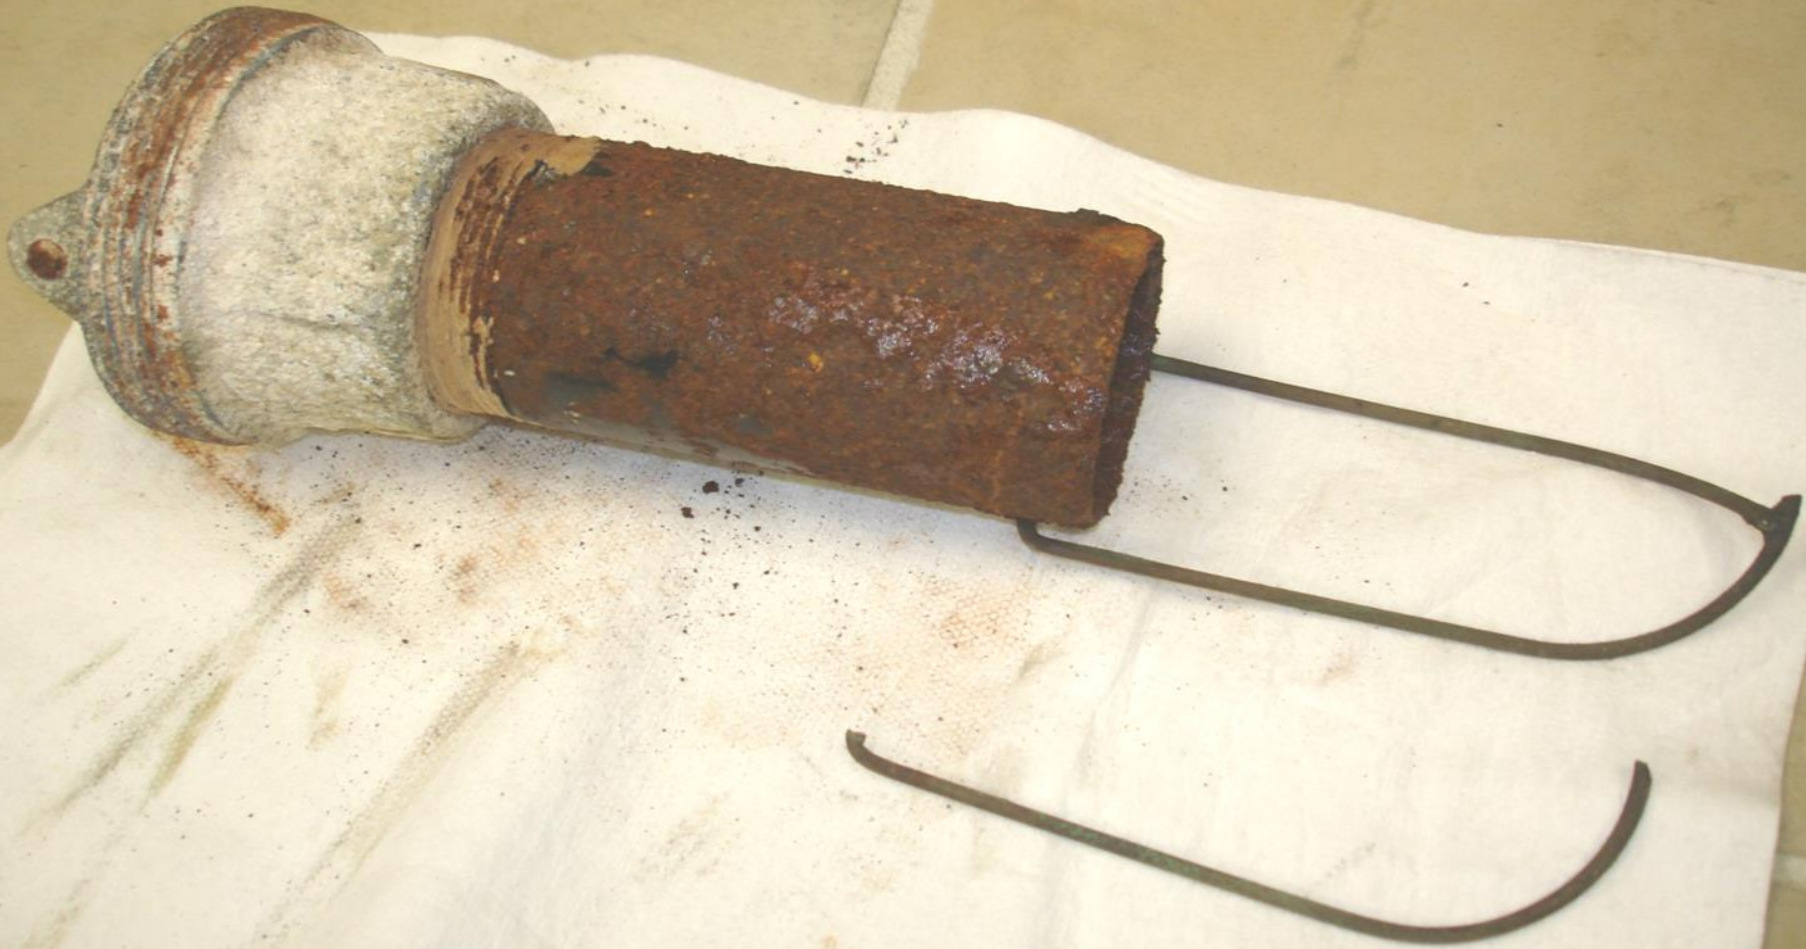
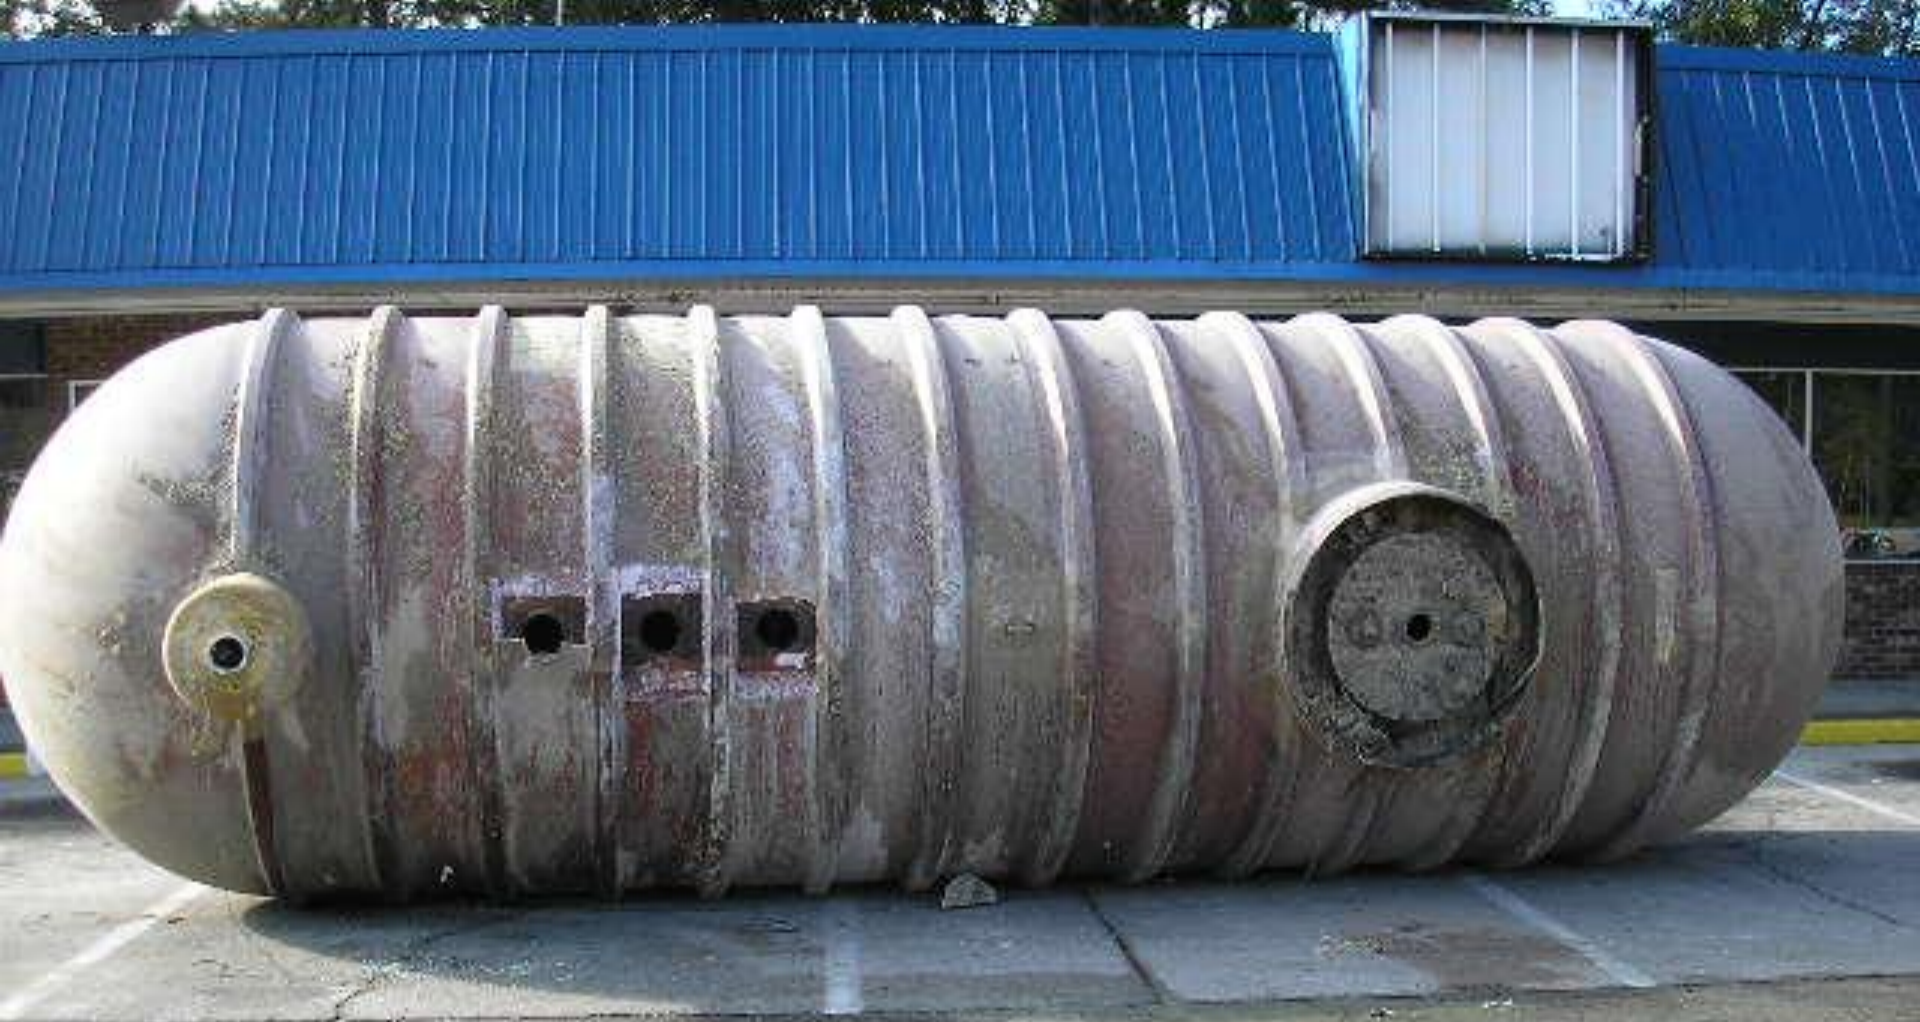
Corrosion on Ball Float Valve Overfill Protection Equipment

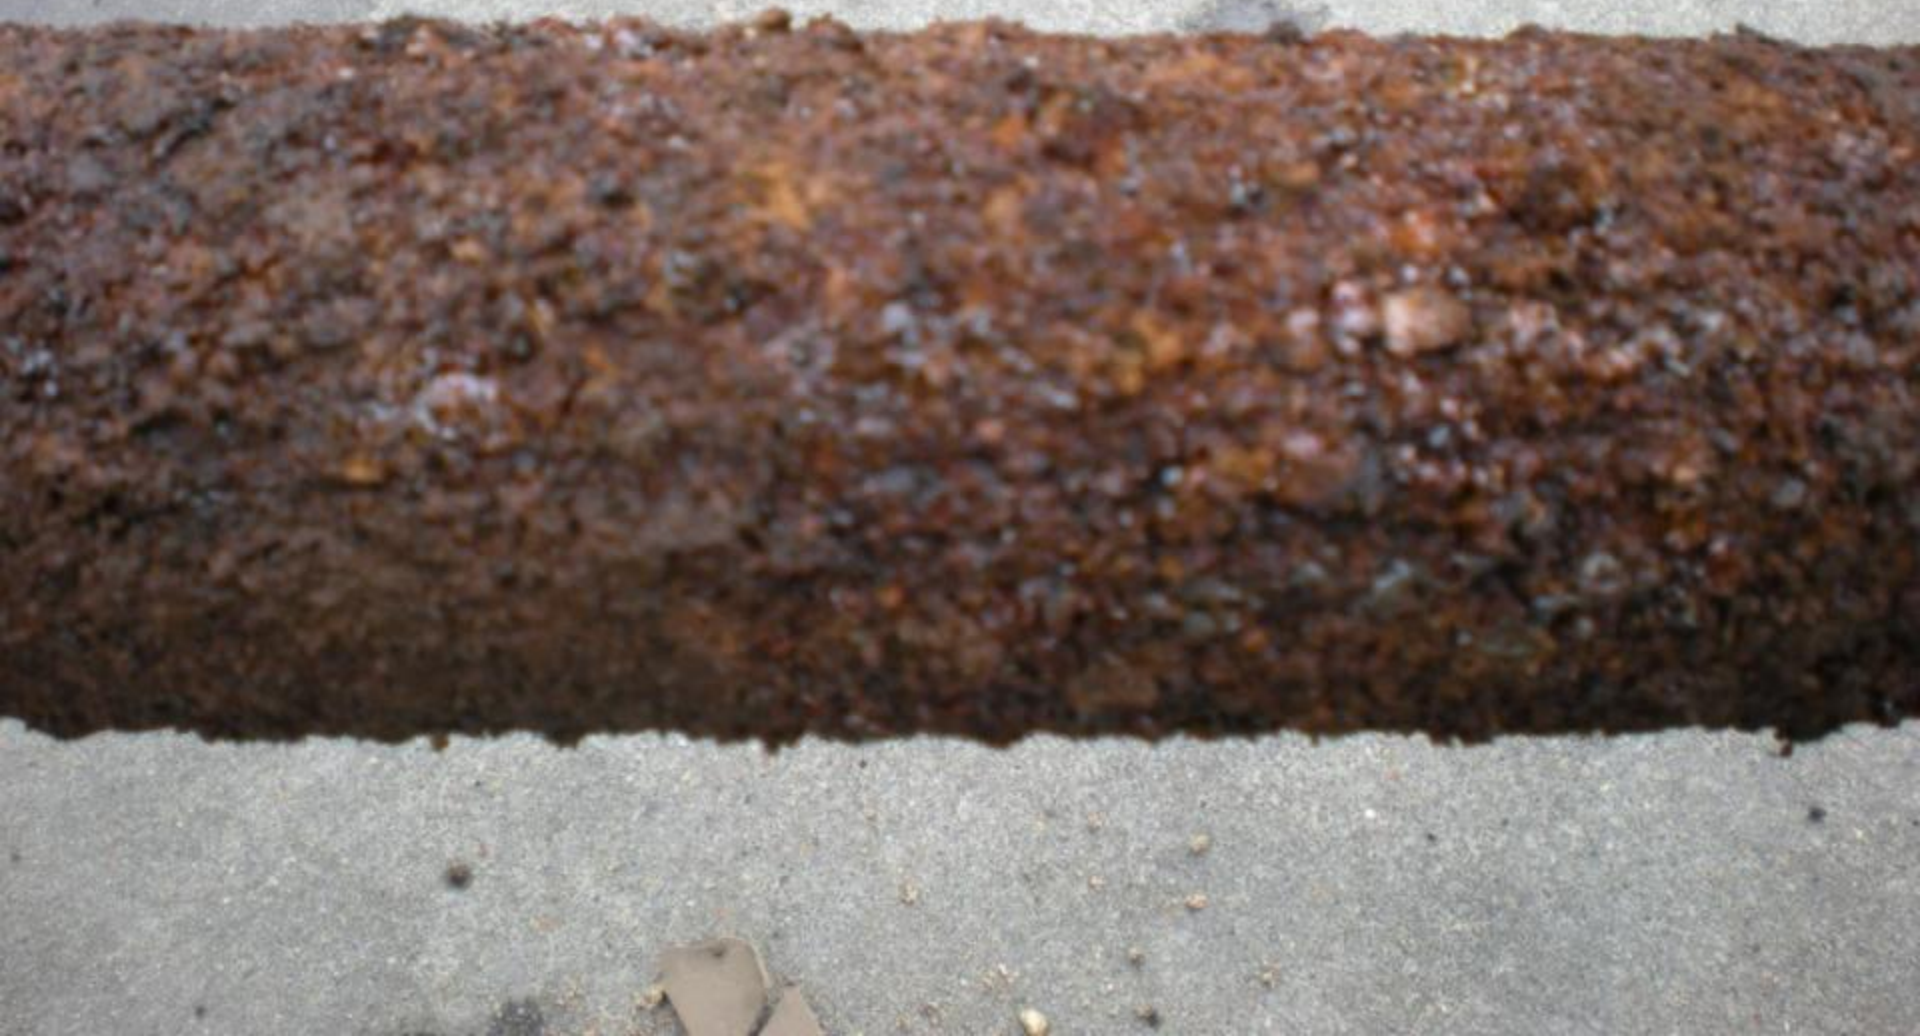
STP column pipe inside FRP tank

Pump connection corroded thru

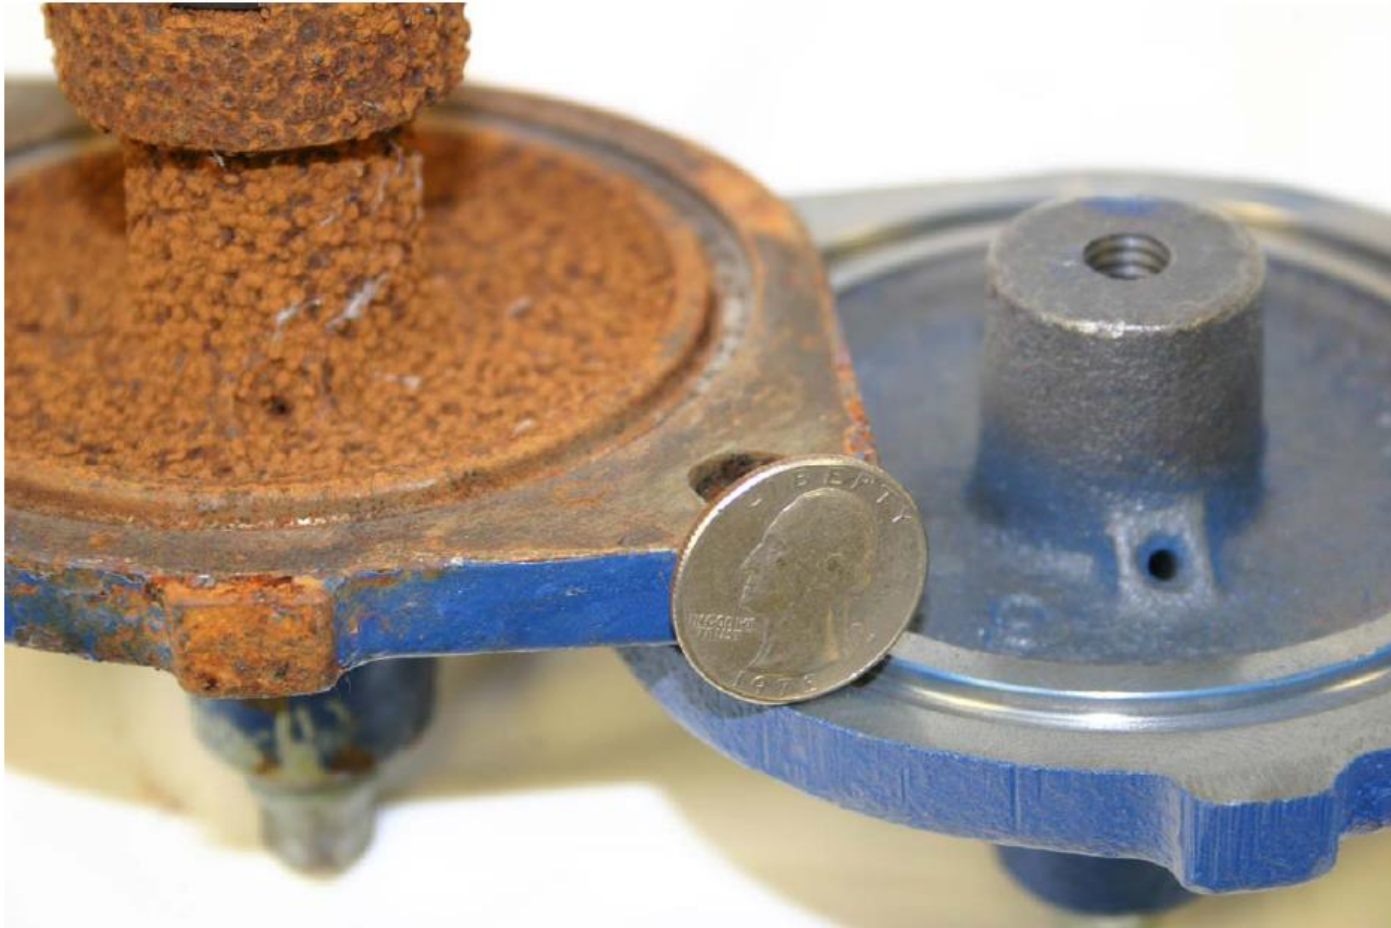
FE Petro Equipment

Old vs New
Corrosion, Pitting

Leak detection equipment not functioning

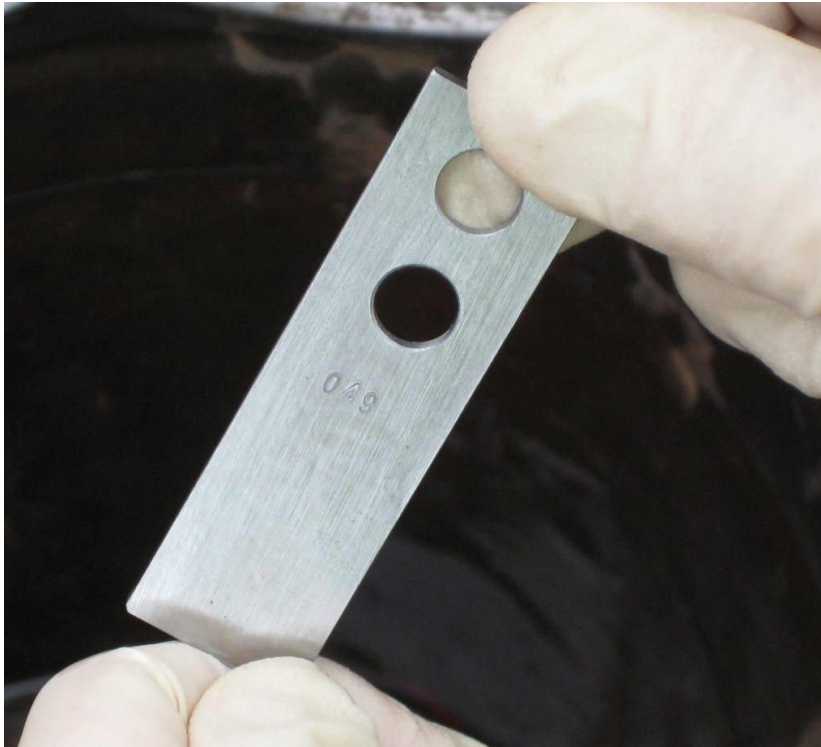
New steel
corrosion coupon
