Emerging Solutions for Biofuel-Induced Corrosion for ASTs & USTs

Real world problems caused by the use of Ethanol, Bio-diesel, and Ultra-Low Sulfur Diesel, and a look at possible solutions

Marshall T. Mott-Smith, President

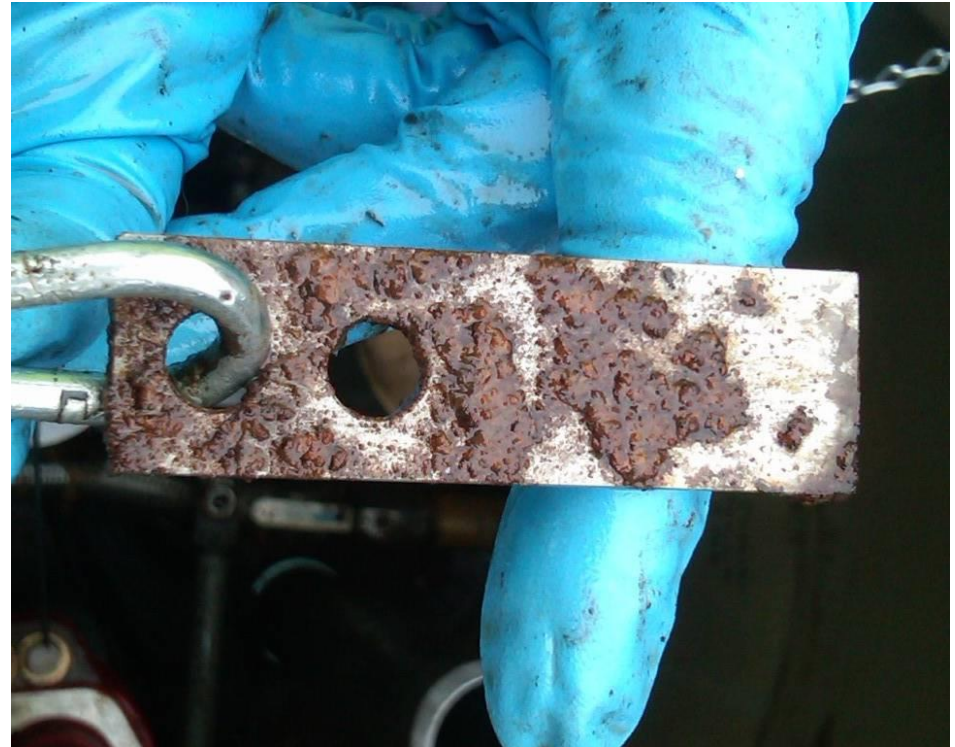
After 3 months

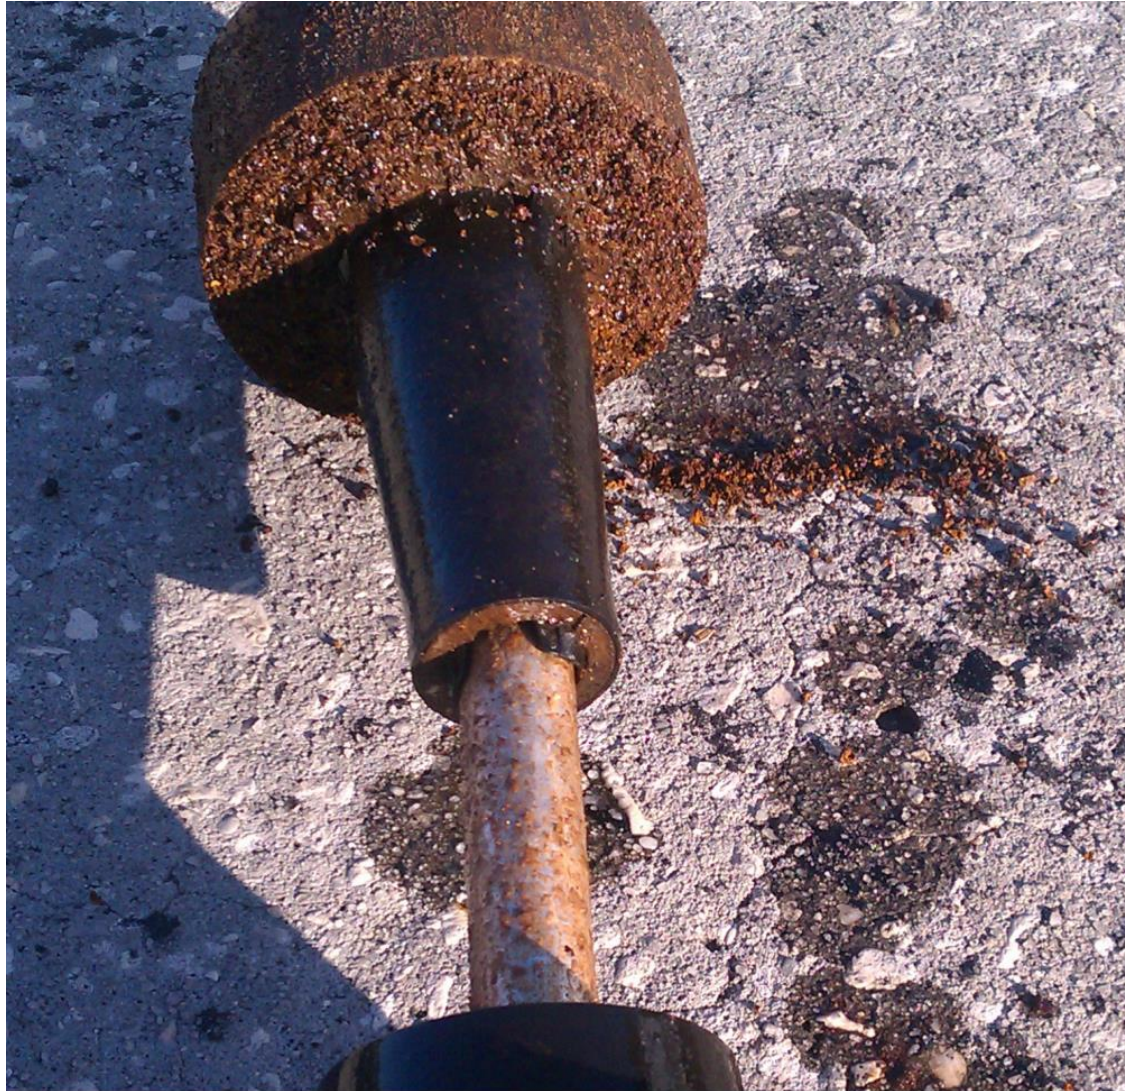
Equipment from Southeast Region in fiberglass tank

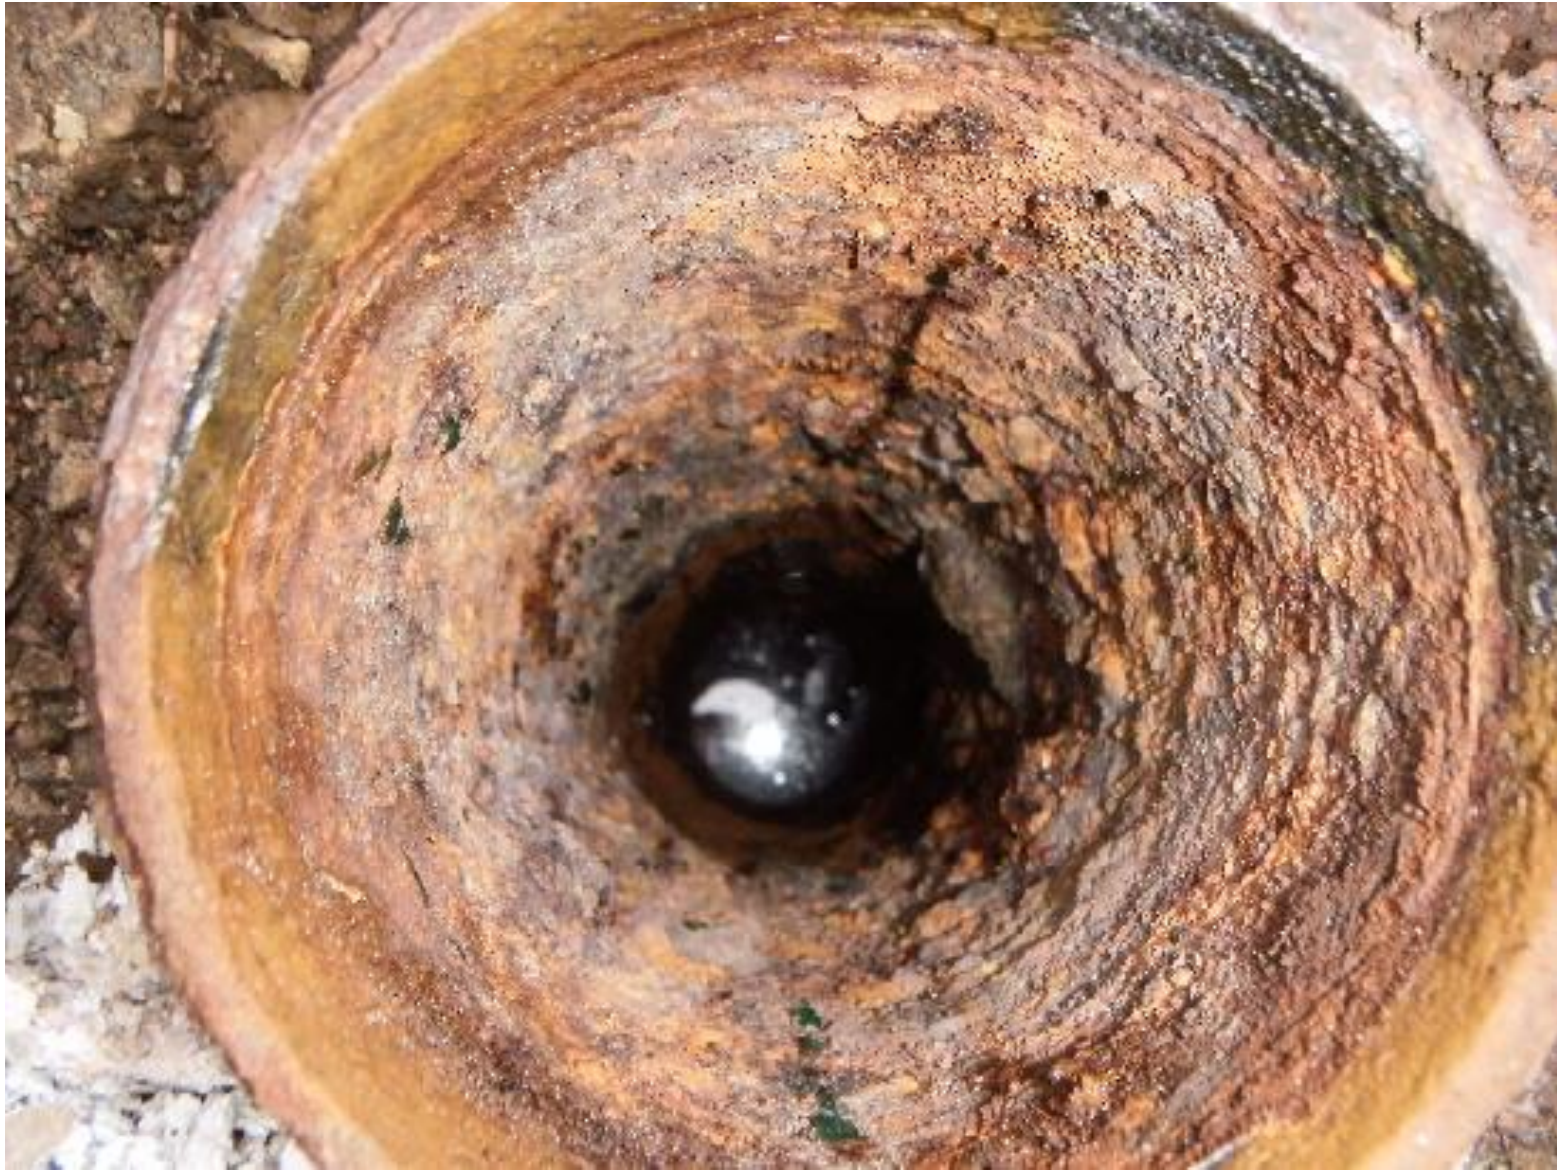
FRP tank riser NW area

Acetate 462 ppm

- Hypothesis that high acetate would indicate high corrosion
- Photos of risers don't indicate this
- Next step cameras inspected inside tanks at 3 locations

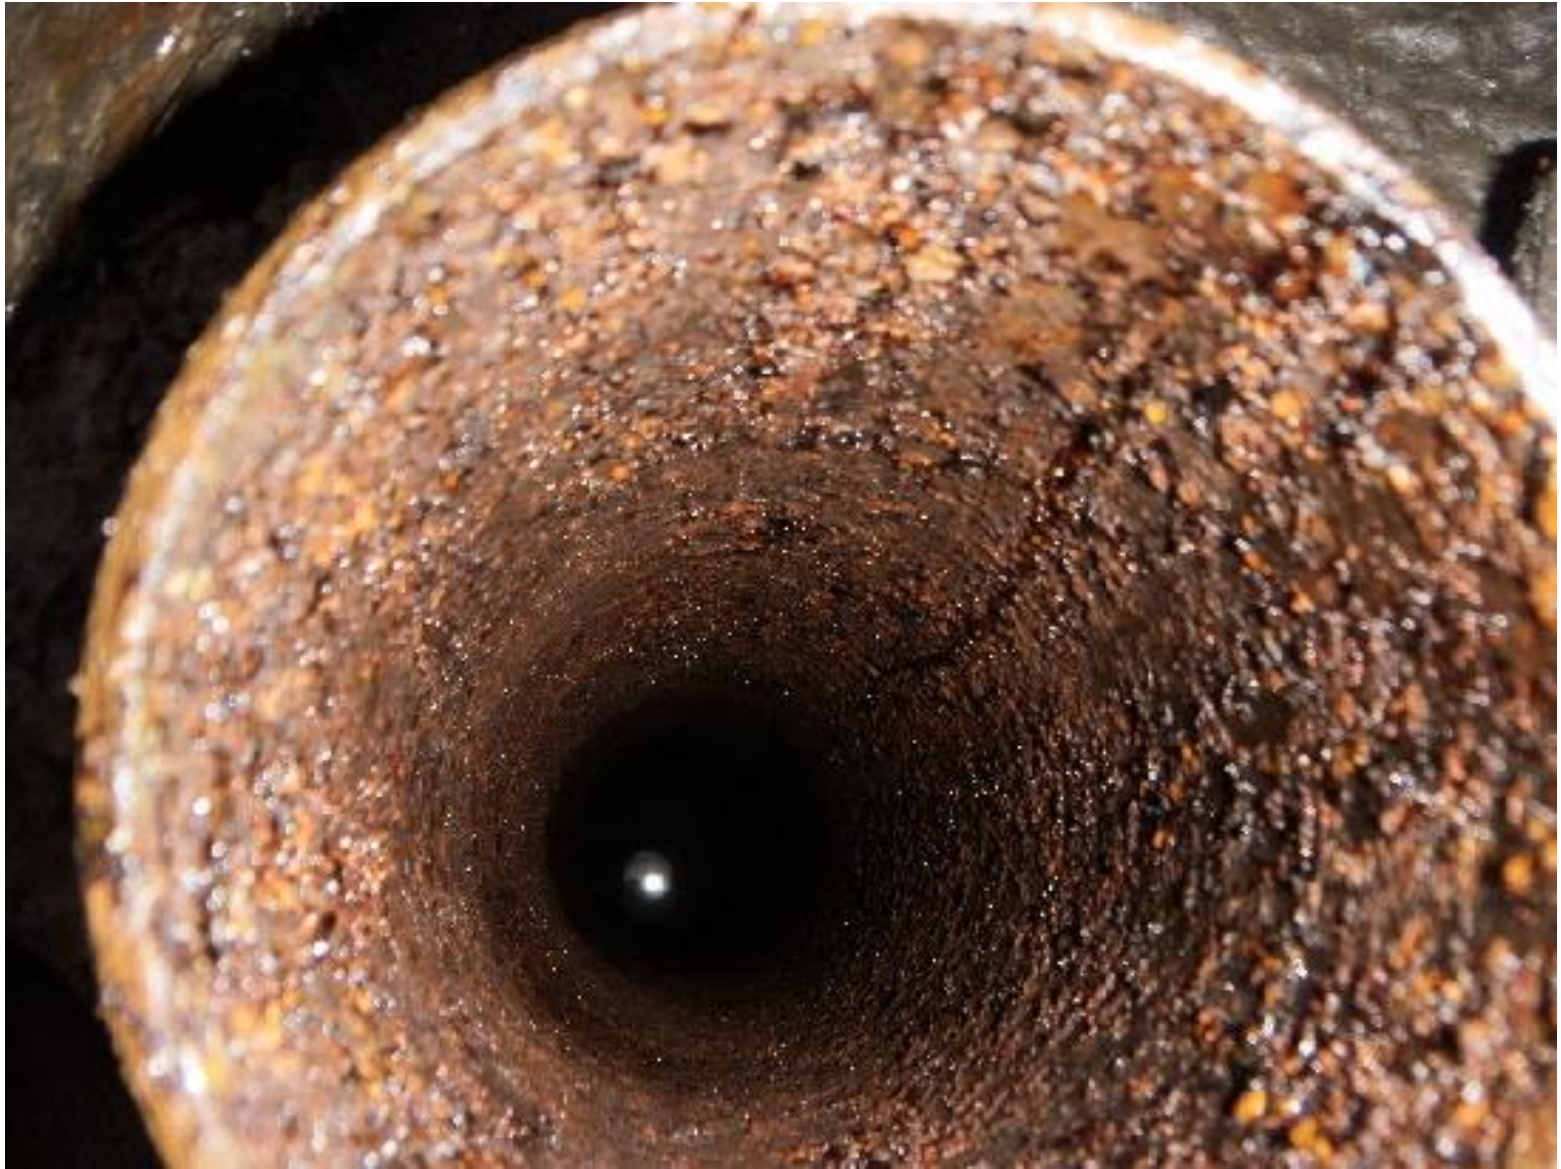
Steel Tank riser, NW area

Acetate 108 ppm

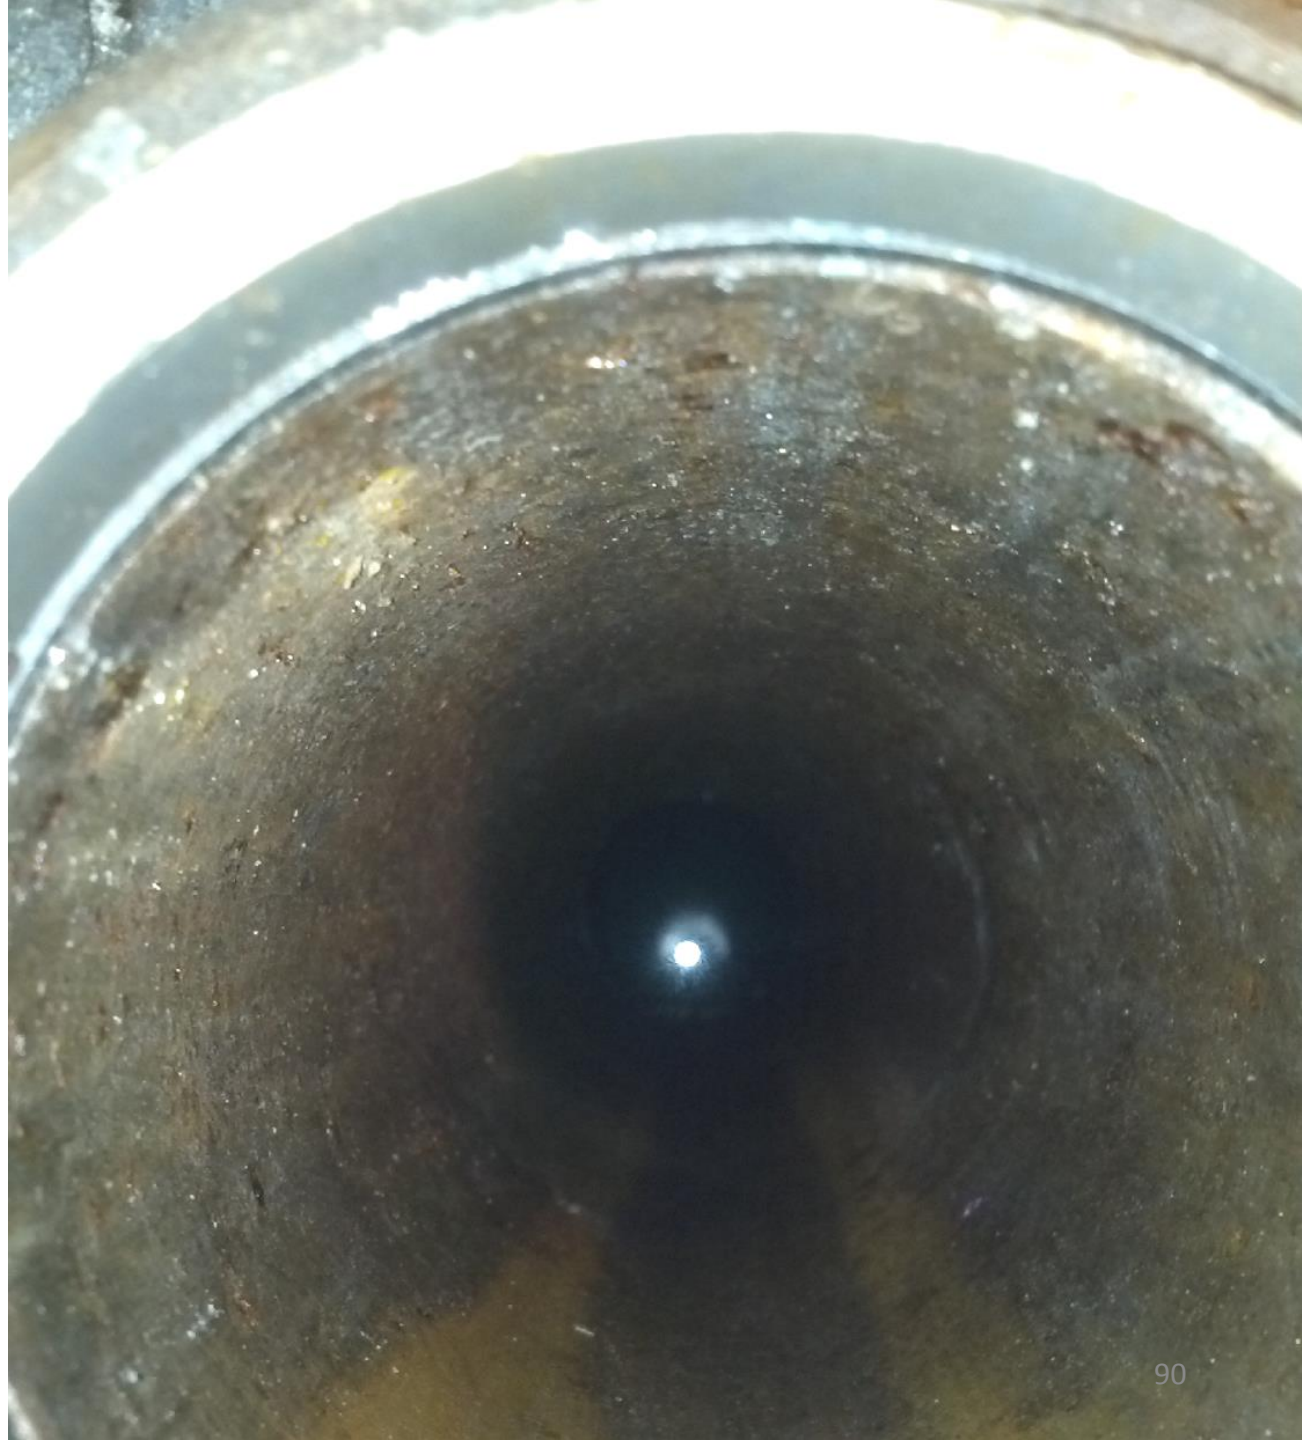
FRP riser,
MA area
Acetate
25,600
ppm
