What's Going On Inside Today's Storage Tanks?

Lorri Grainawi, STI/SPFA NISTM November 7, 2013 Columbus, OH

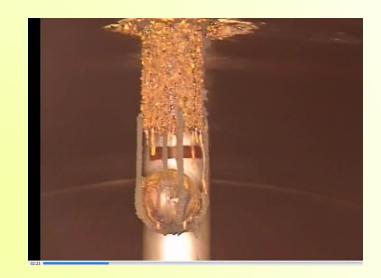
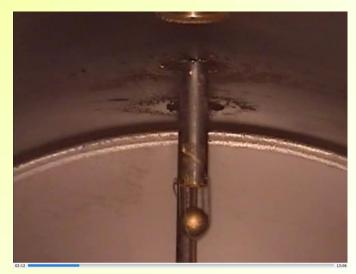
- Fuel samples extracted and tested
- Example Las Vegas service station tanks under same owner
- FRP tank vapor control fitting top right photo
- Steel tank vapor control fitting – bottom right photo

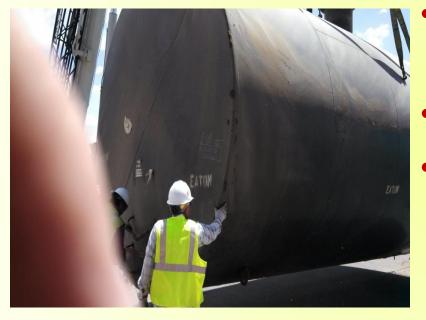
1986 Sti-P3 E85 Tank Removed in 2013 – No Leaks

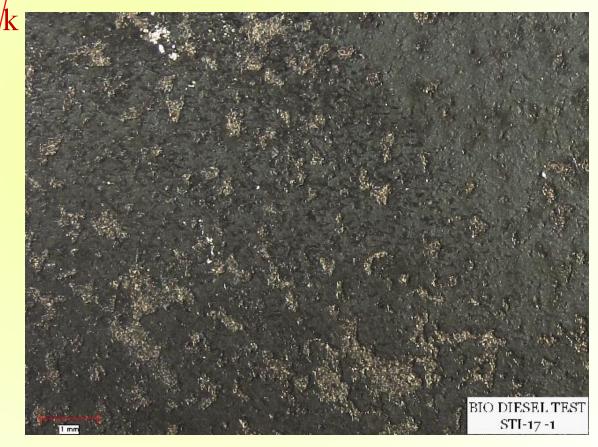
100 % animal-based biodiesel, no water
