# **Emerging Solutions for Biofuel- Induced Corrosion for ASTs & USTs**

Real world problems caused by the use of Ethanol, Bio-diesel, and Ultra-Low Sulfur Diesel, and a look at possible solutions

Marshall T. Mott-Smith, President, Mott-Smith Consulting Group, LLC
1933 Commonwealth Lane, Tallahassee, FI 32303
marshall@mott-smithconsulting.com
www.mott-smithconsulting.com
850-391-9835 850-766 2786 cell
850-591-1434 cell

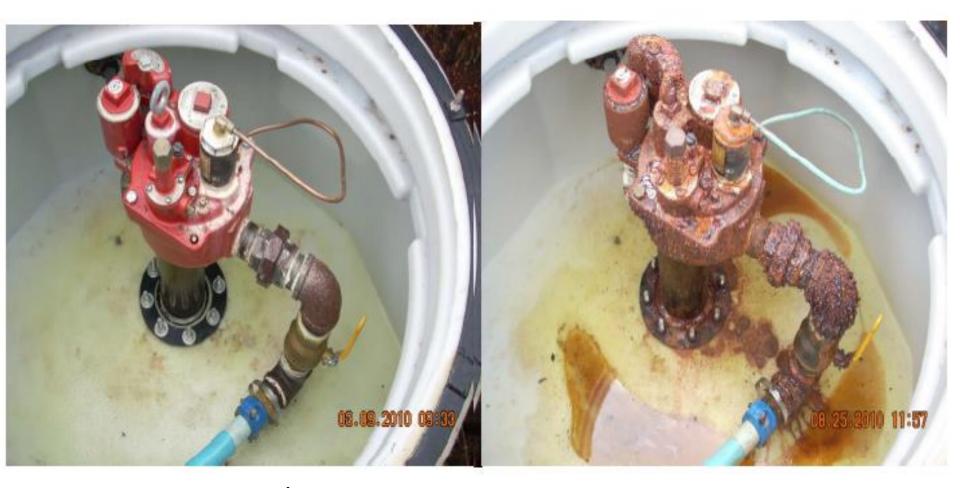
#### How Long Does It Take For This Severe Corrosion To Occur?

Tennessee - March 2010

Tennessee - August 2010

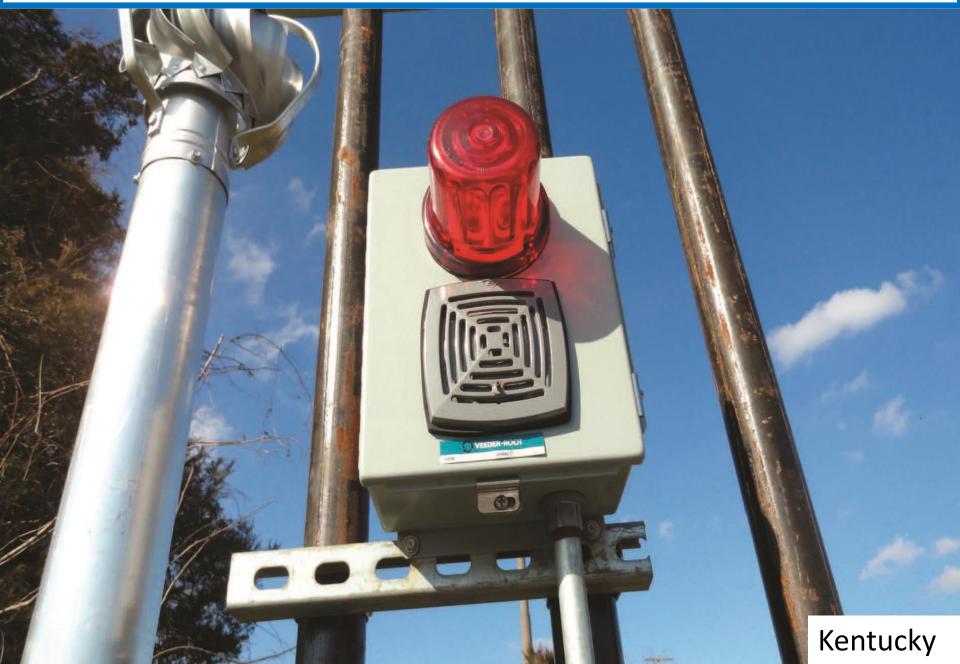
# What's this "whirlybird" doing here with the tank vents?

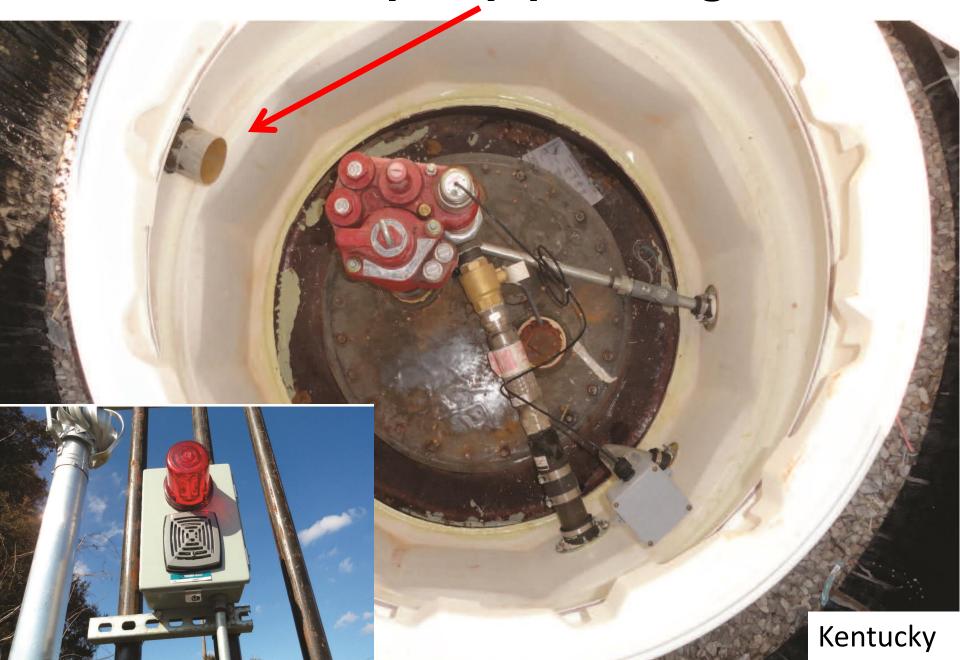
# What's this open pipe doing here?

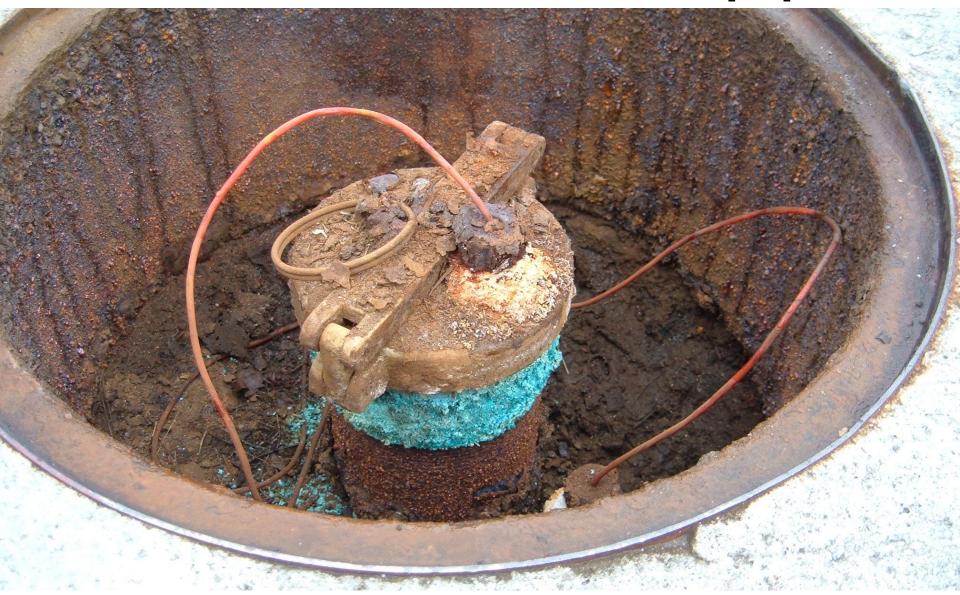
# Other Problem Areas – ATG Equipment

Evidence of vapor leaks

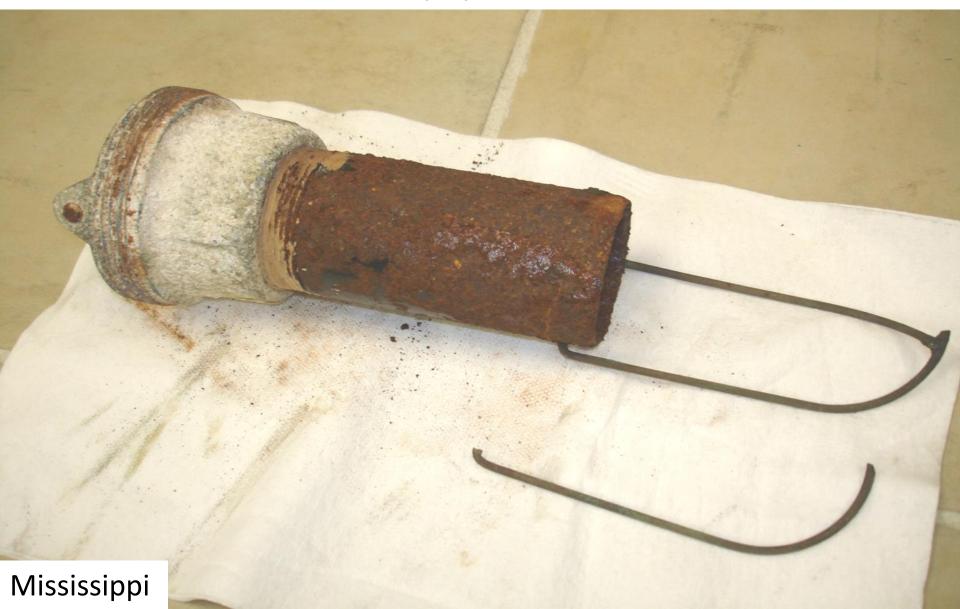
# Corrosion on Ball Float Valve Overfill Protection Equipment

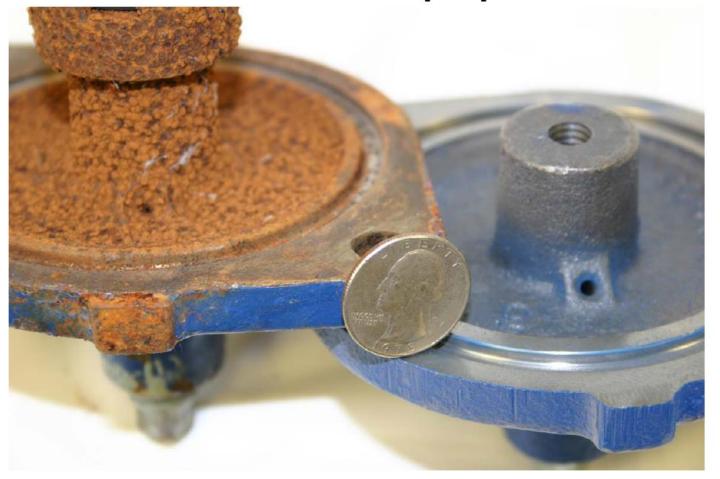
# FE Petro Equipment

Old vs New Corrosion, Pitting

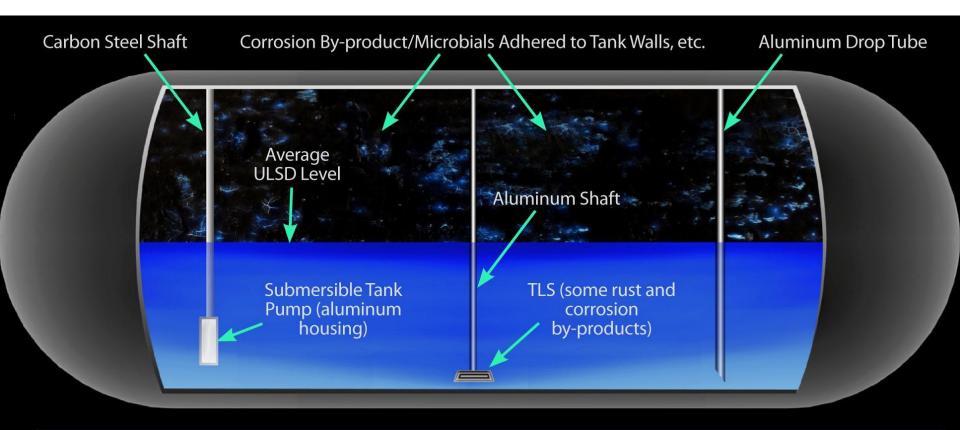
#### **ULSD Corrosion – UST Detail**

UST showing corrosion and possible microbial corrosion spots.

# **Likely Causes**

- No one cause, but rather a mixture......
- Microbial influence getting a lot of attention:
- Salt and other contaminants also a contributing factor?
- Corrosion inhibitor depletion (aka "soap") theory acidic additives form soaps if contacted with excessive tank water cations from salts or caustic:
- Poor housekeeping, no biological monitoring, improper application of biocides exacerbates problem

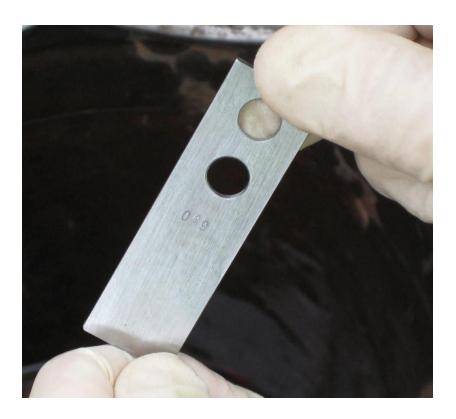
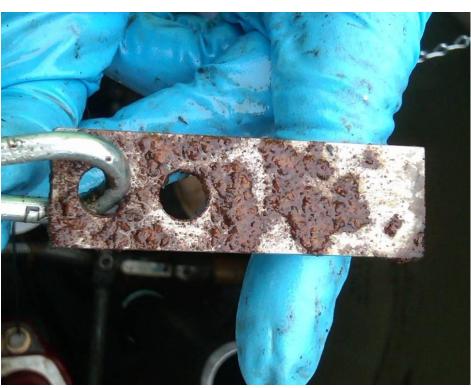
## **ULSD Corrosion – Assessment**

New steel corrosion coupon

After 3 months

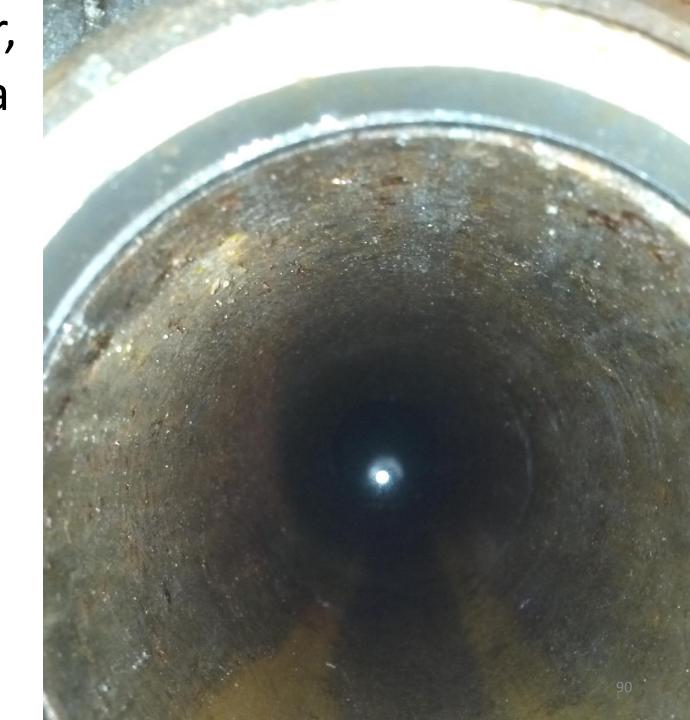
FRP riser, MA area Acetate 25,600 ppm
