Shop-Fabricated Aboveground Storage Tank Inspections – Expect the Unexpected...

Mott-Smith Consulting Group, LLC

Marshall T. Mott-Smith, President Mott-Smith Consulting Group, LLC

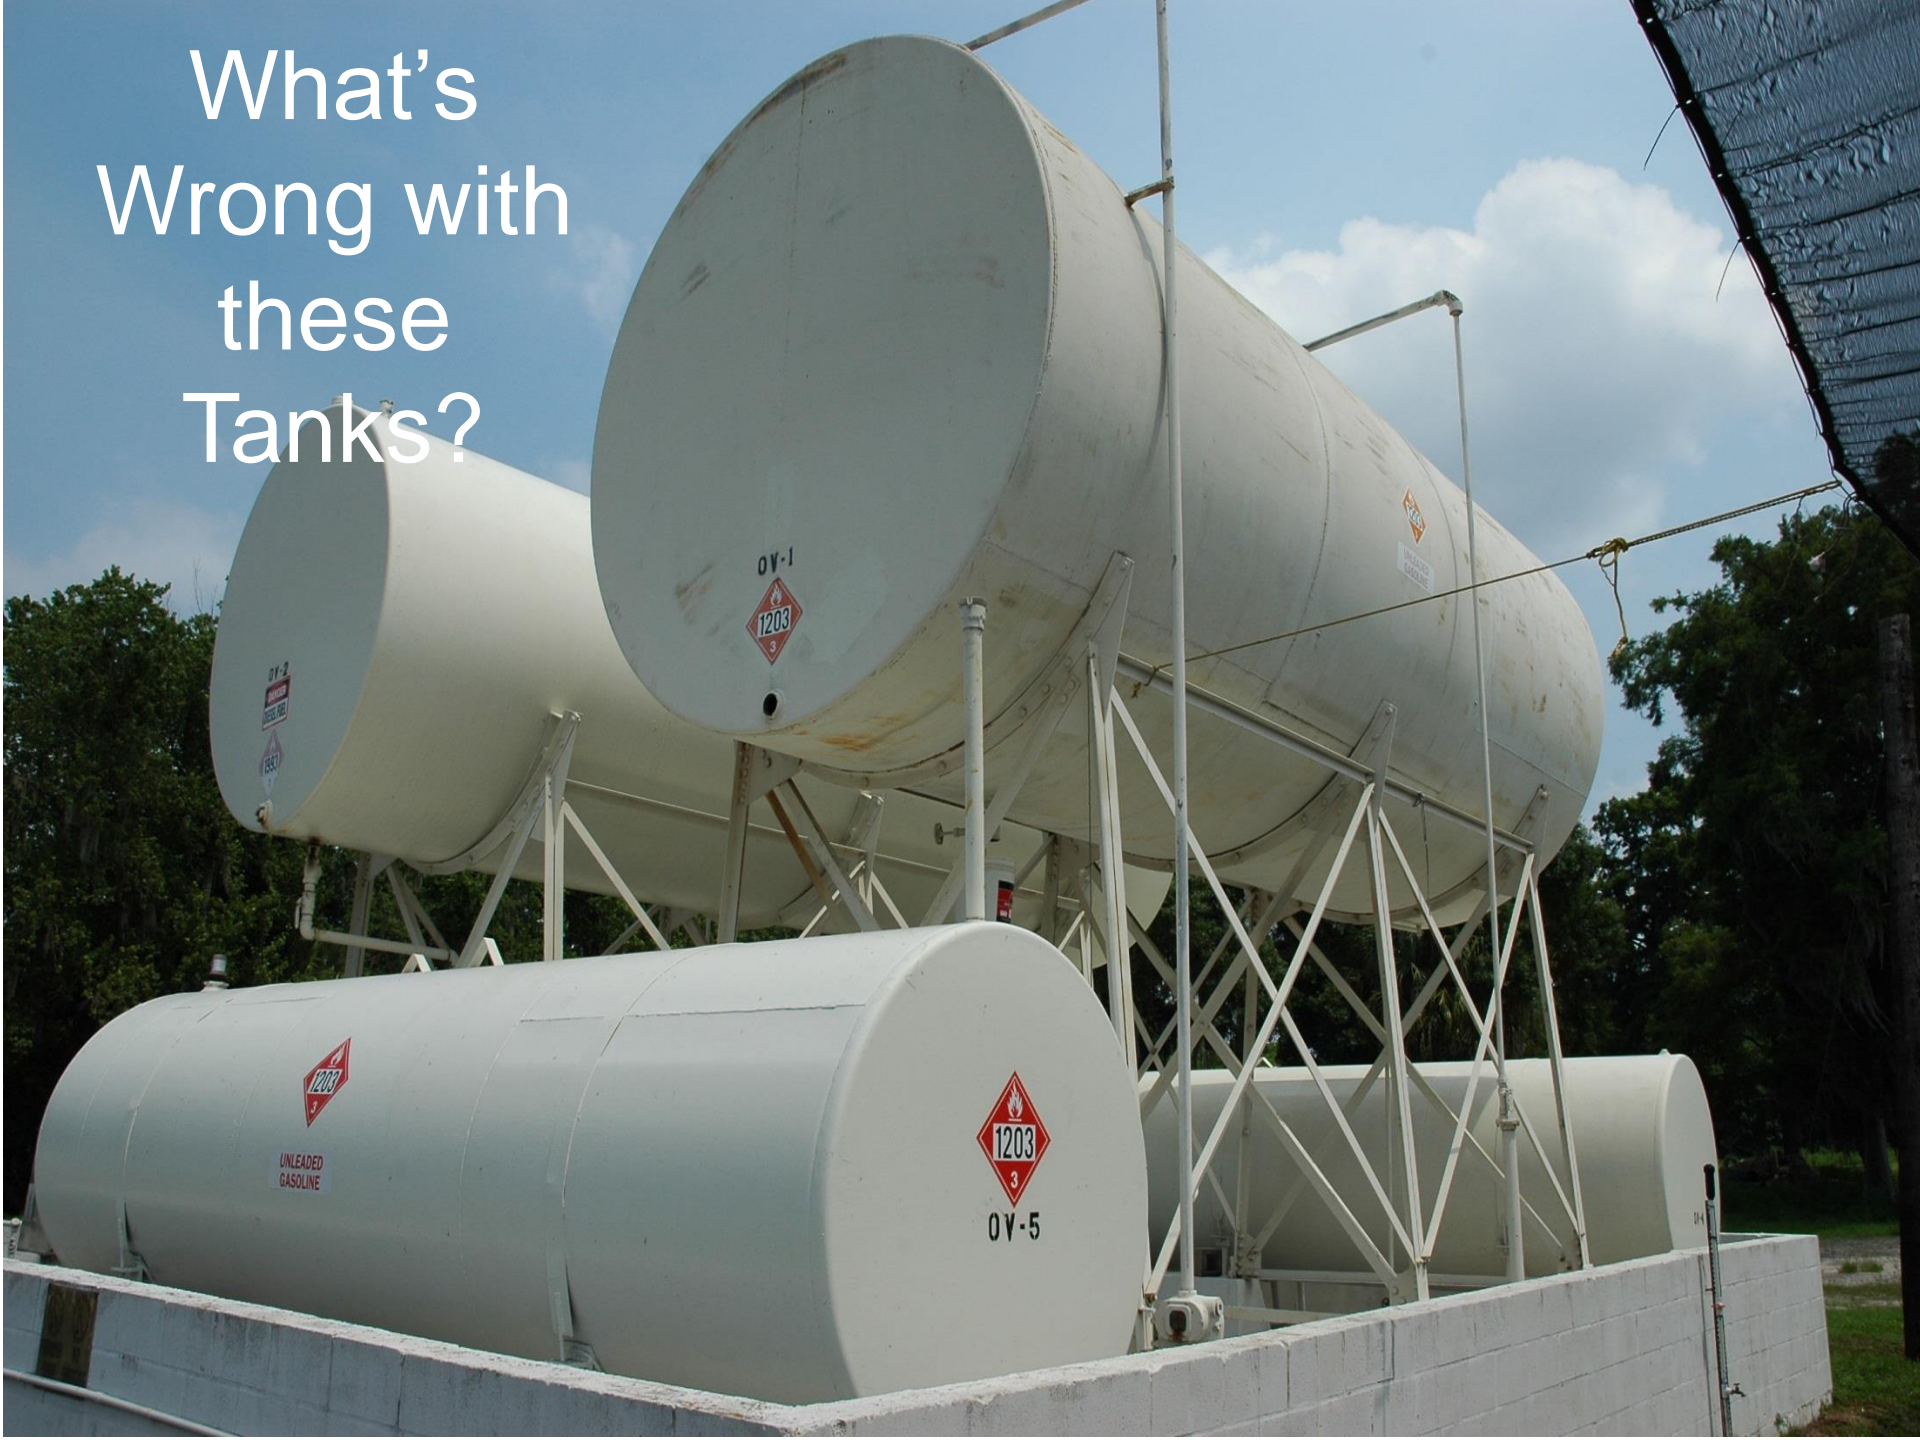
Supports for tanks > 12" high
must have a fire resistance
rating of 2 hours

What's Wrong with these Tanks?

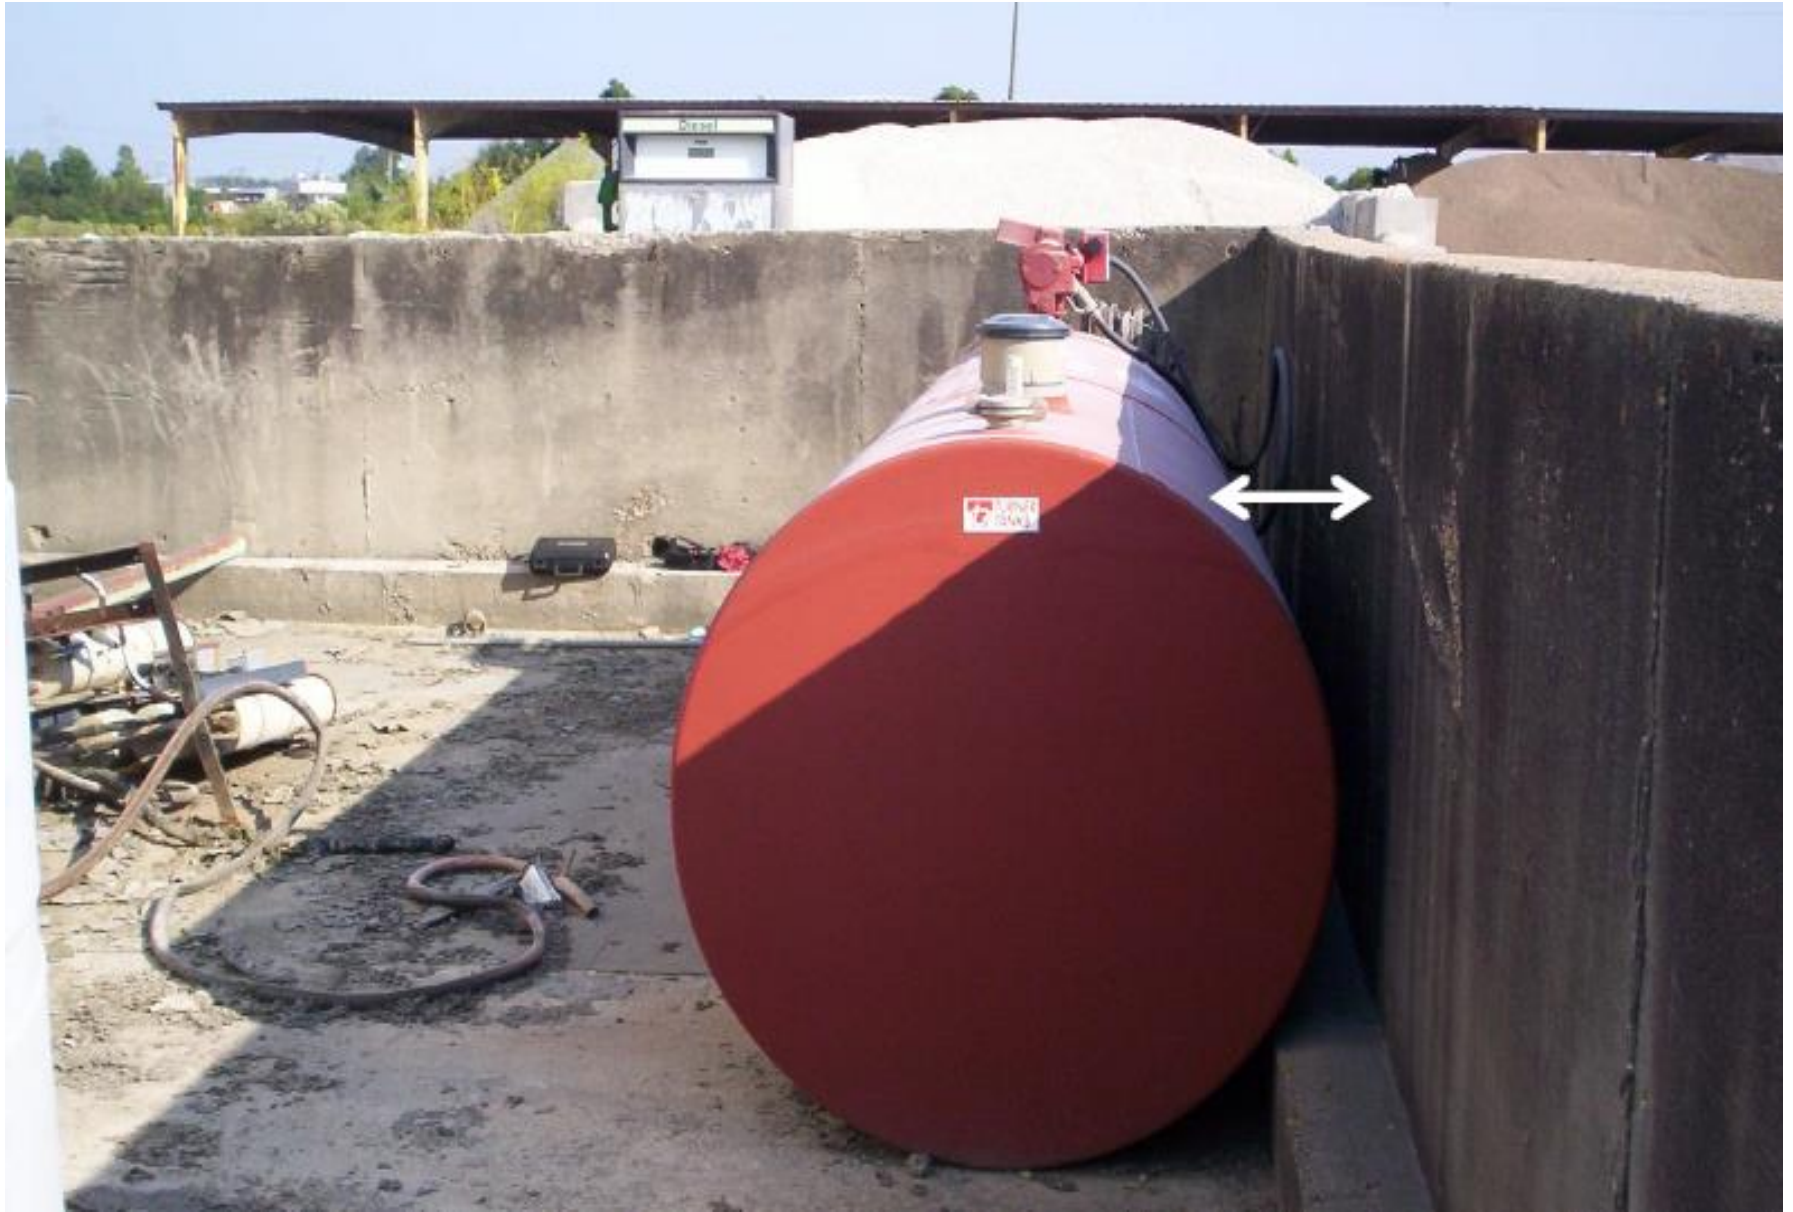
Single-wall Tanks
Must be at Least
100 ft. from the
Property Line

21 ft. to property line

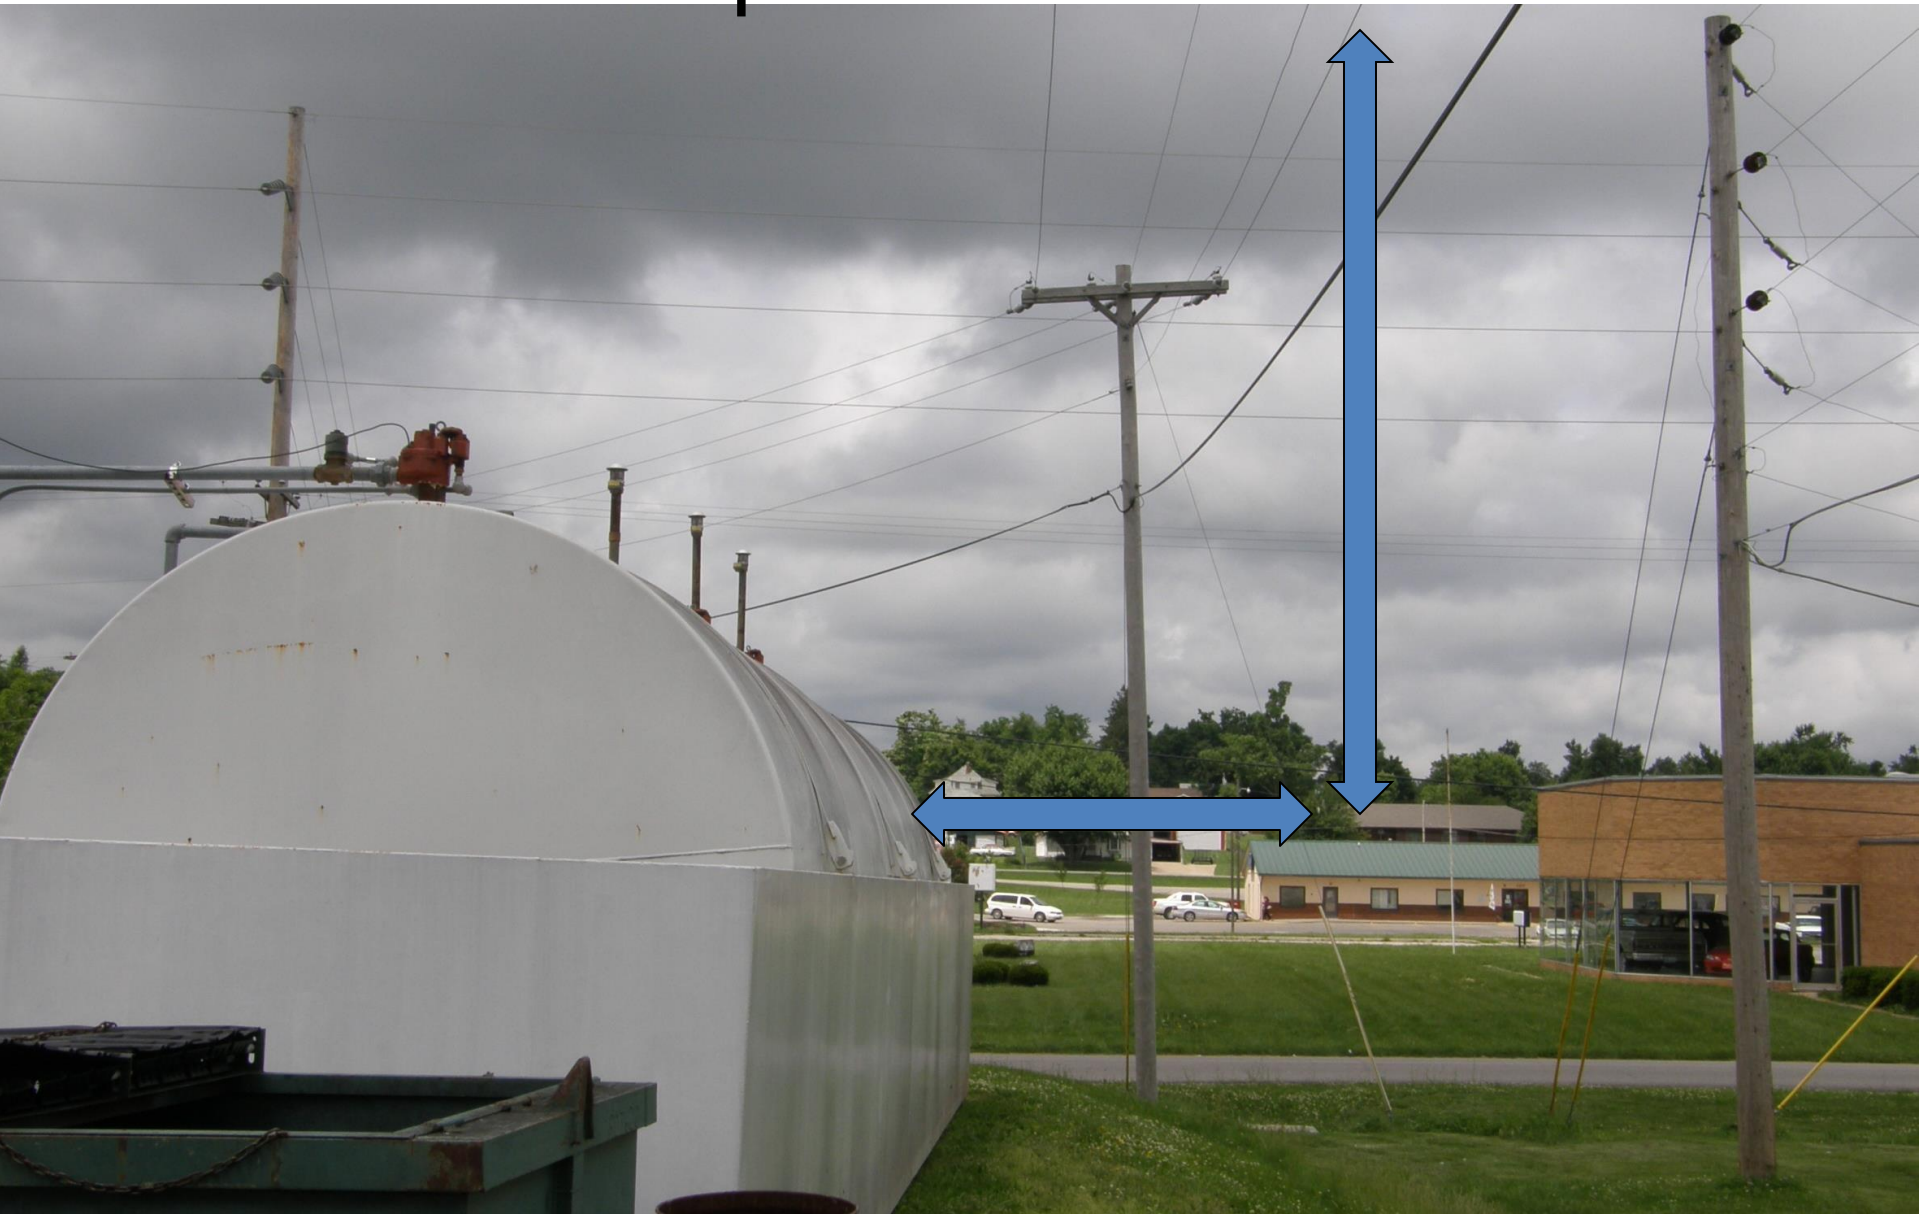
Anything
wrong here?

Power lines shall maintain a 10 foot horizontal separation from tank shell

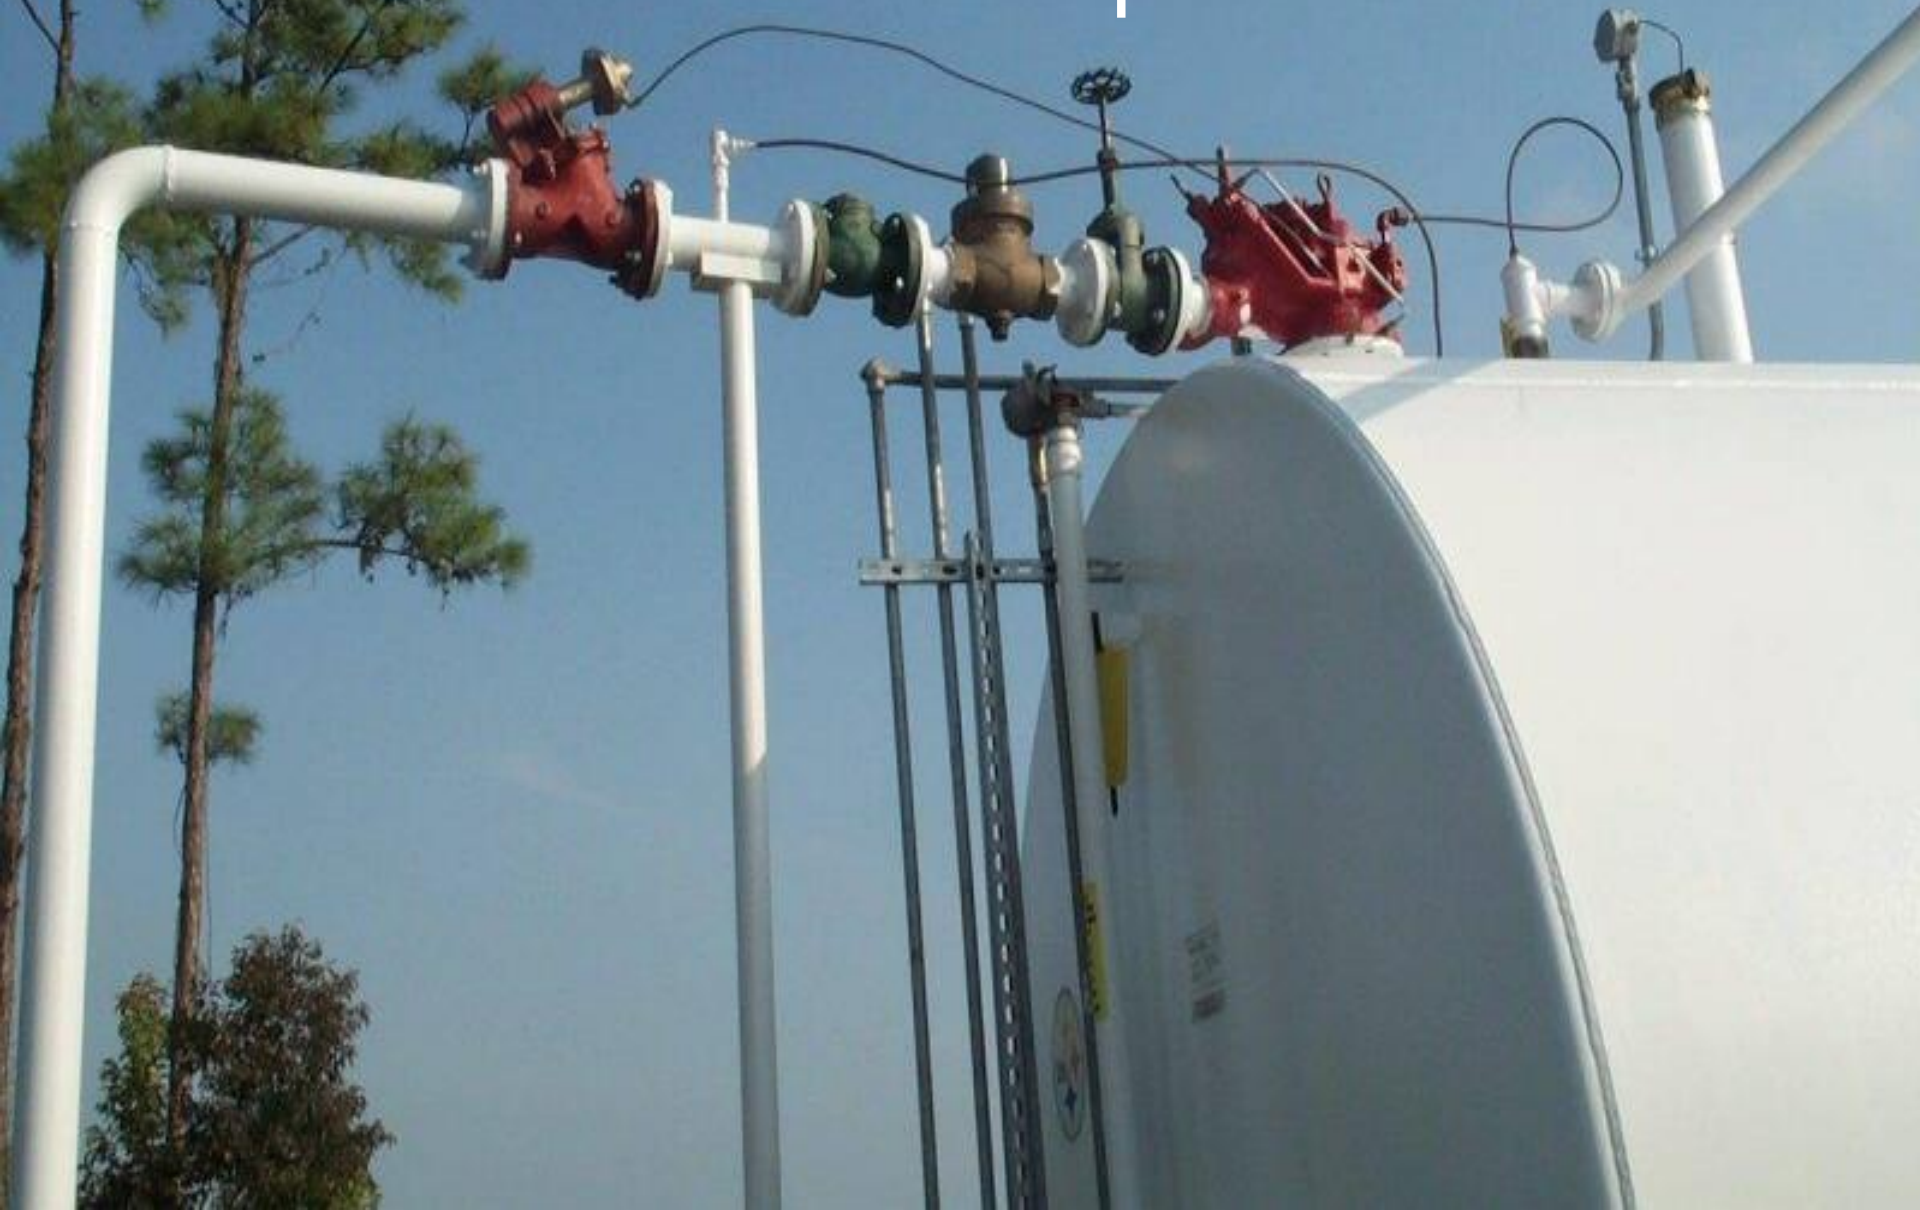
MLLD INSTALLED ON STP UPSTREAM
FROM ANTI SIPHON VALVE NOT PER
PEI/RP 200-96.

MORRISON 910-ER SPRING
LOADED CHECK ANTI-
SIPHON VALVE

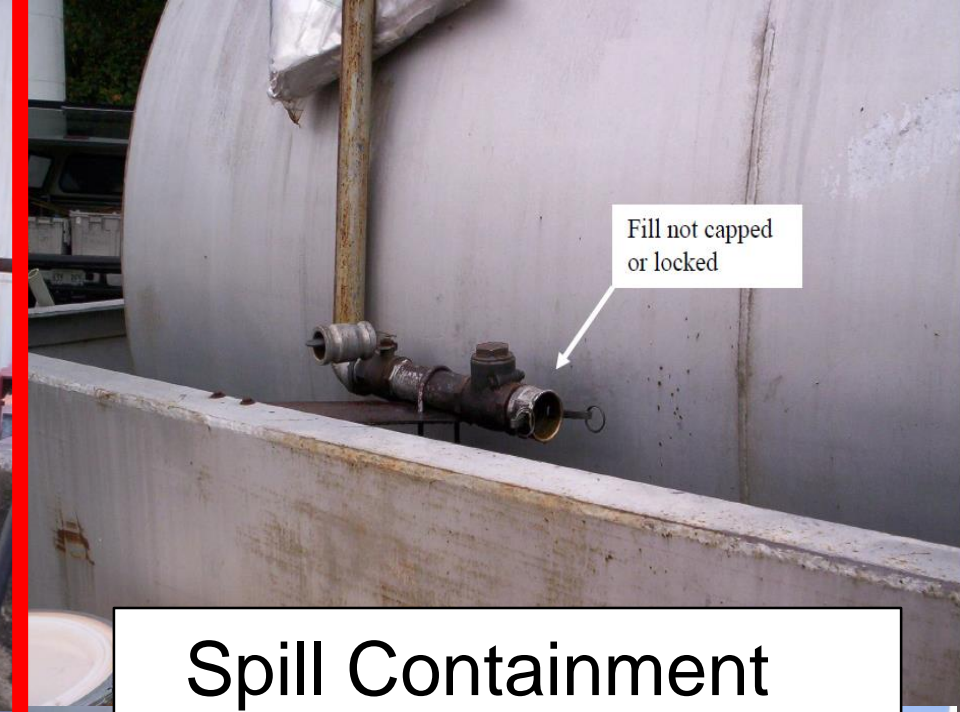
No Spill Containment

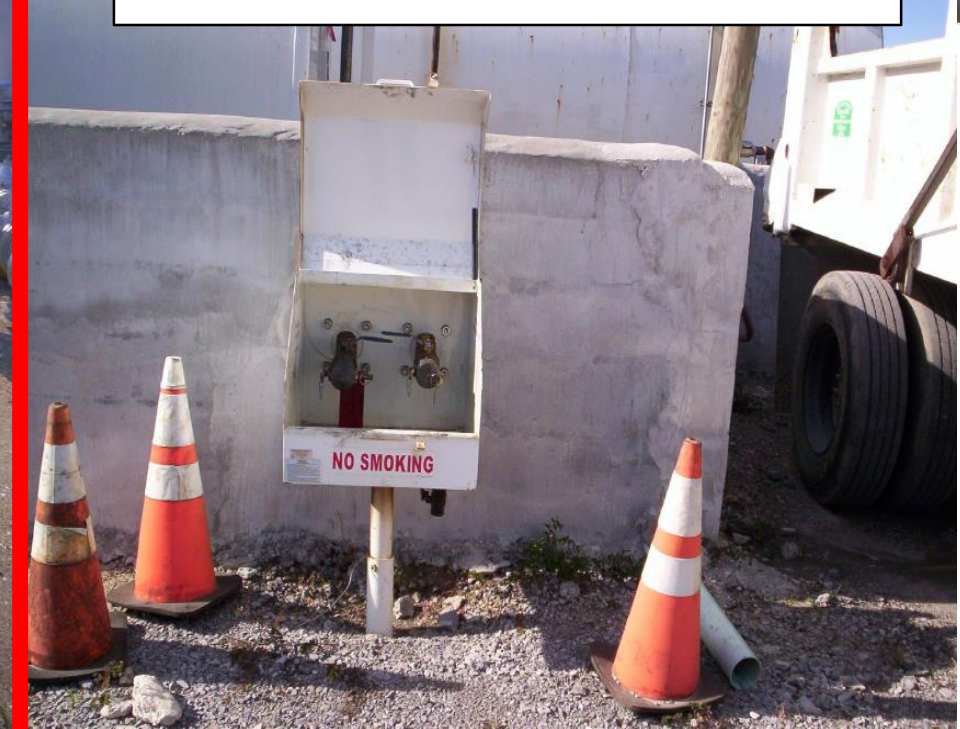
Spill Containment

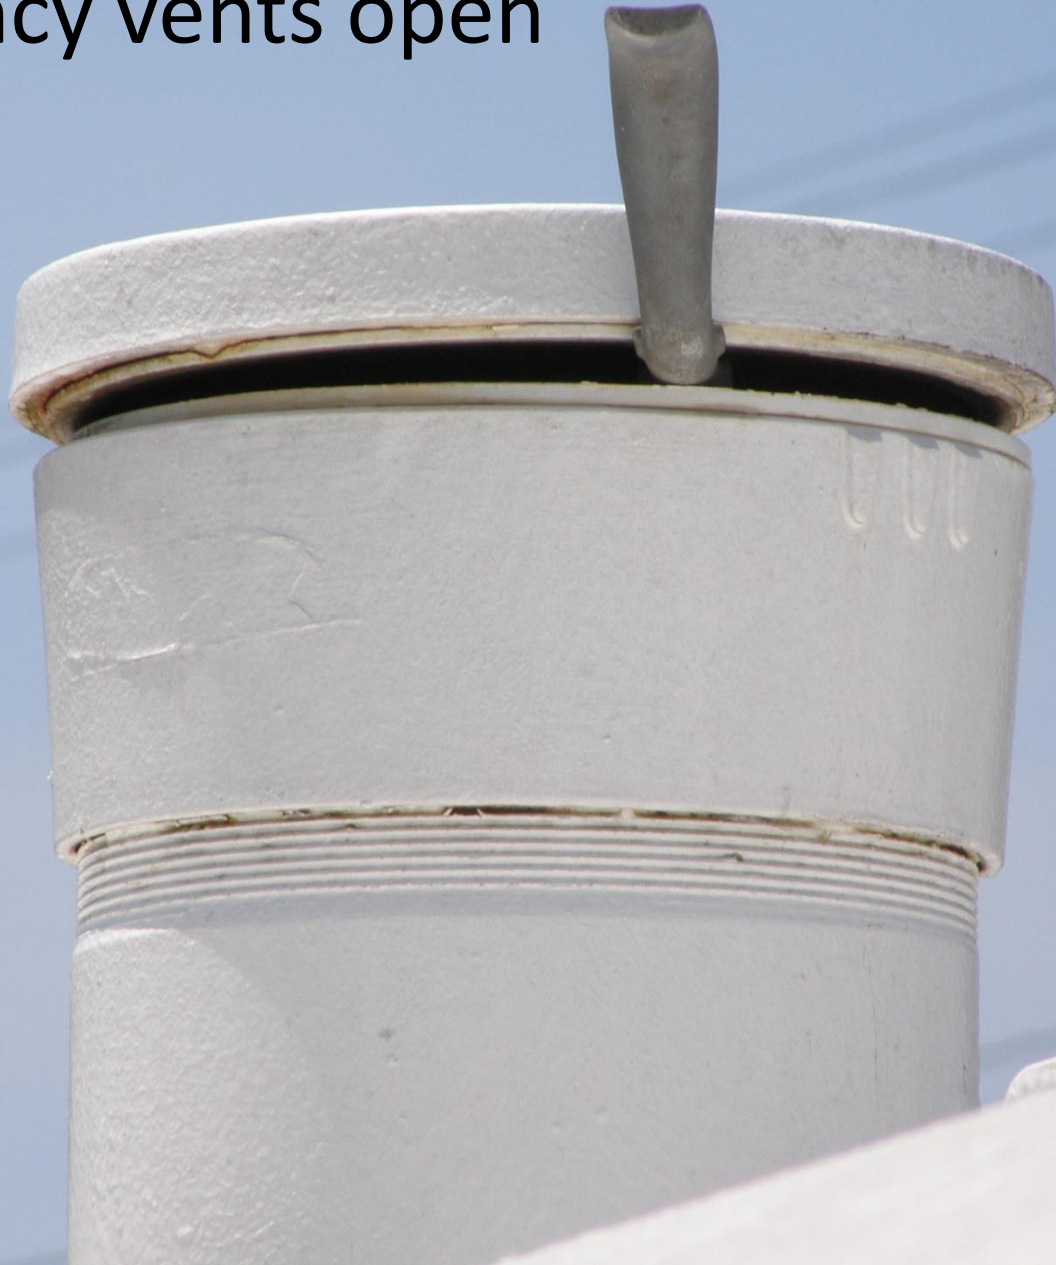
Obstructed Long-bolt
Man-way Vents

Ice cream scoops work well for blocking
Emergency vents open

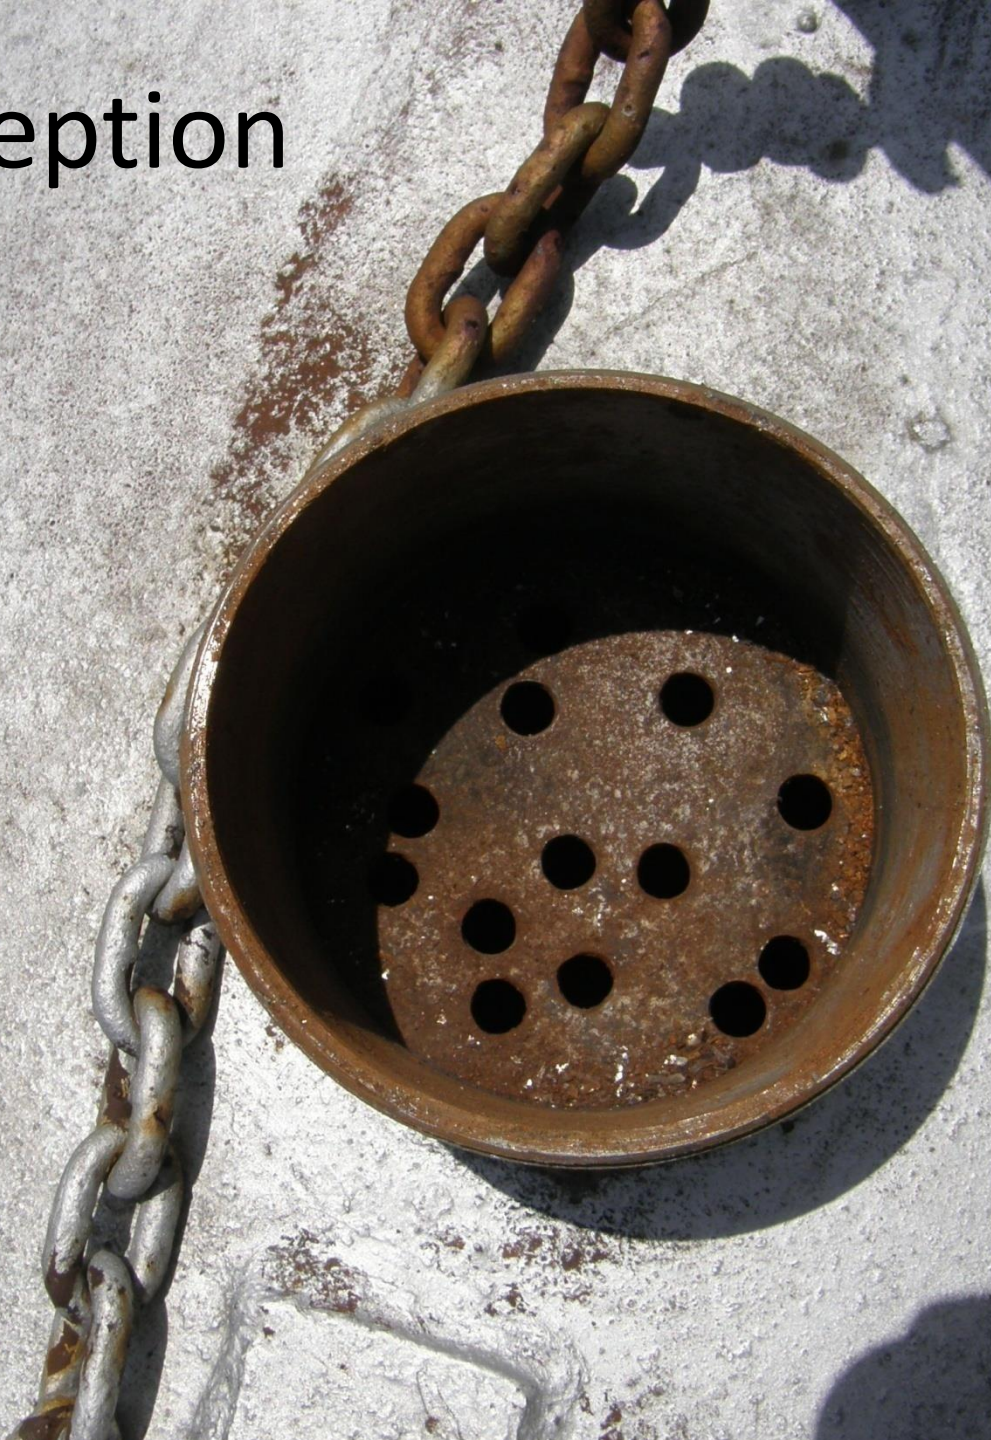
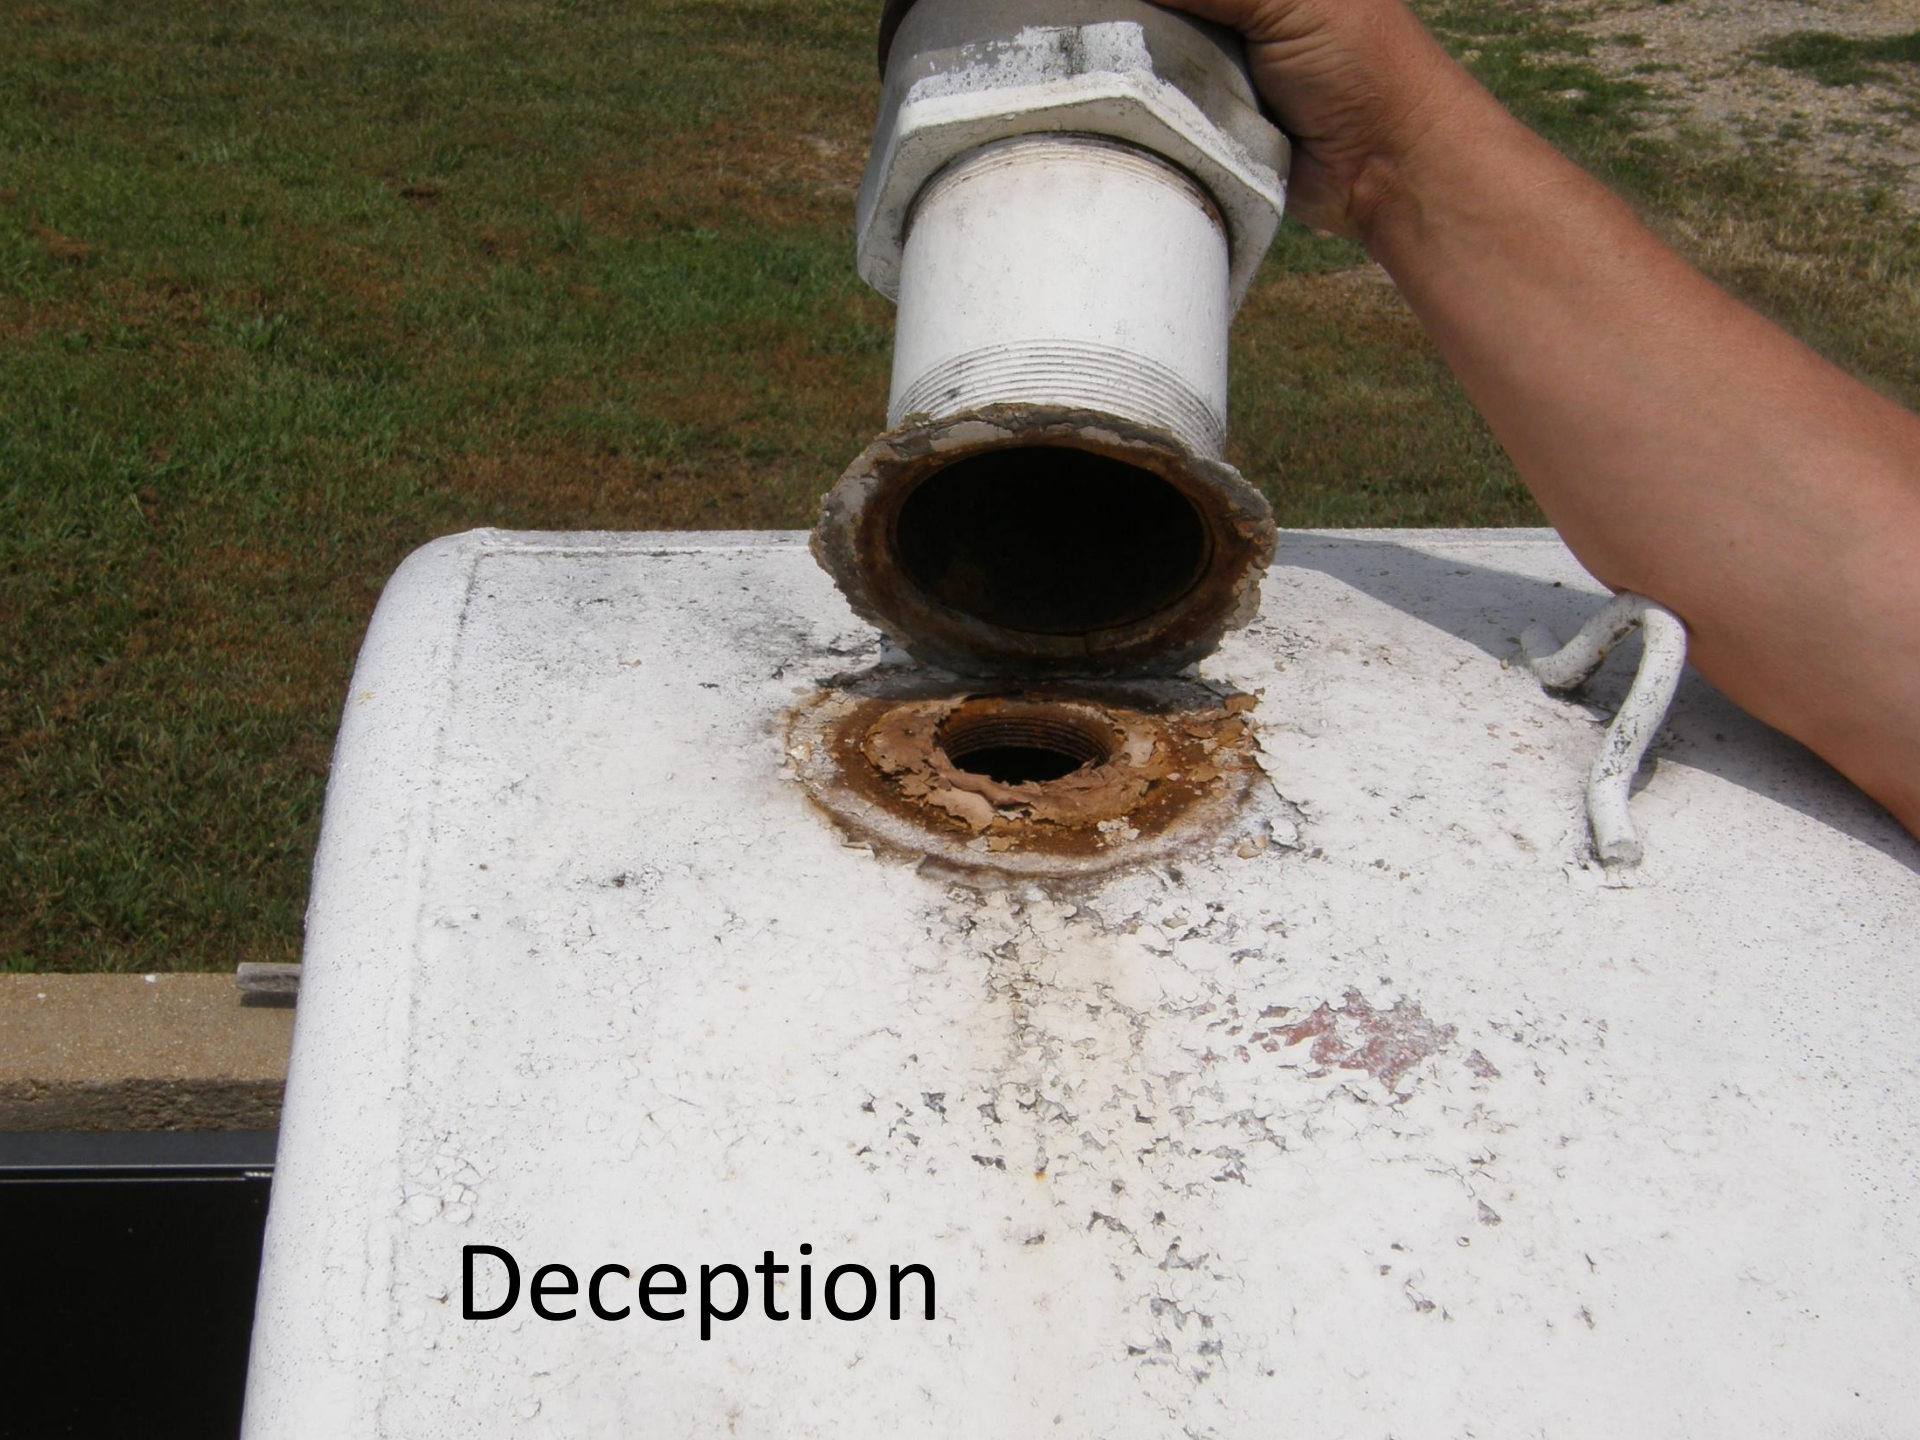
Emergency Venting Deception

Deception

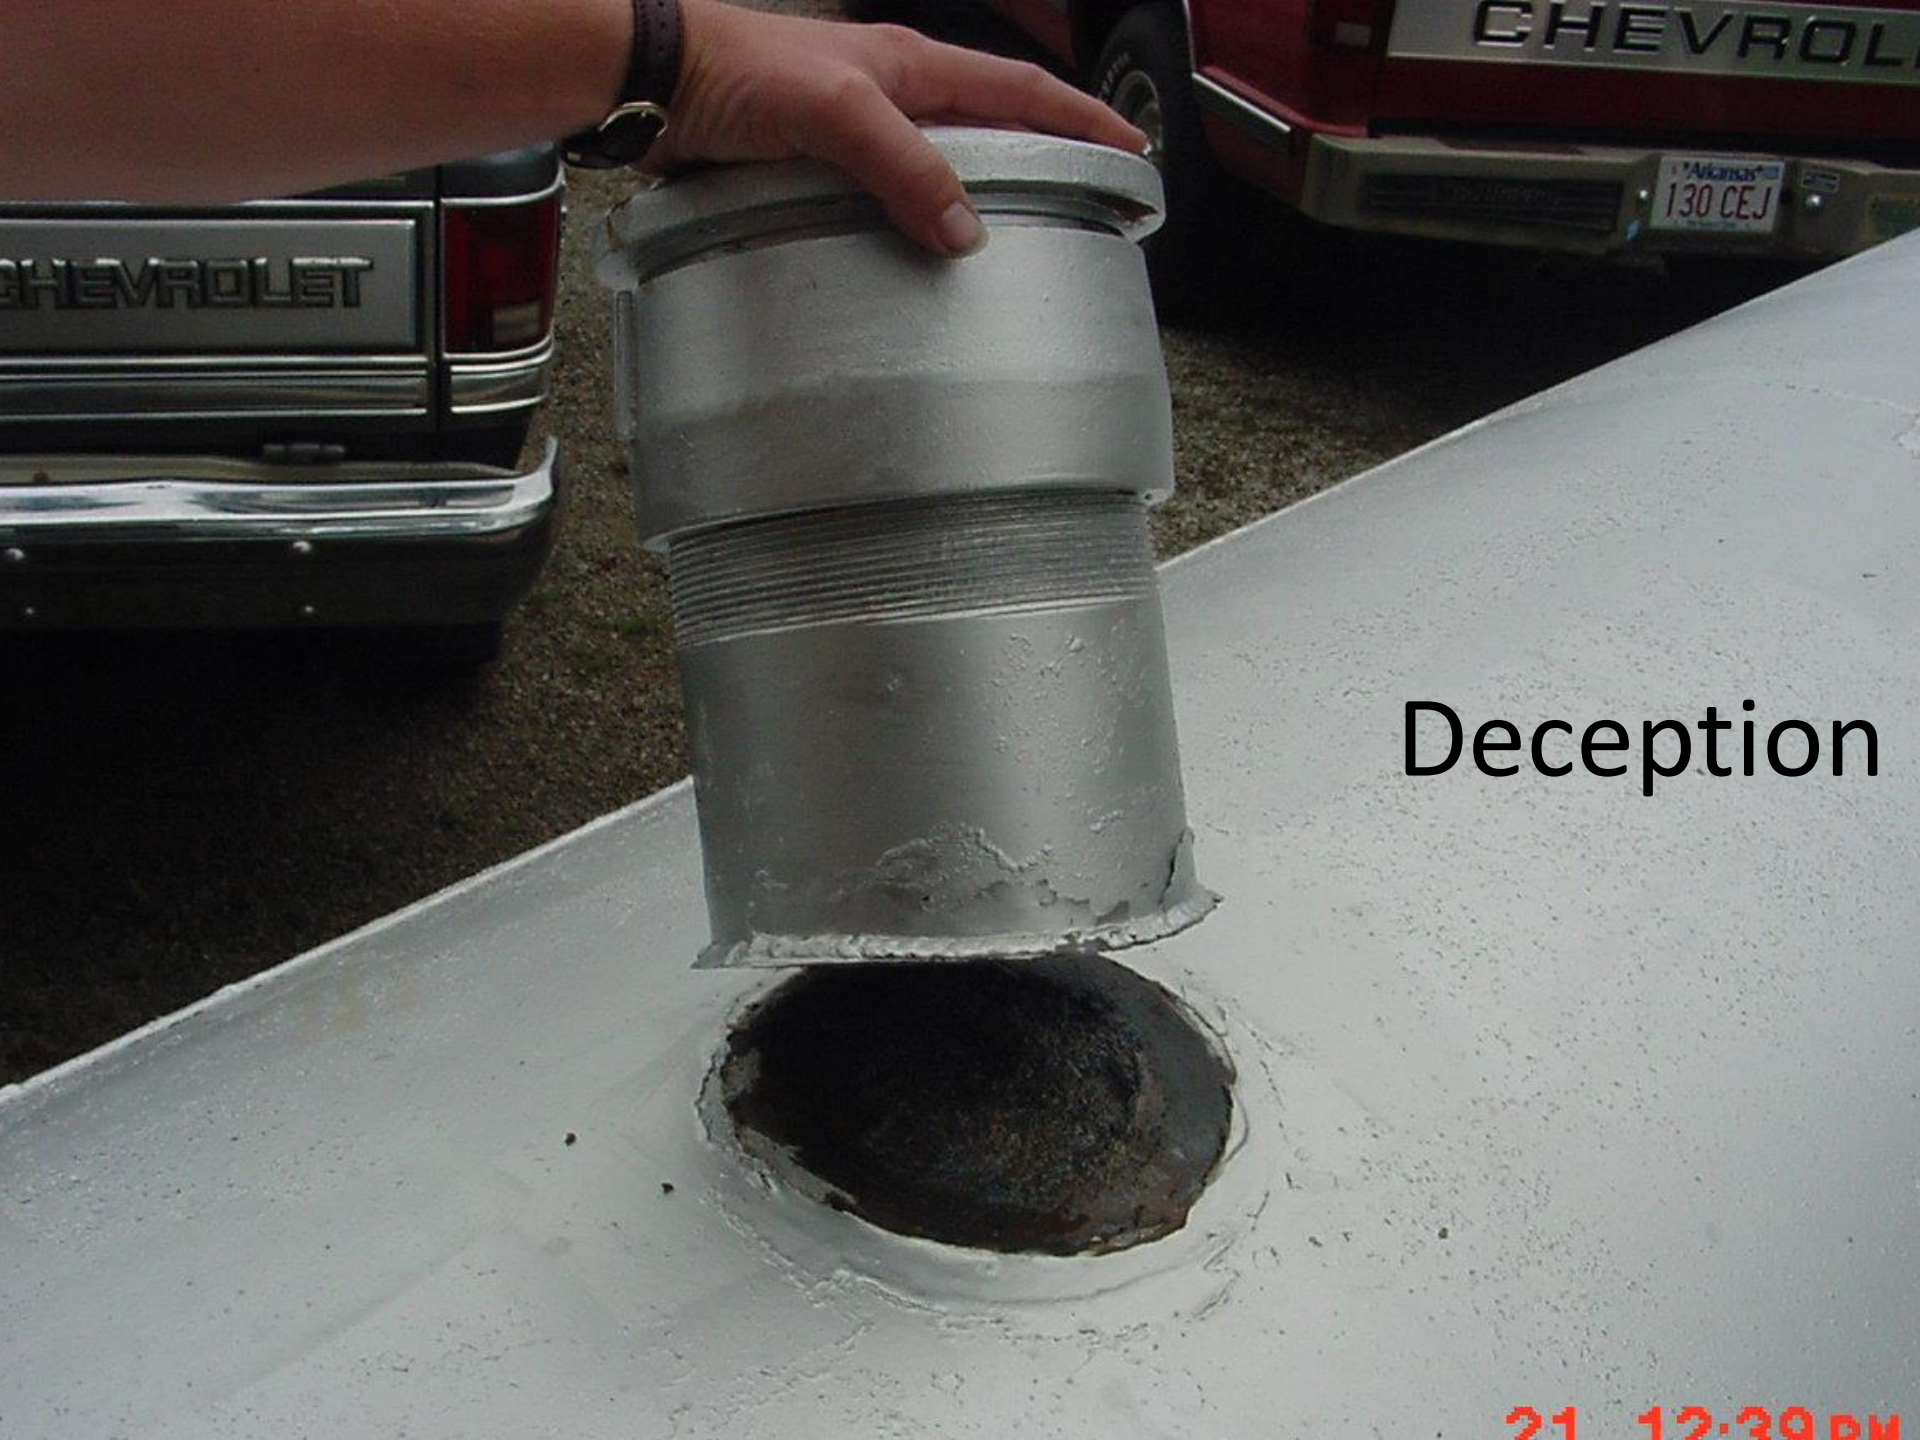
Deception

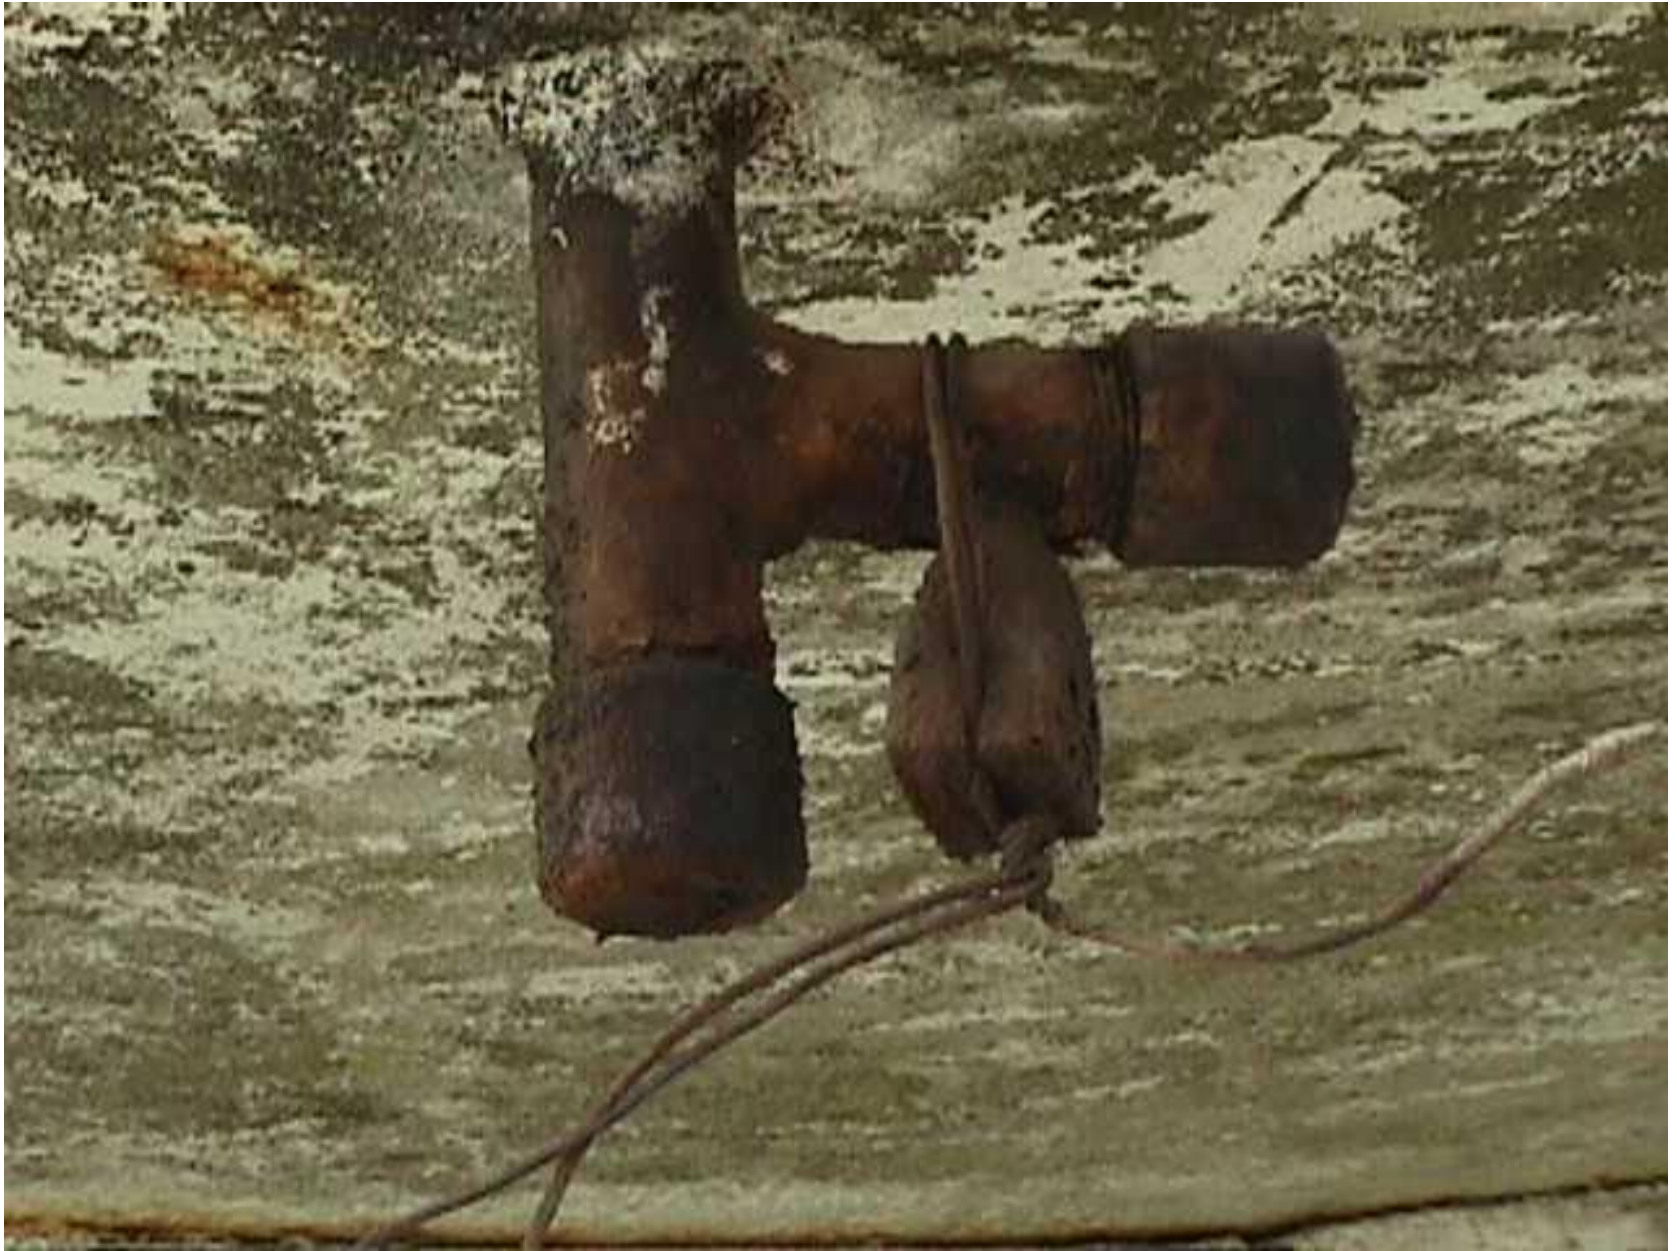
Hickory Plug

Repairs

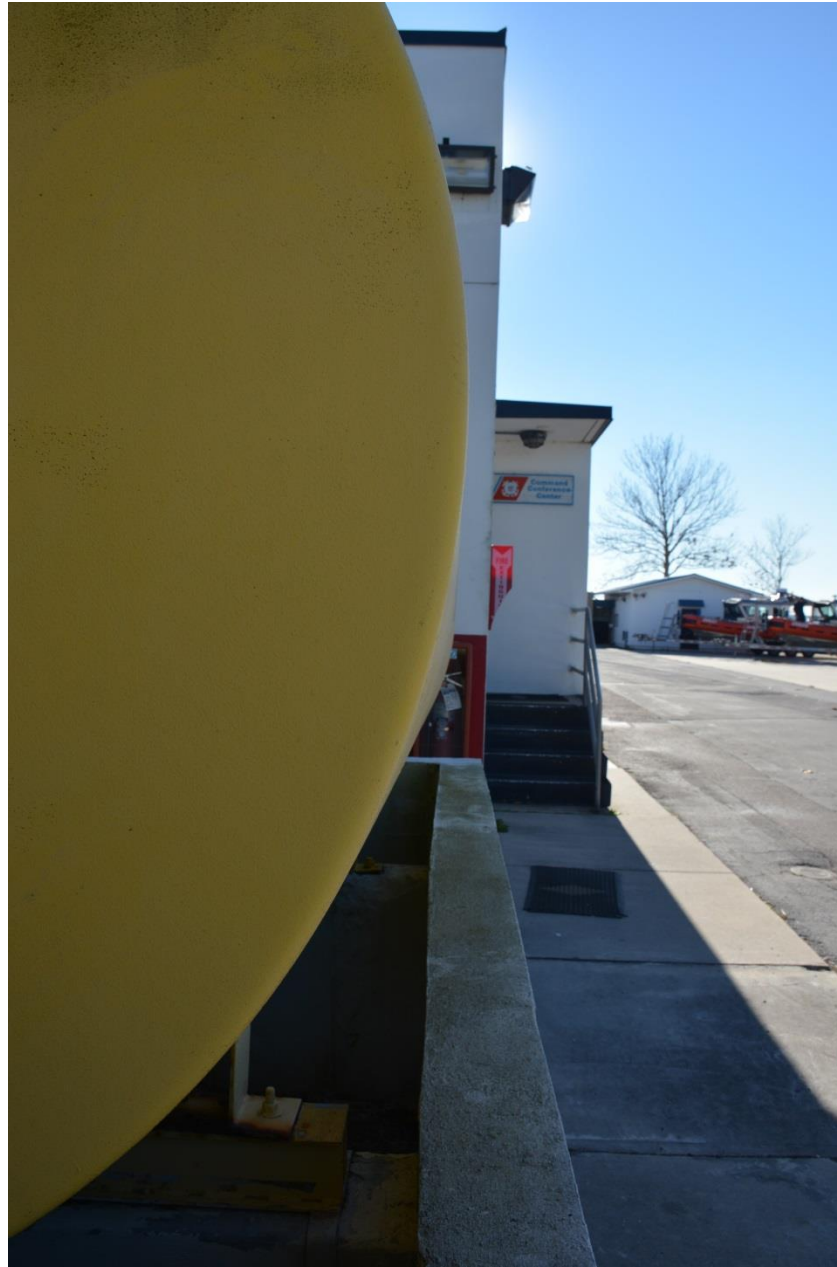
Side of Tank Near Dike-Wall
