Shop-Fabricated Aboveground Storage Tank Inspections – Expect the Unexpected...

Mott-Smith Consulting Group, LLC

Marshall T. Mott-Smith, President Mott-Smith Consulting Group, LLC

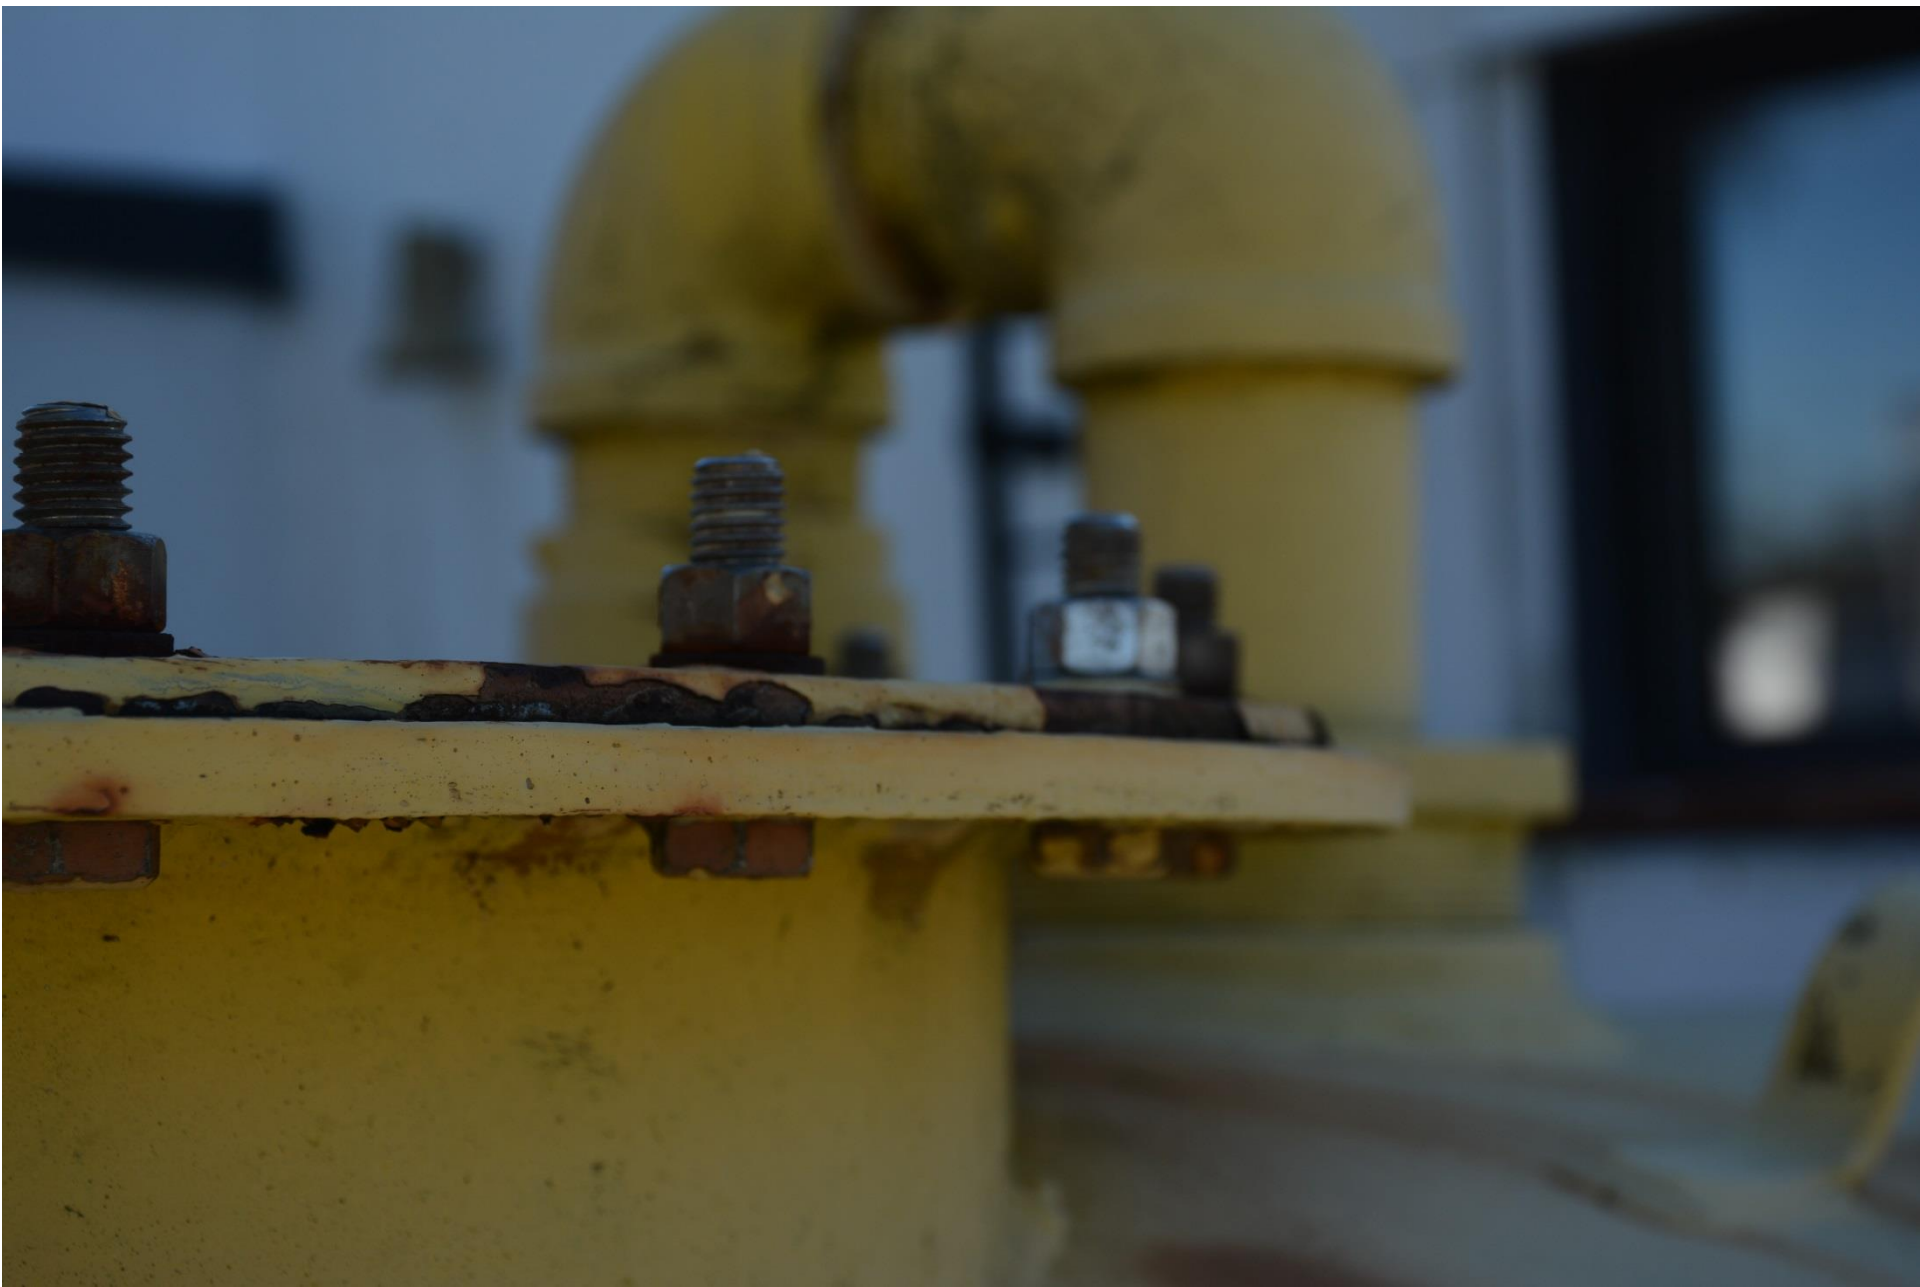
Tank Top

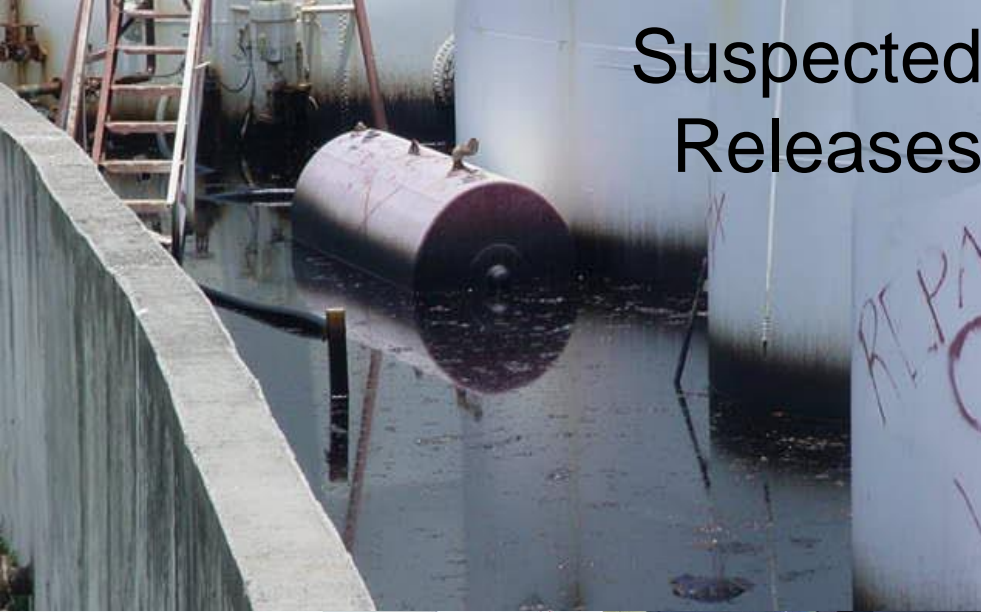
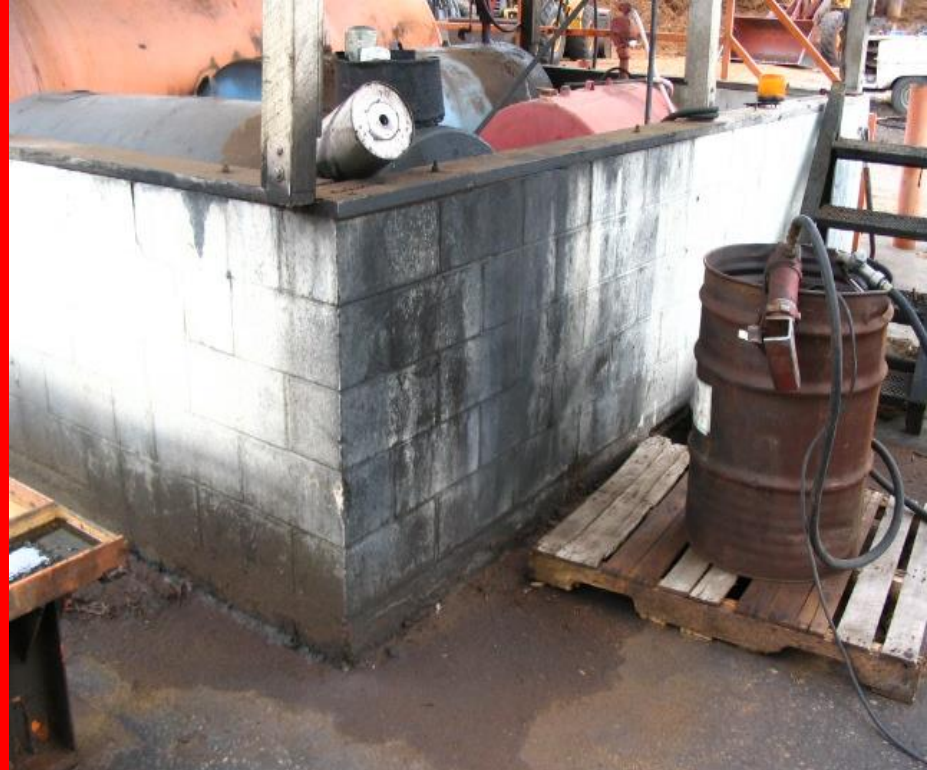
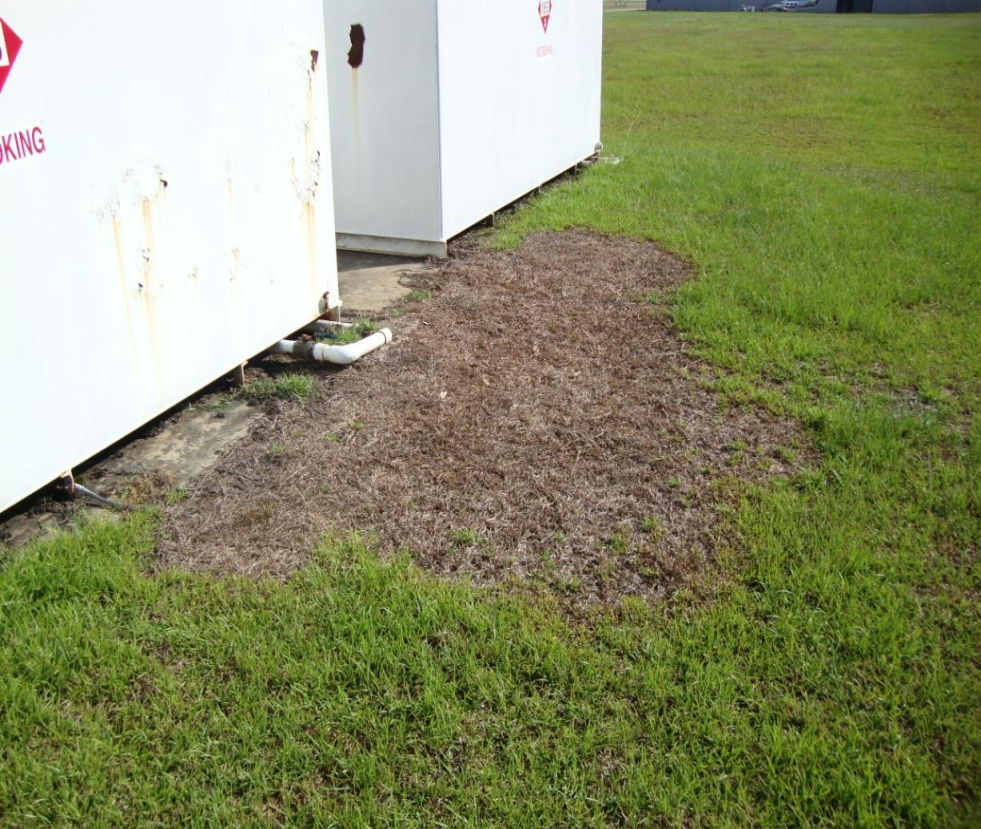
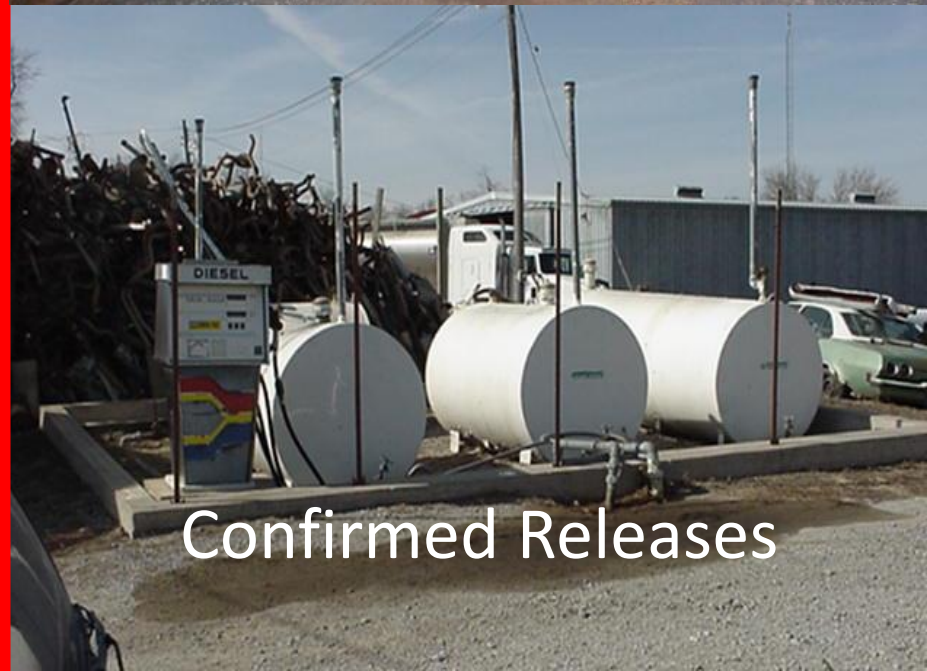
Suspected Releases

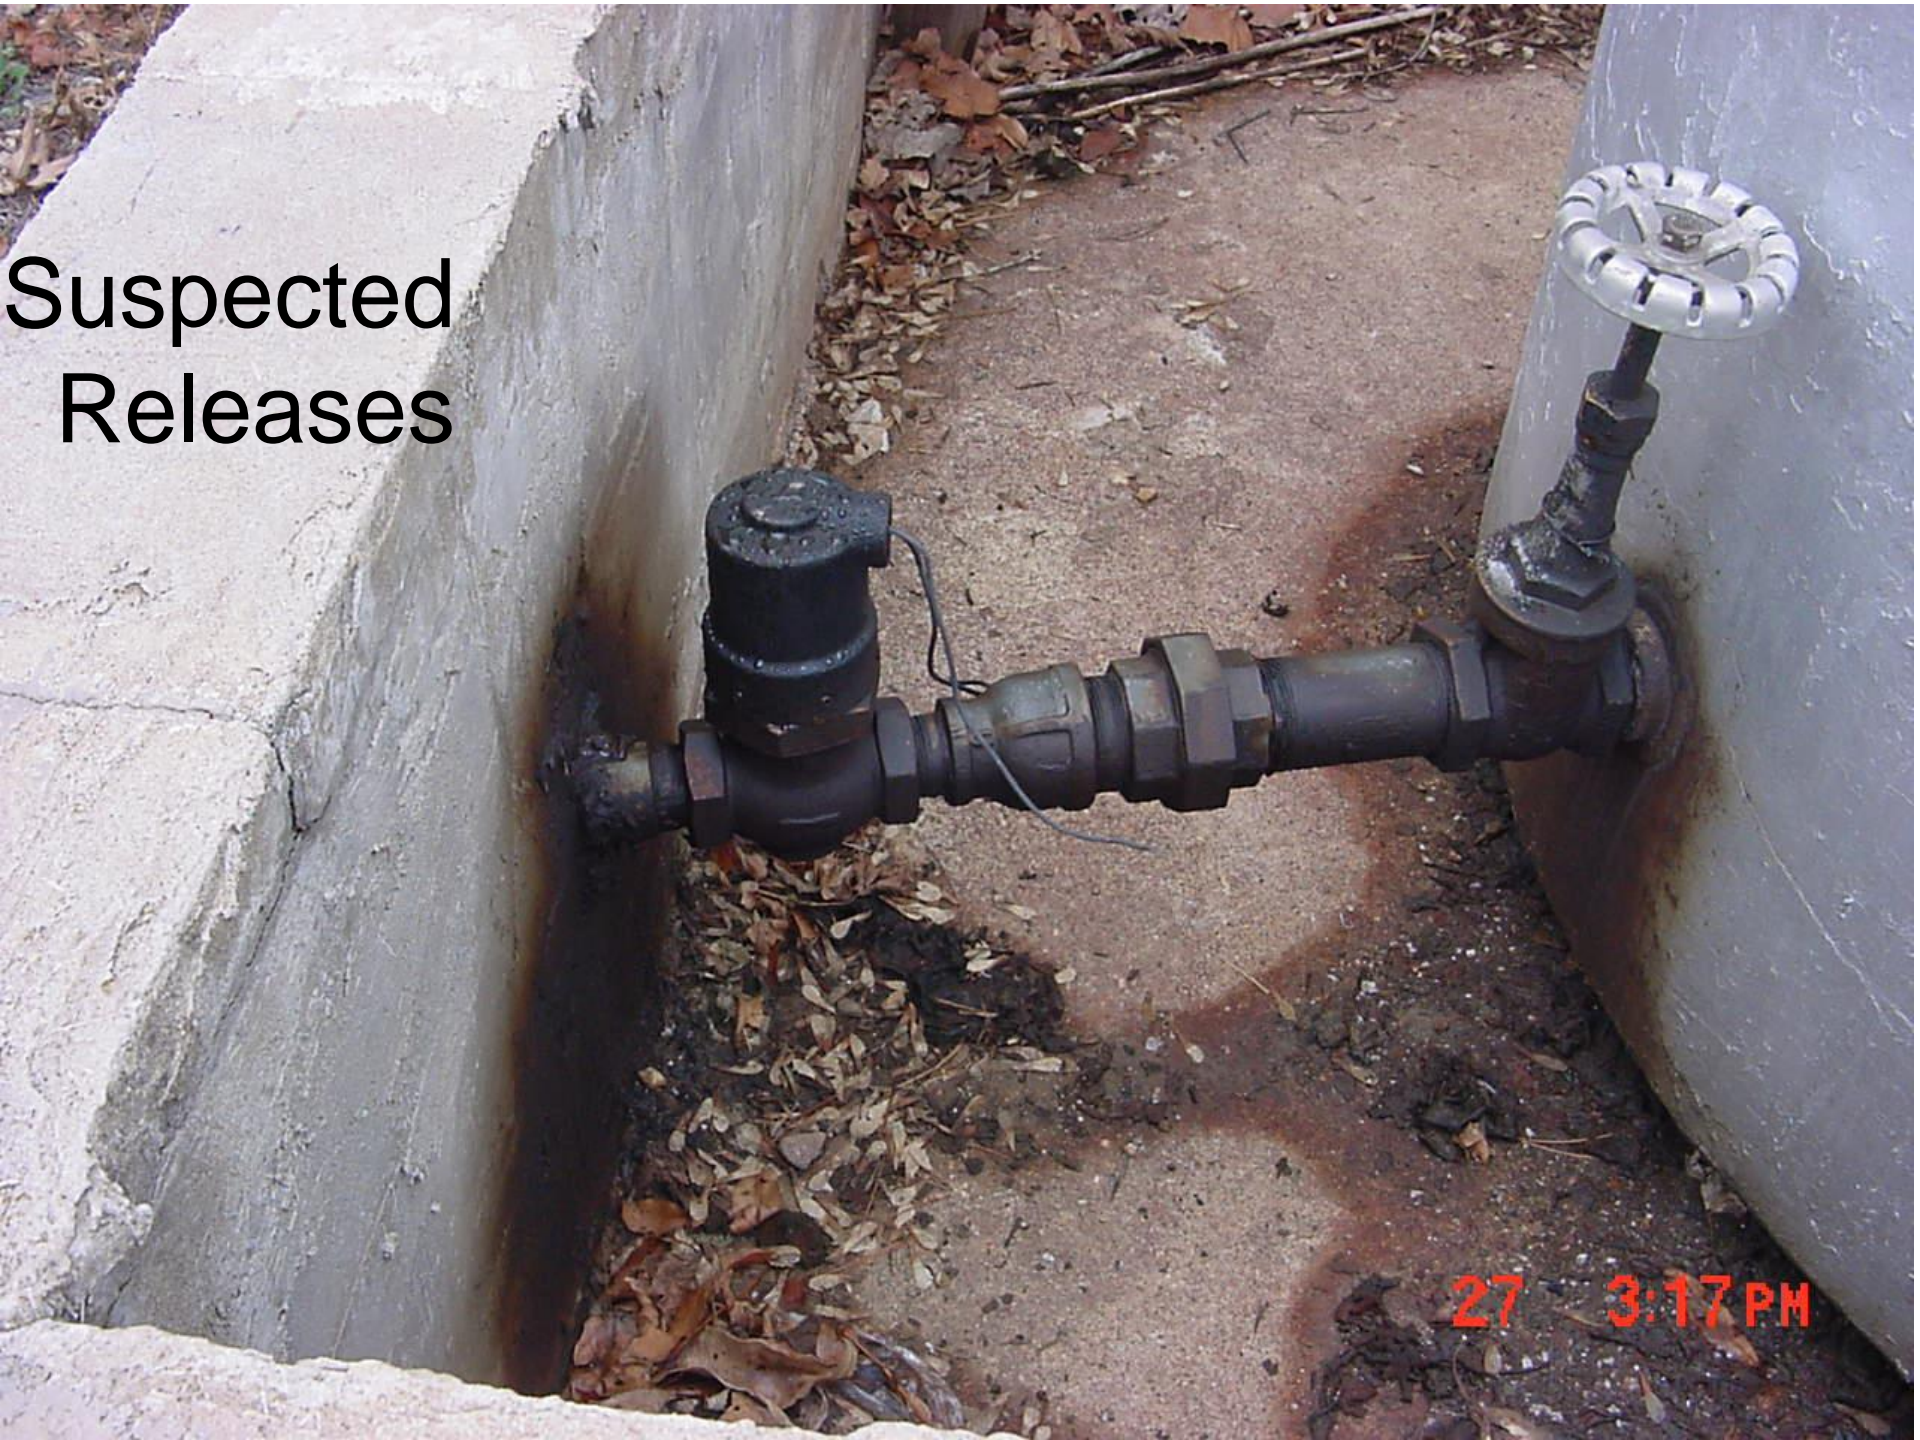
Suspected
Releases

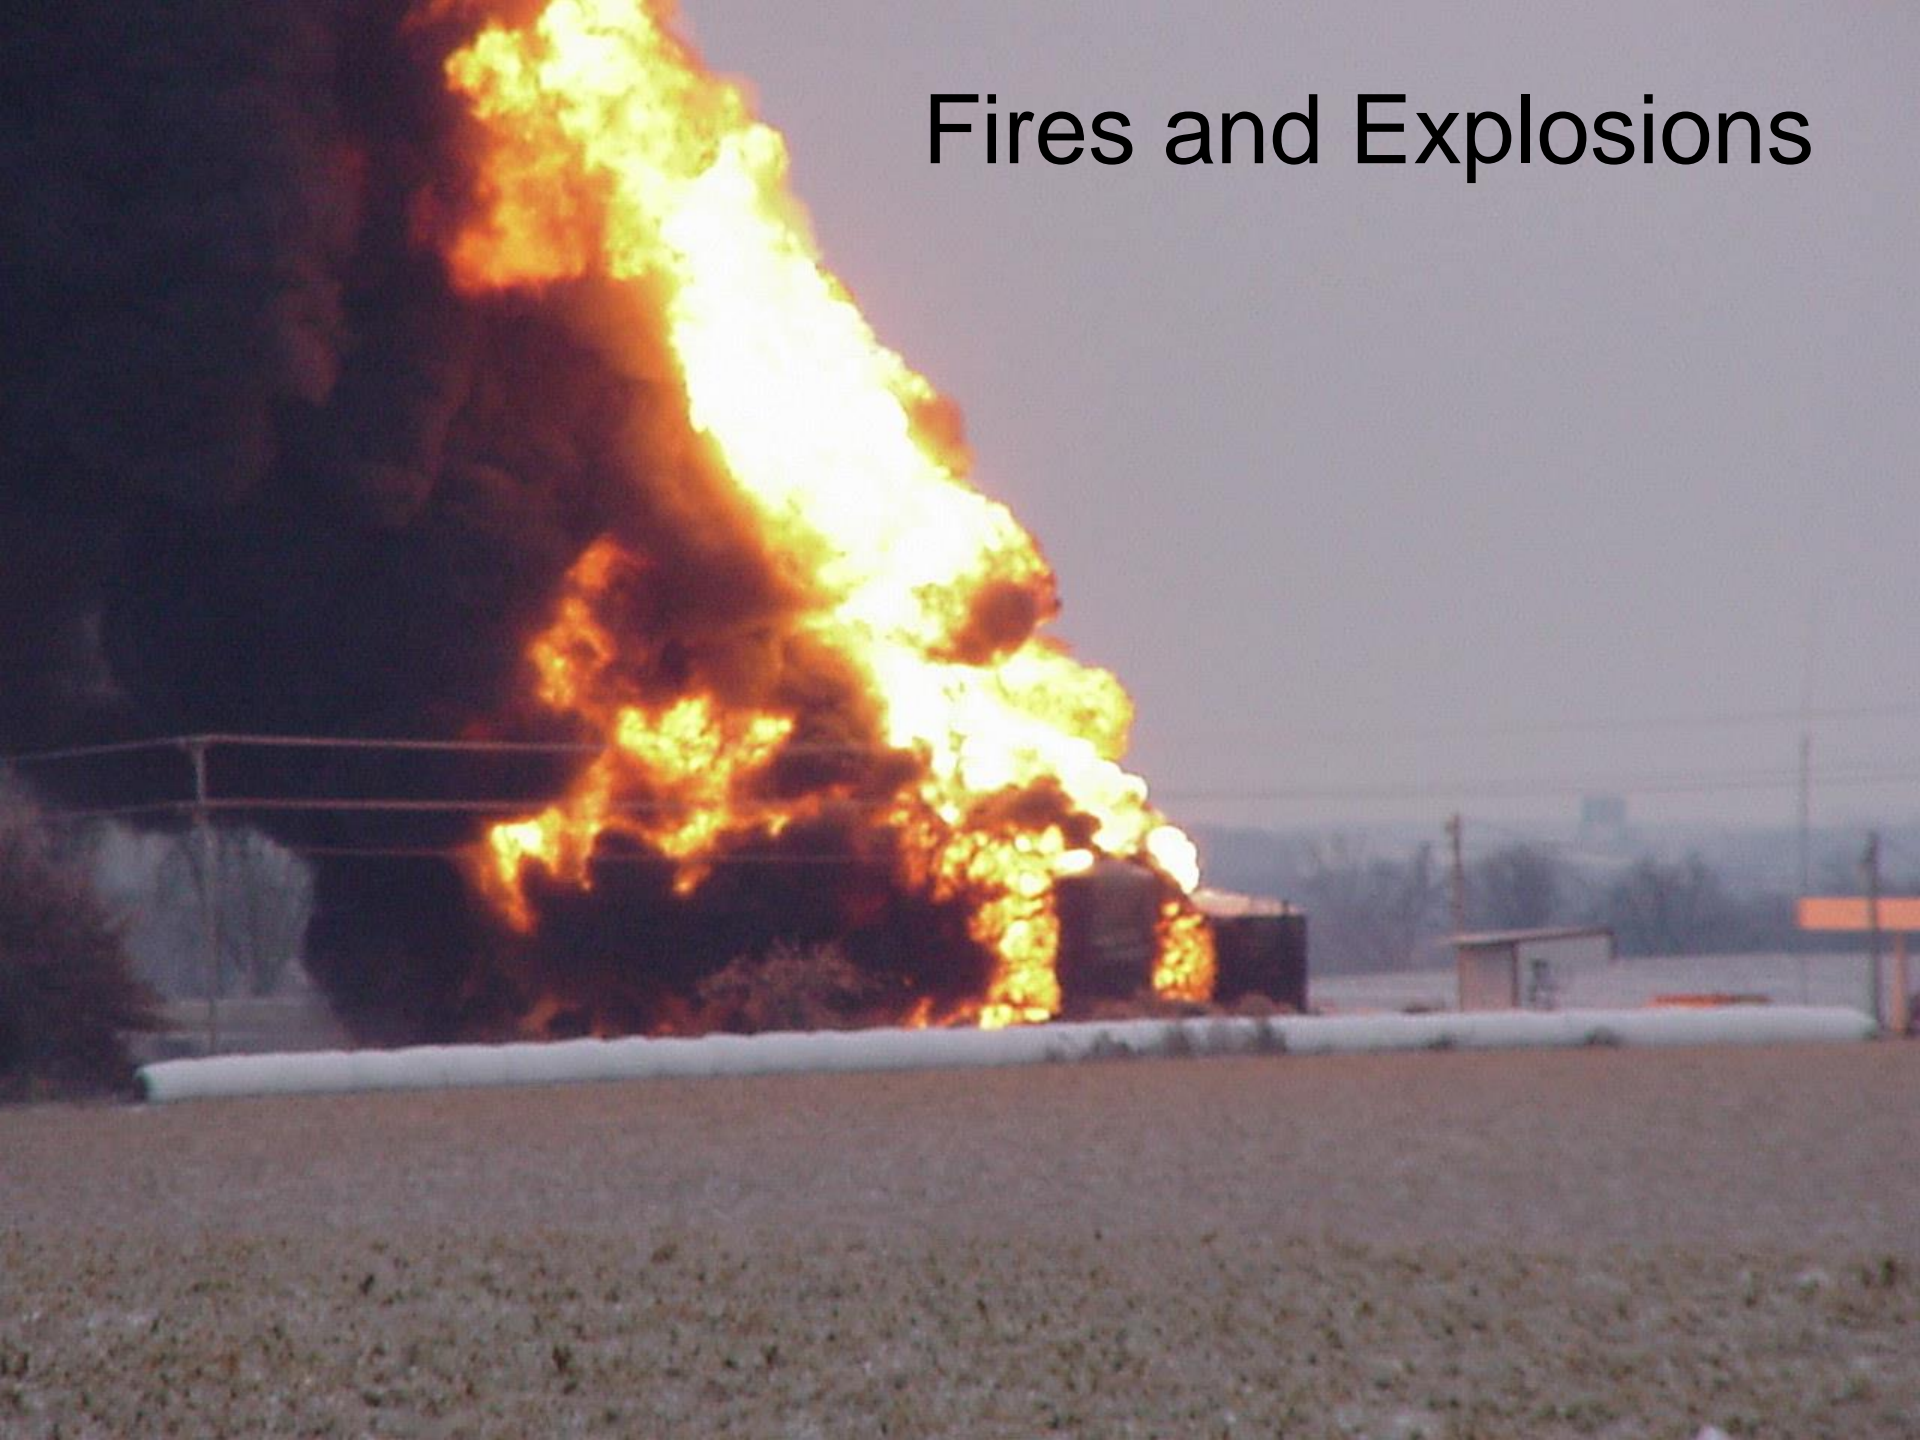
Fires and Explosions

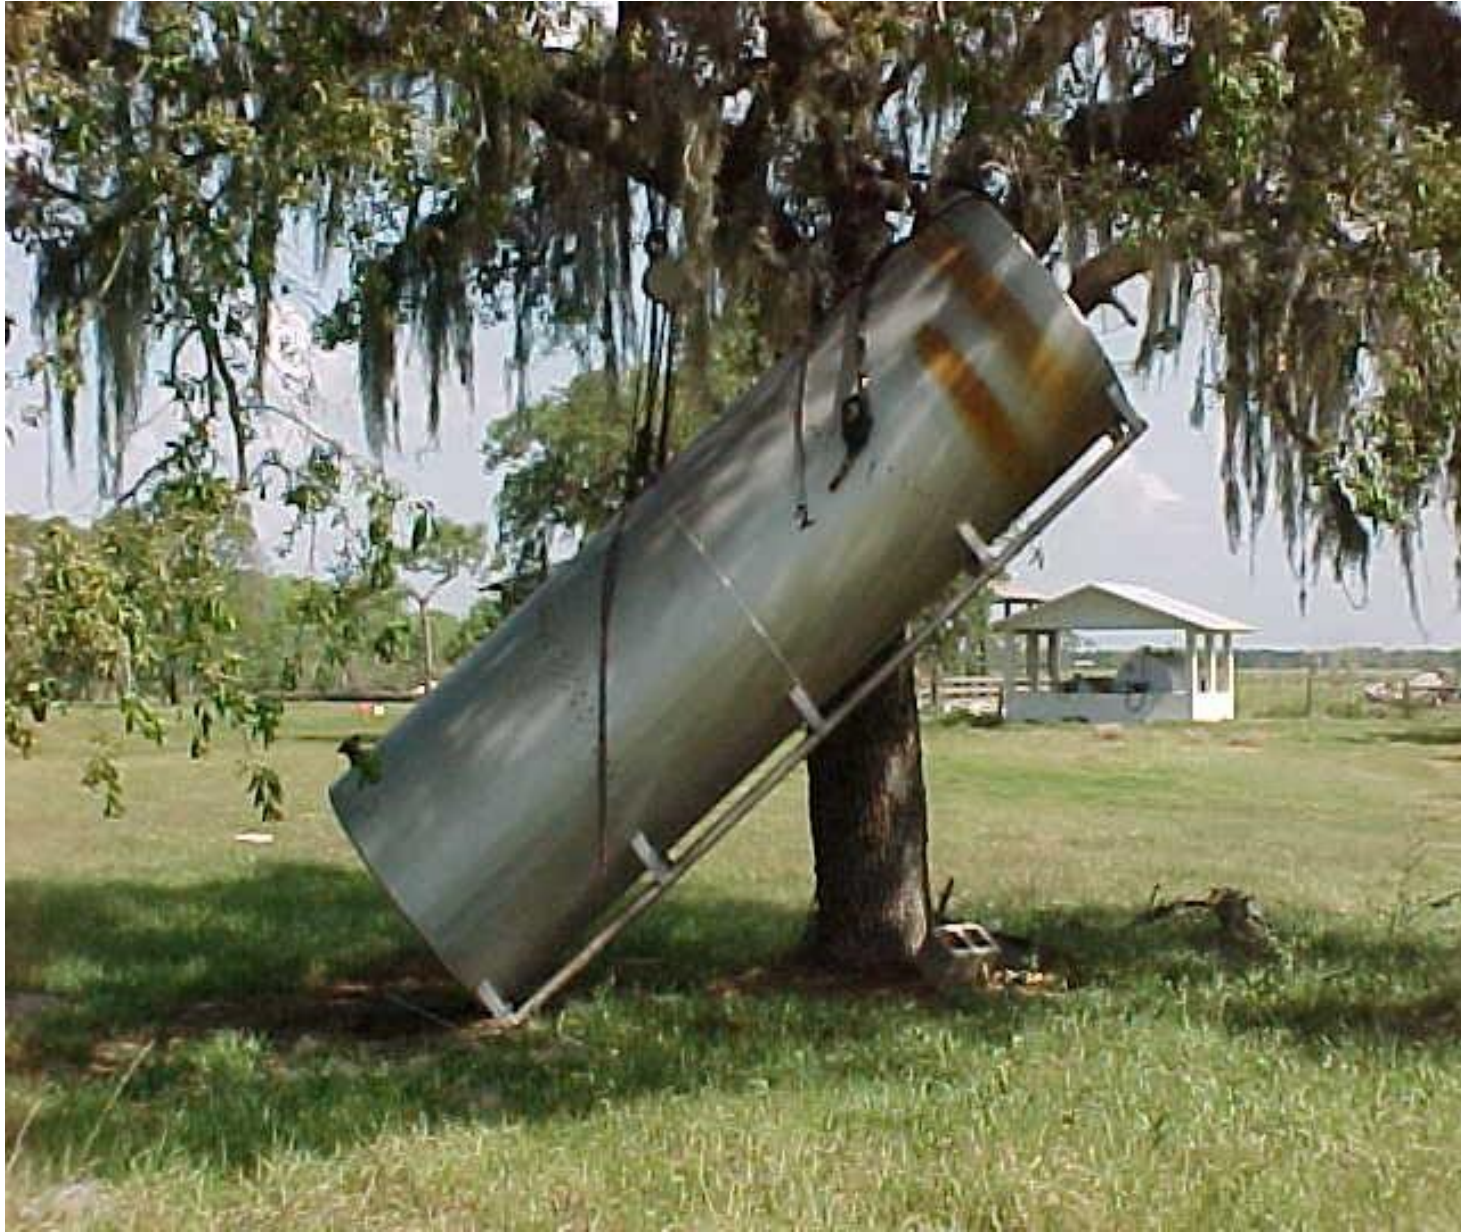
Is this an aboveground tank?

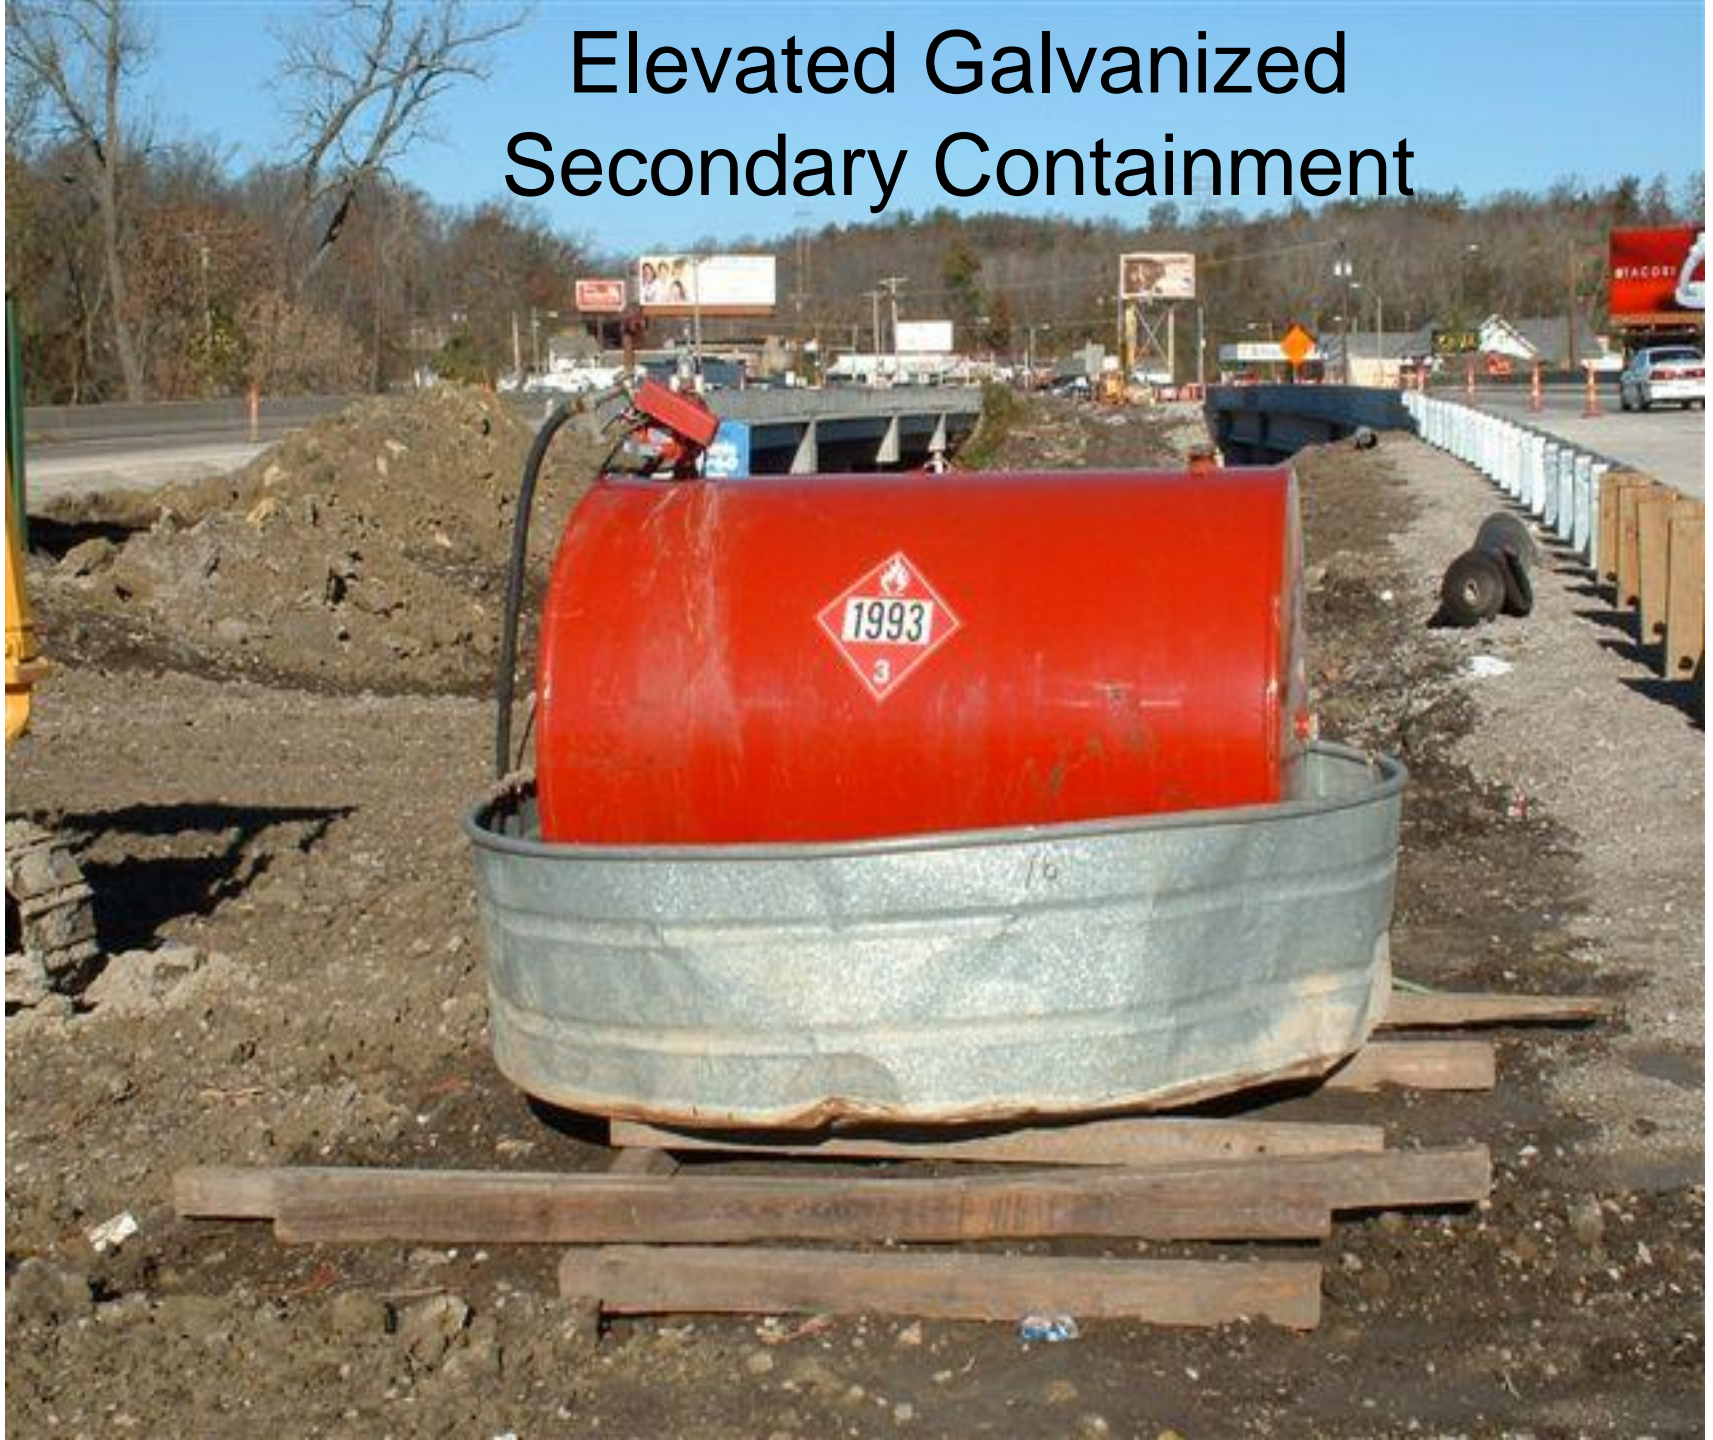
Elevated Galvanized Secondary Containment

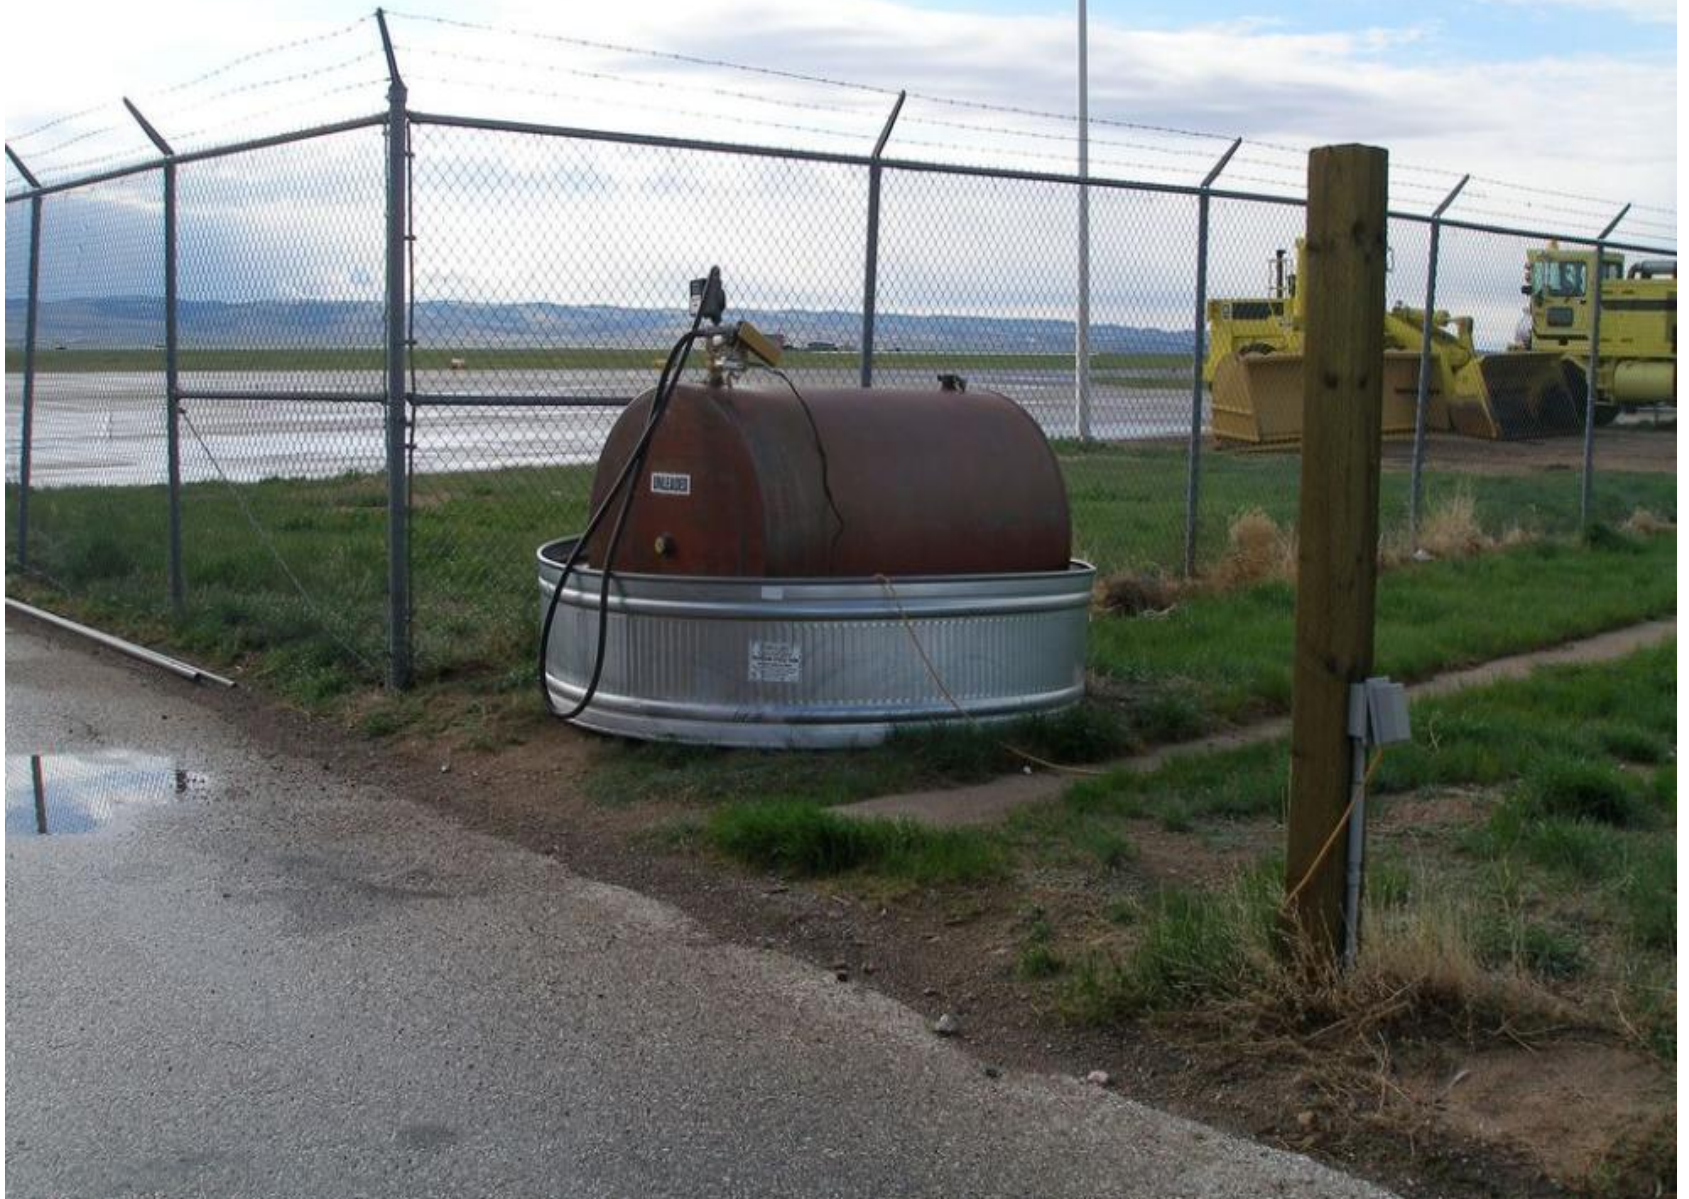
Non-Elevated Galvanized Secondary Containment

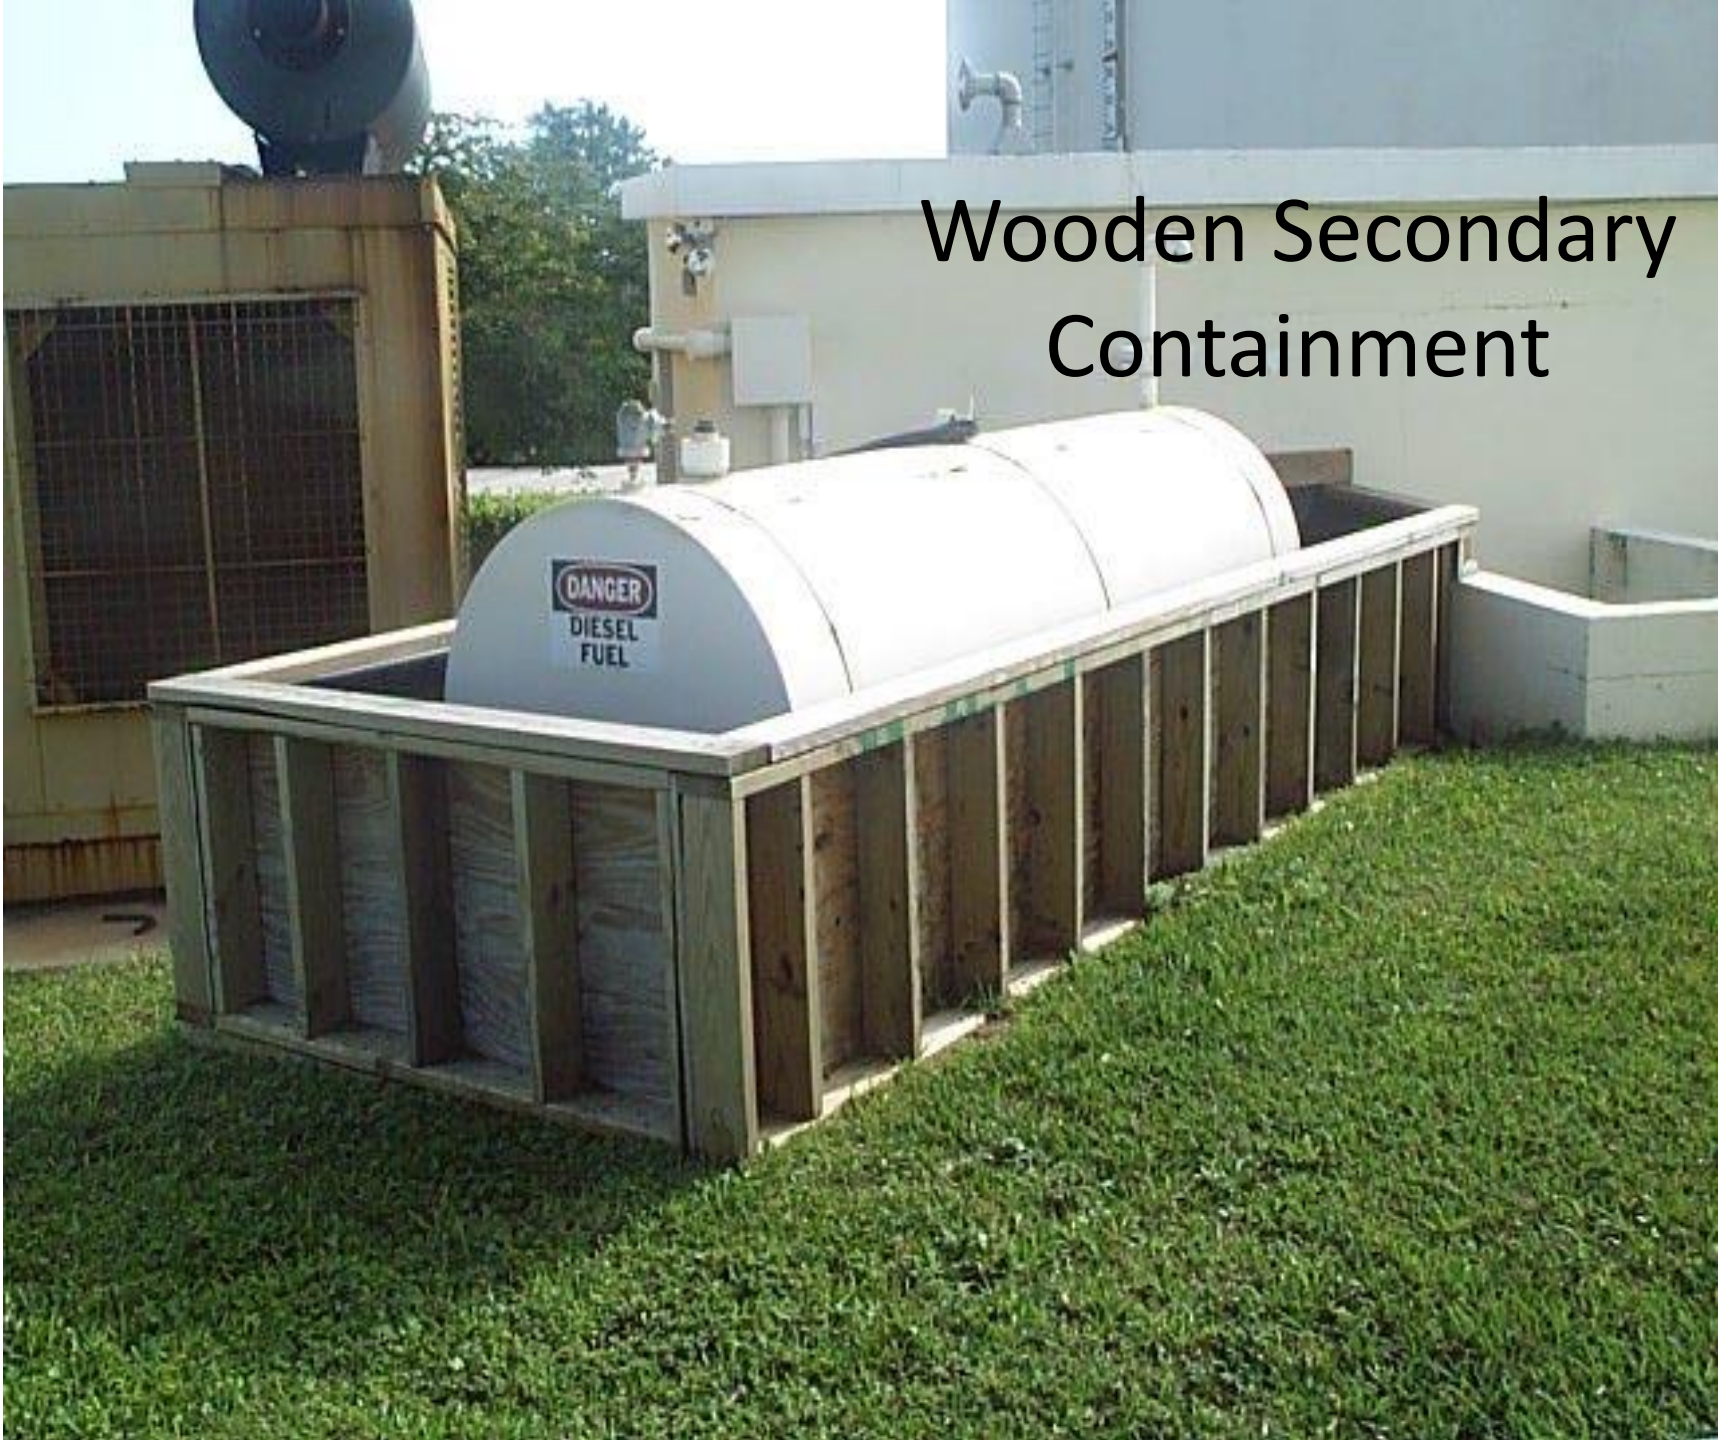
Wooden Secondary Containment

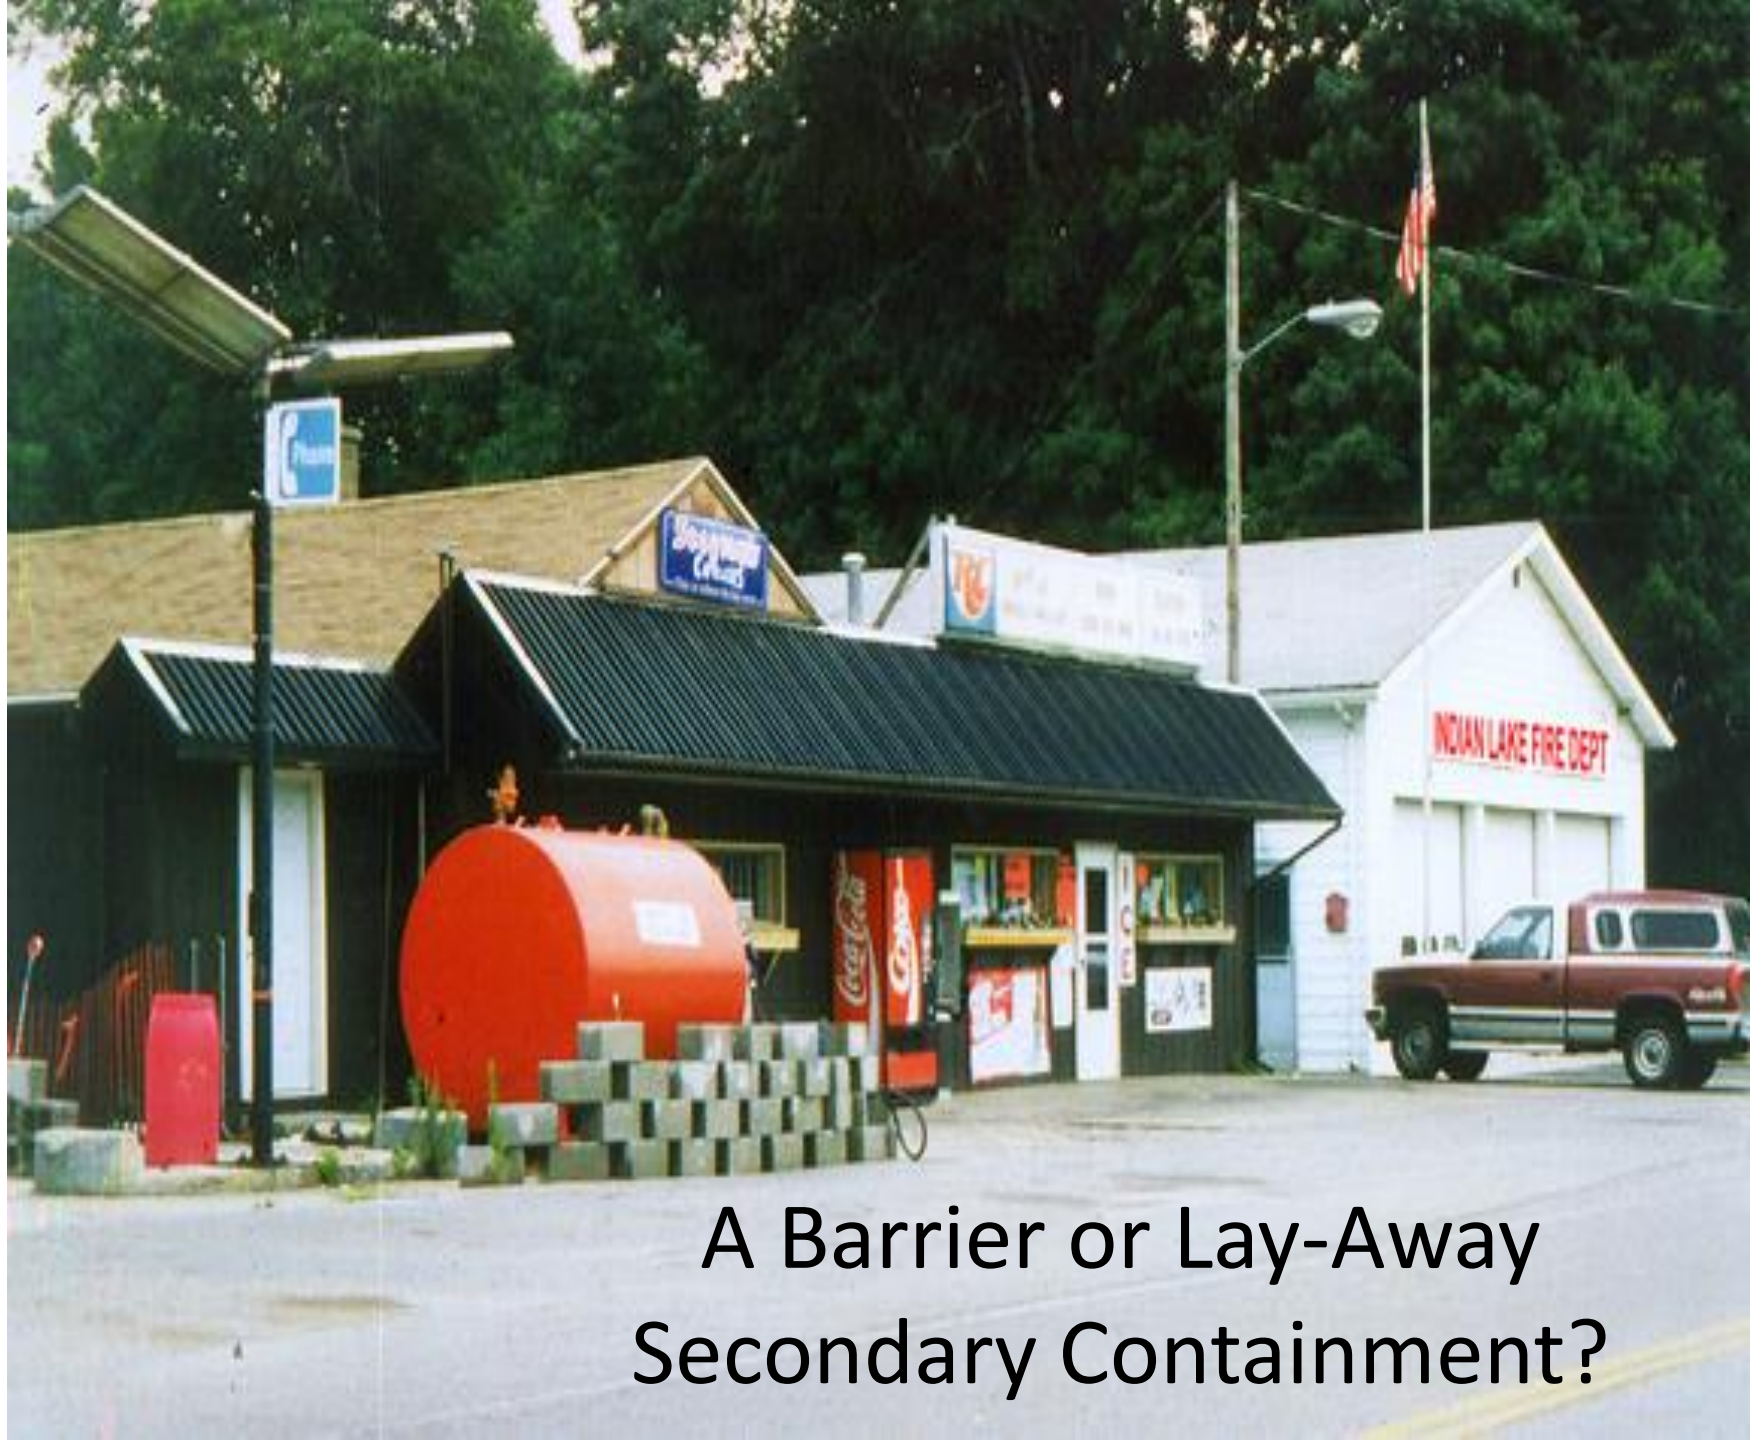
A Barrier or Lay-Away
Secondary Containment?
