Shop-Fabricated Aboveground Storage Tank Inspections – Expect the Unexpected...

Mott-Smith Consulting Group, LLC

Marshall T. Mott-Smith, President Mott-Smith Consulting Group, LLC

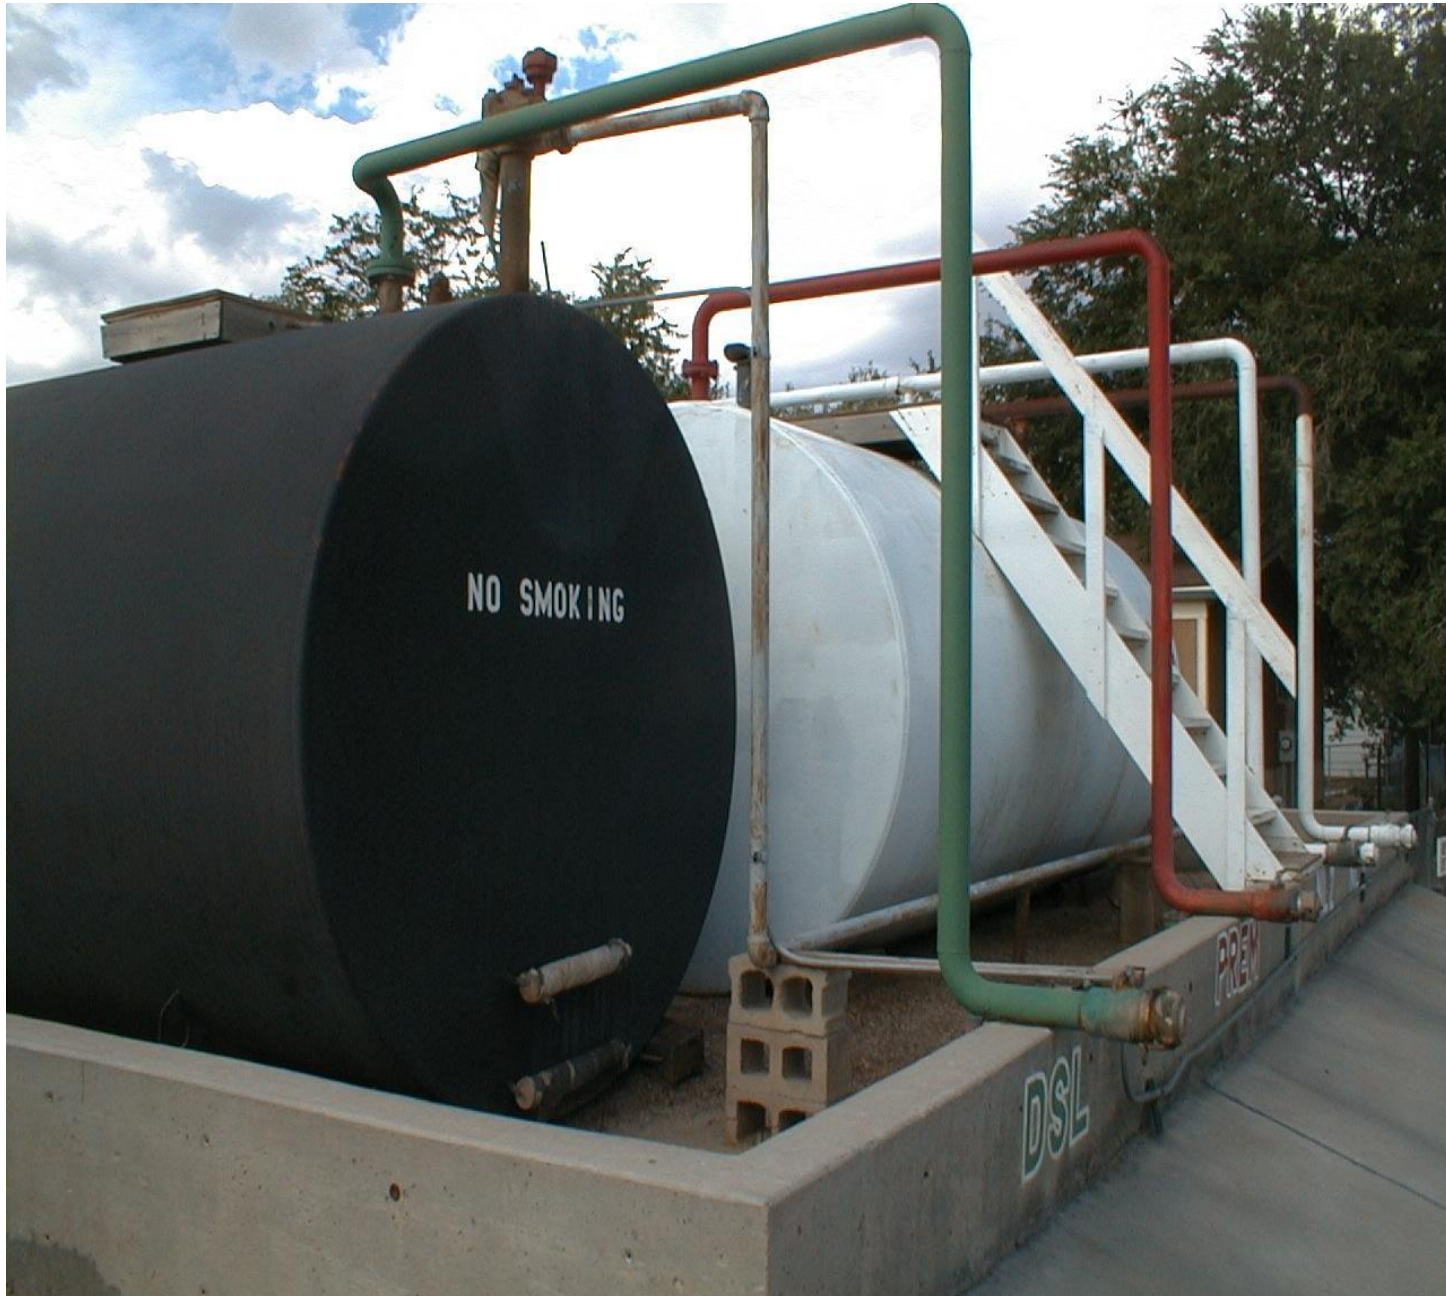
Using USTs as ASTs

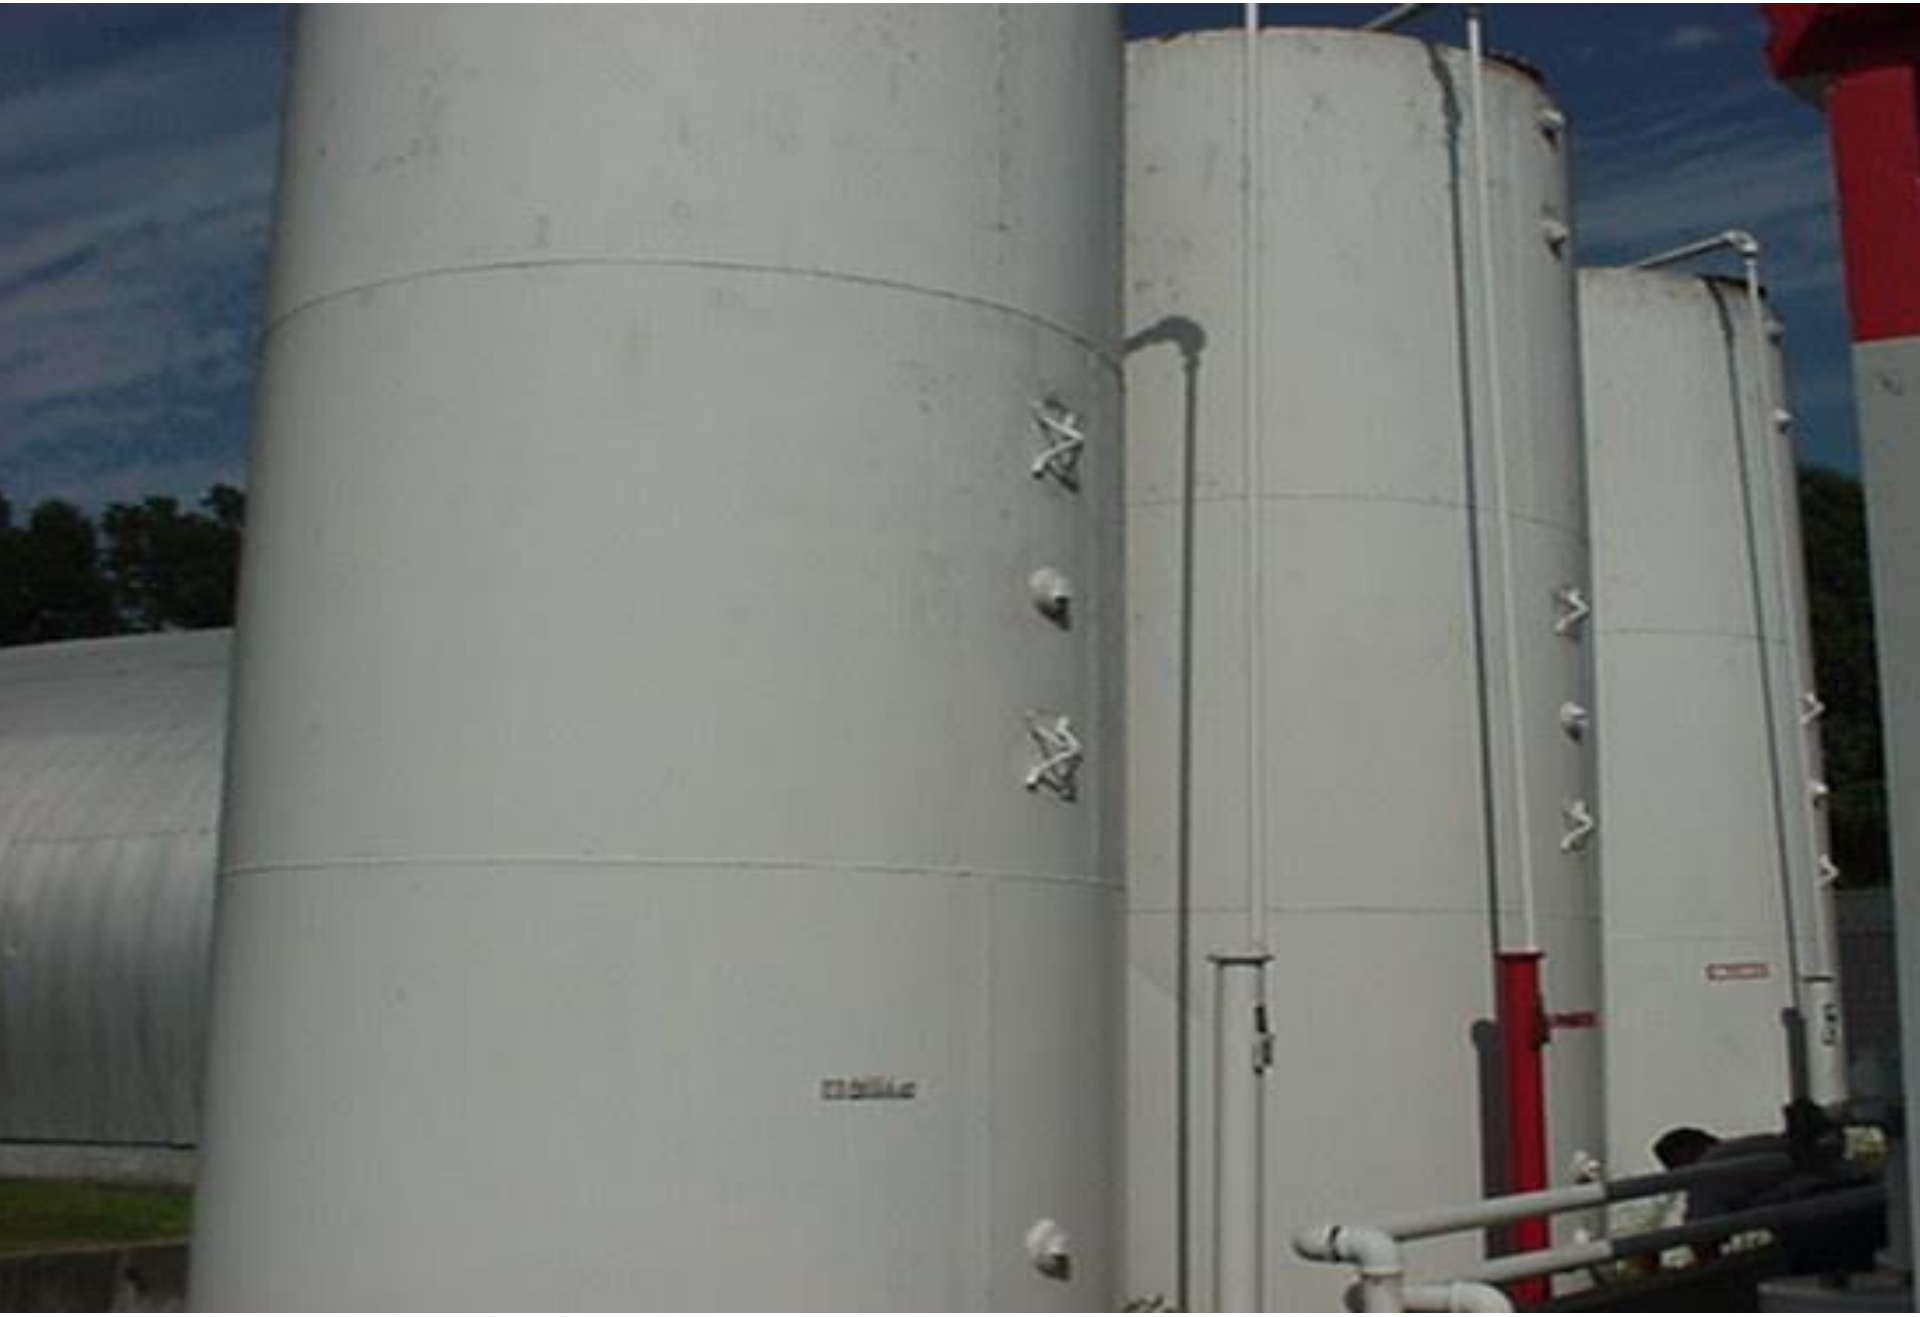
Convertizontals

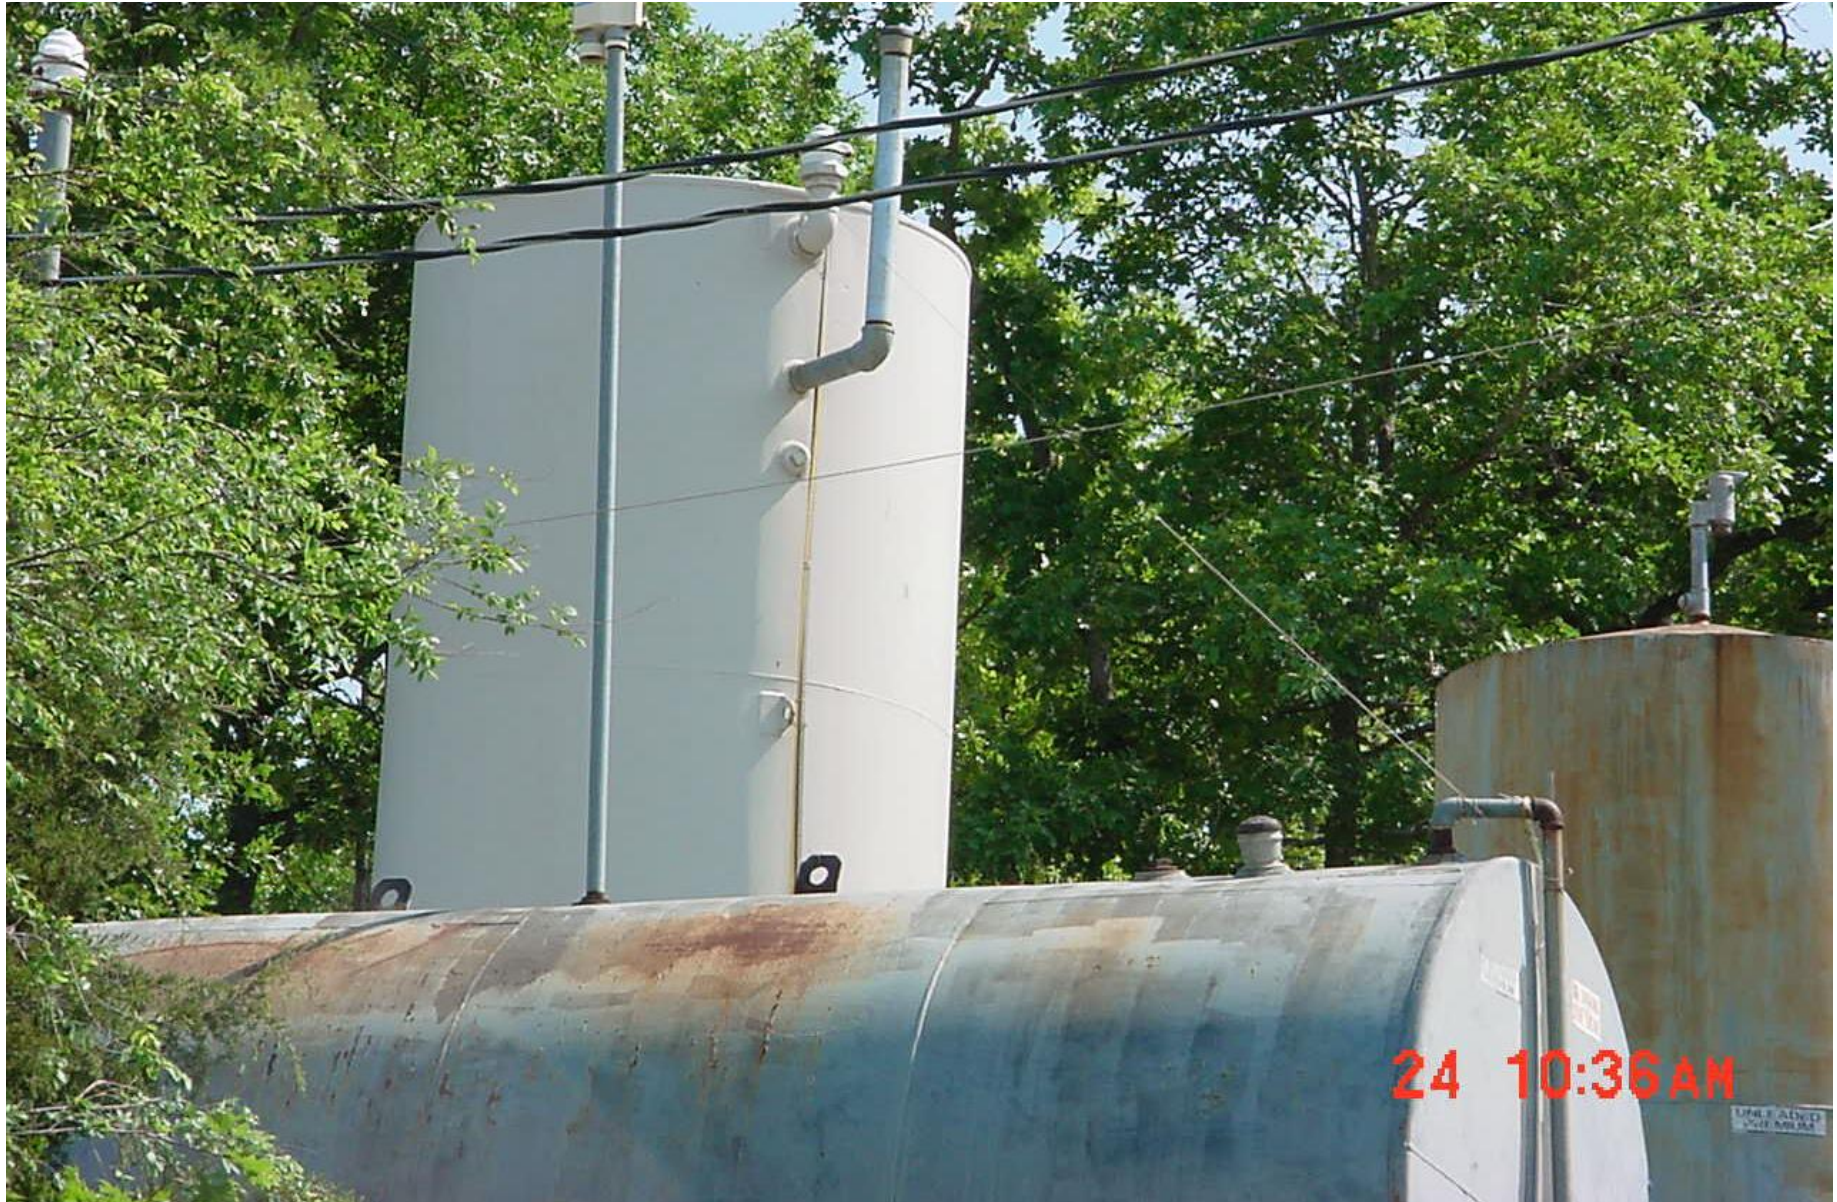
Ozark tank farm featuring the UL 142/58 convertizontal side draft. Very rare

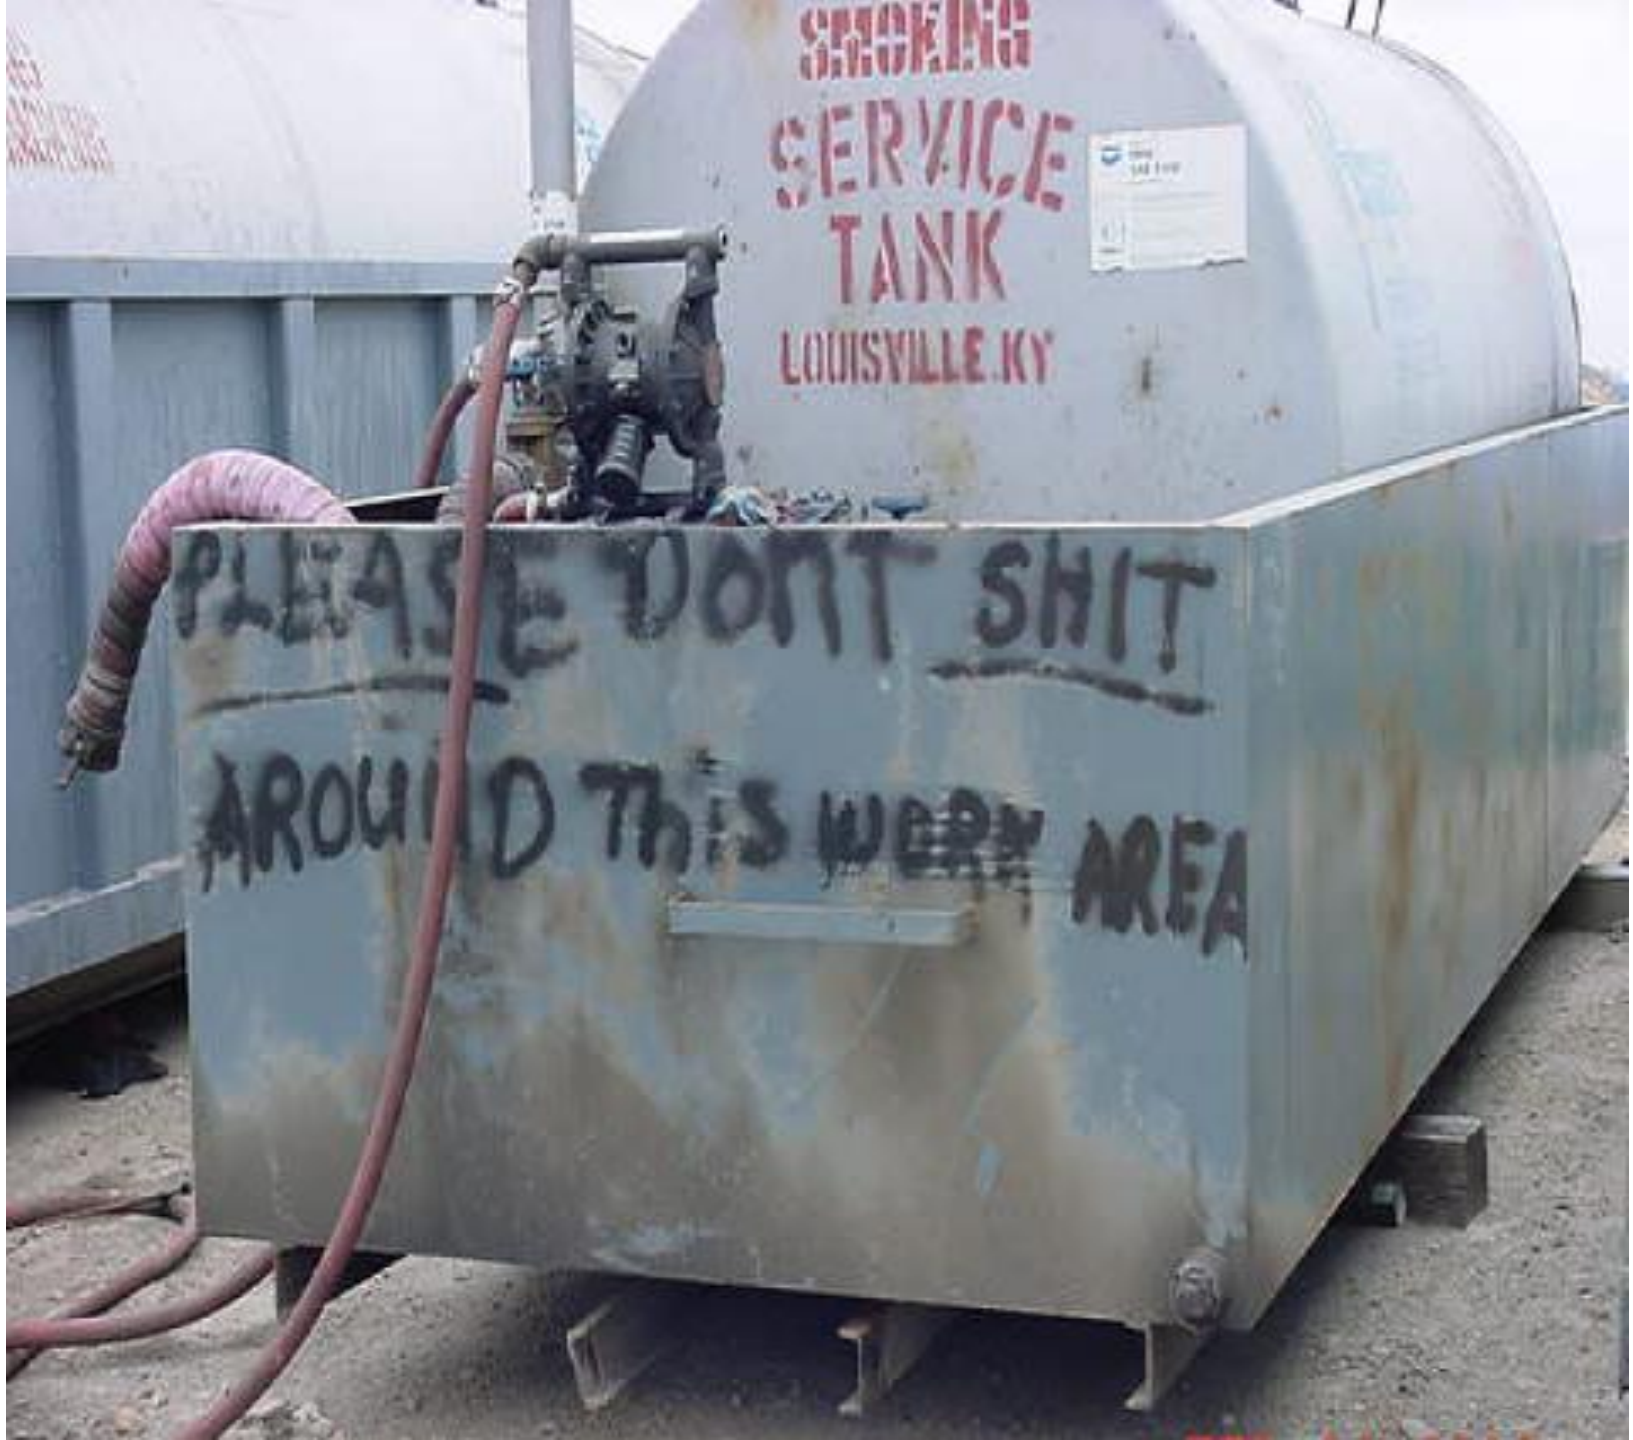
Gotta Get Under the 550 Gallon Regulatory Threshold...

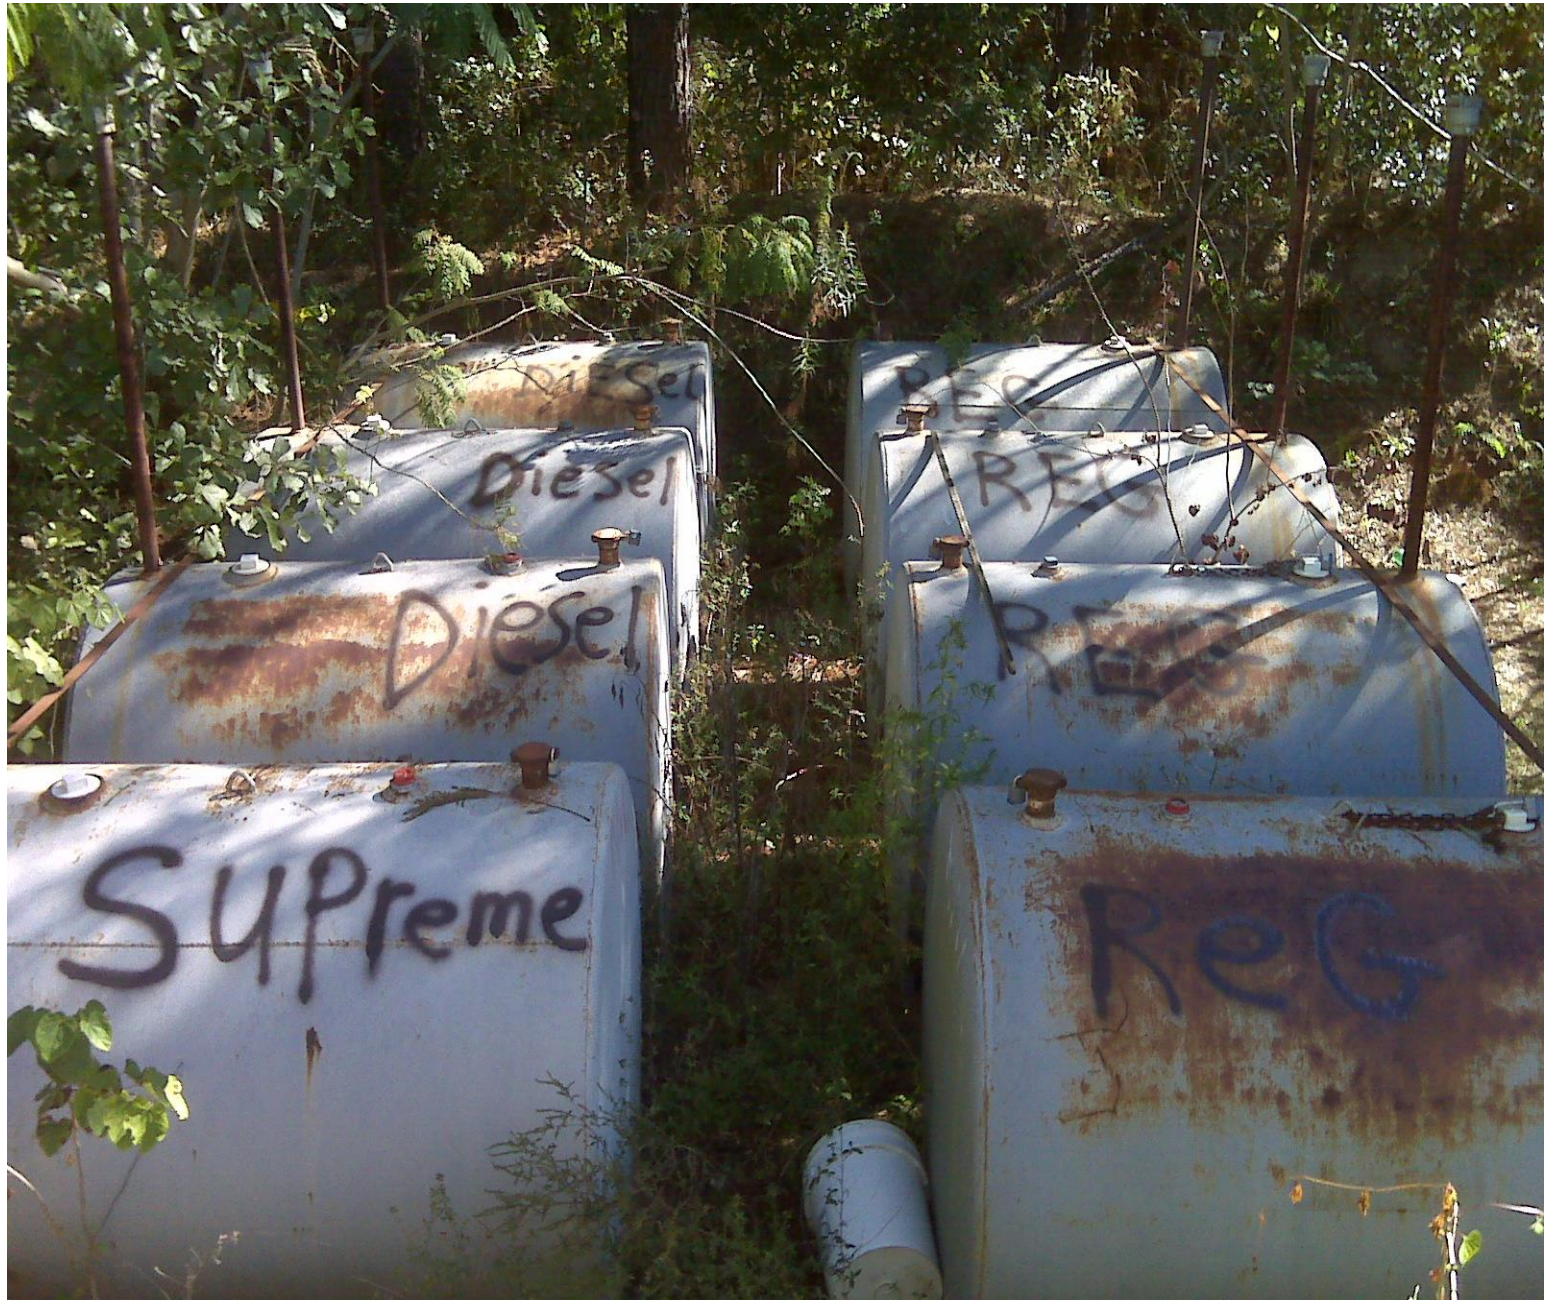
What Happens When You Over-Pressurize a Convault...

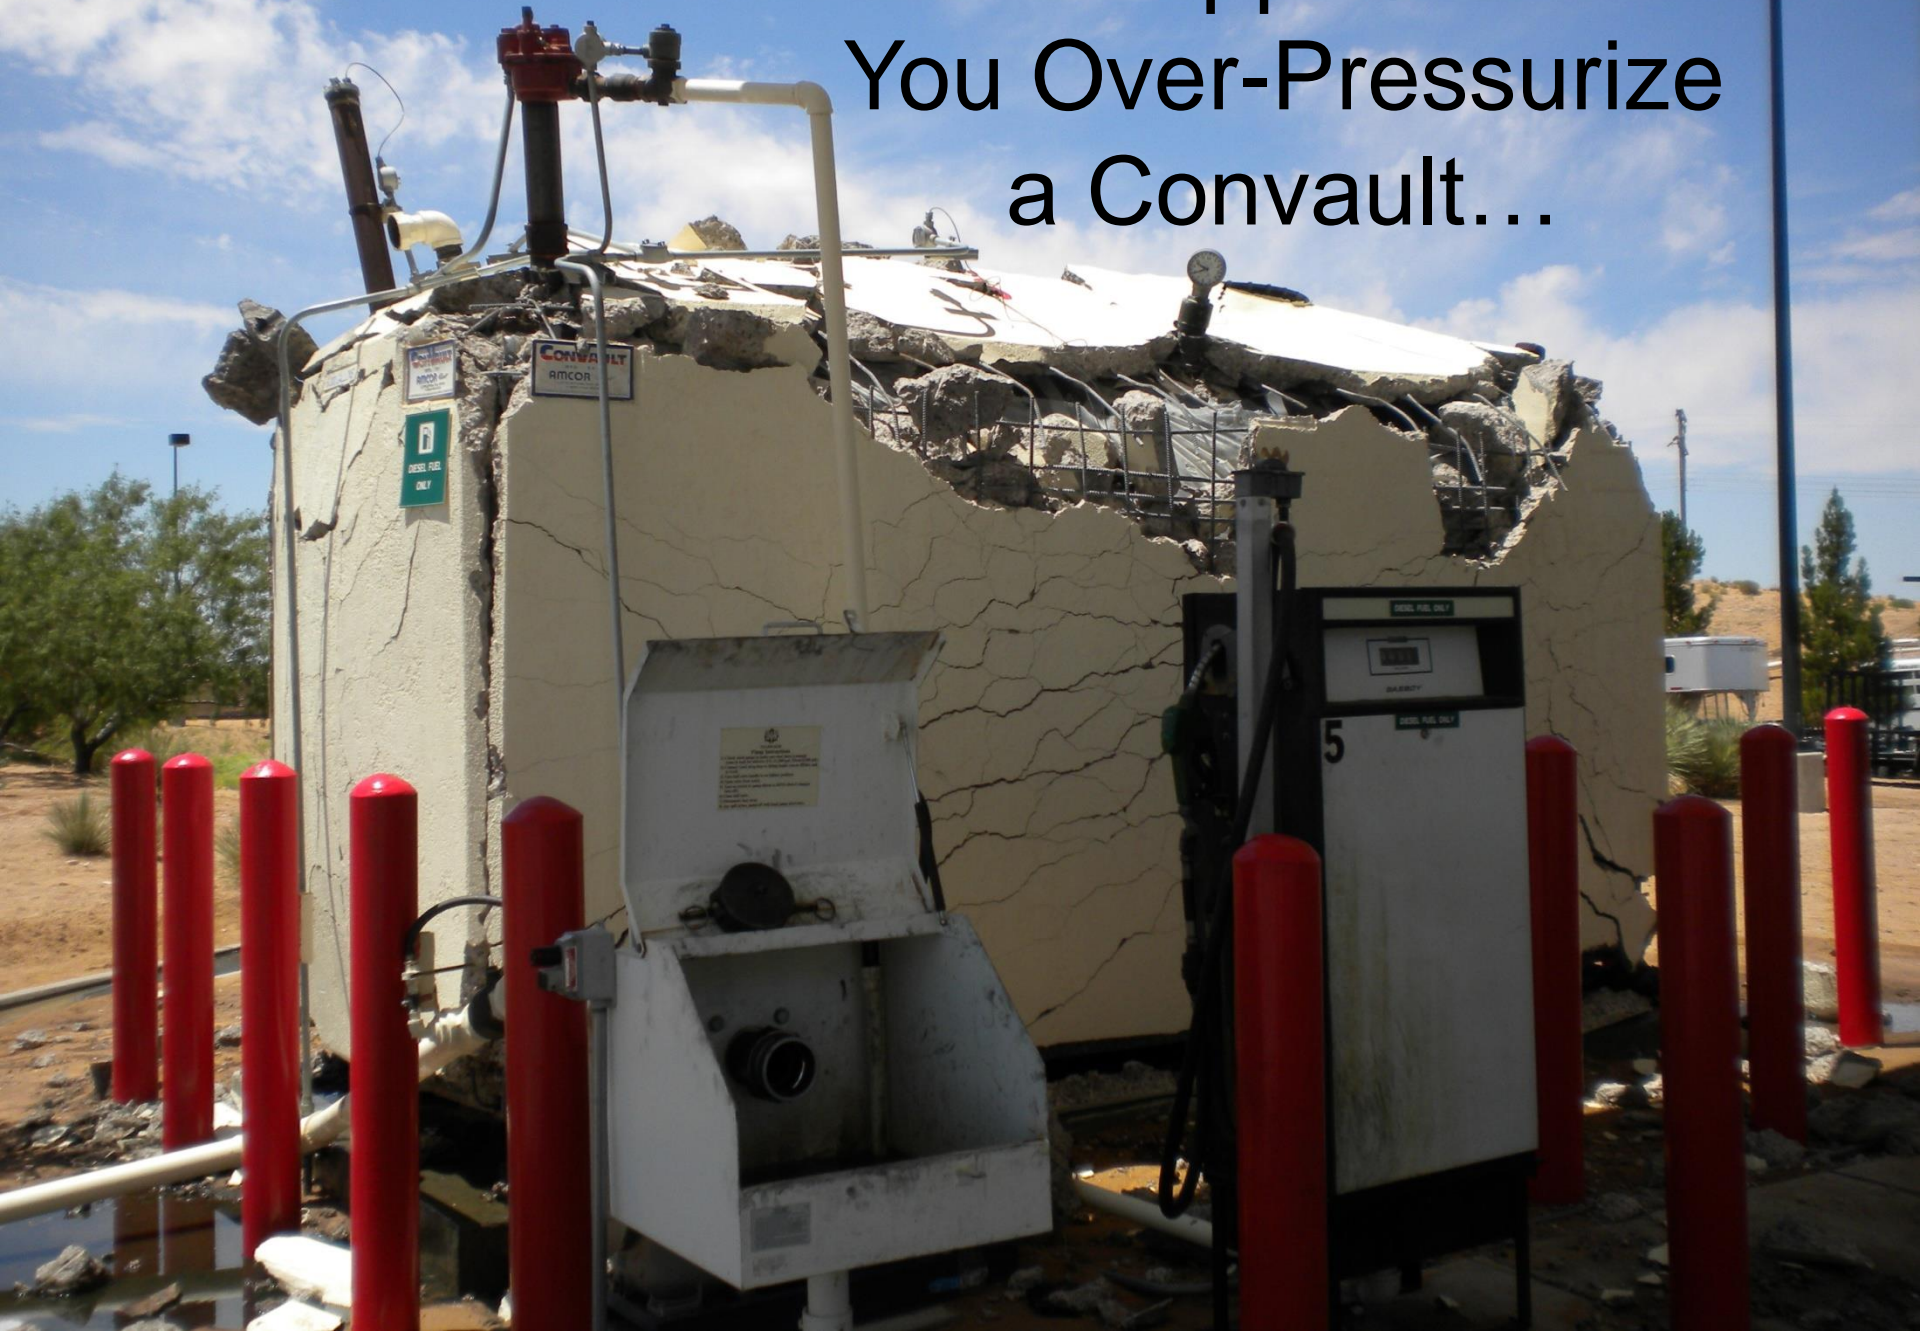
What Happens When You Drop a Concrete Silo on a Convault...

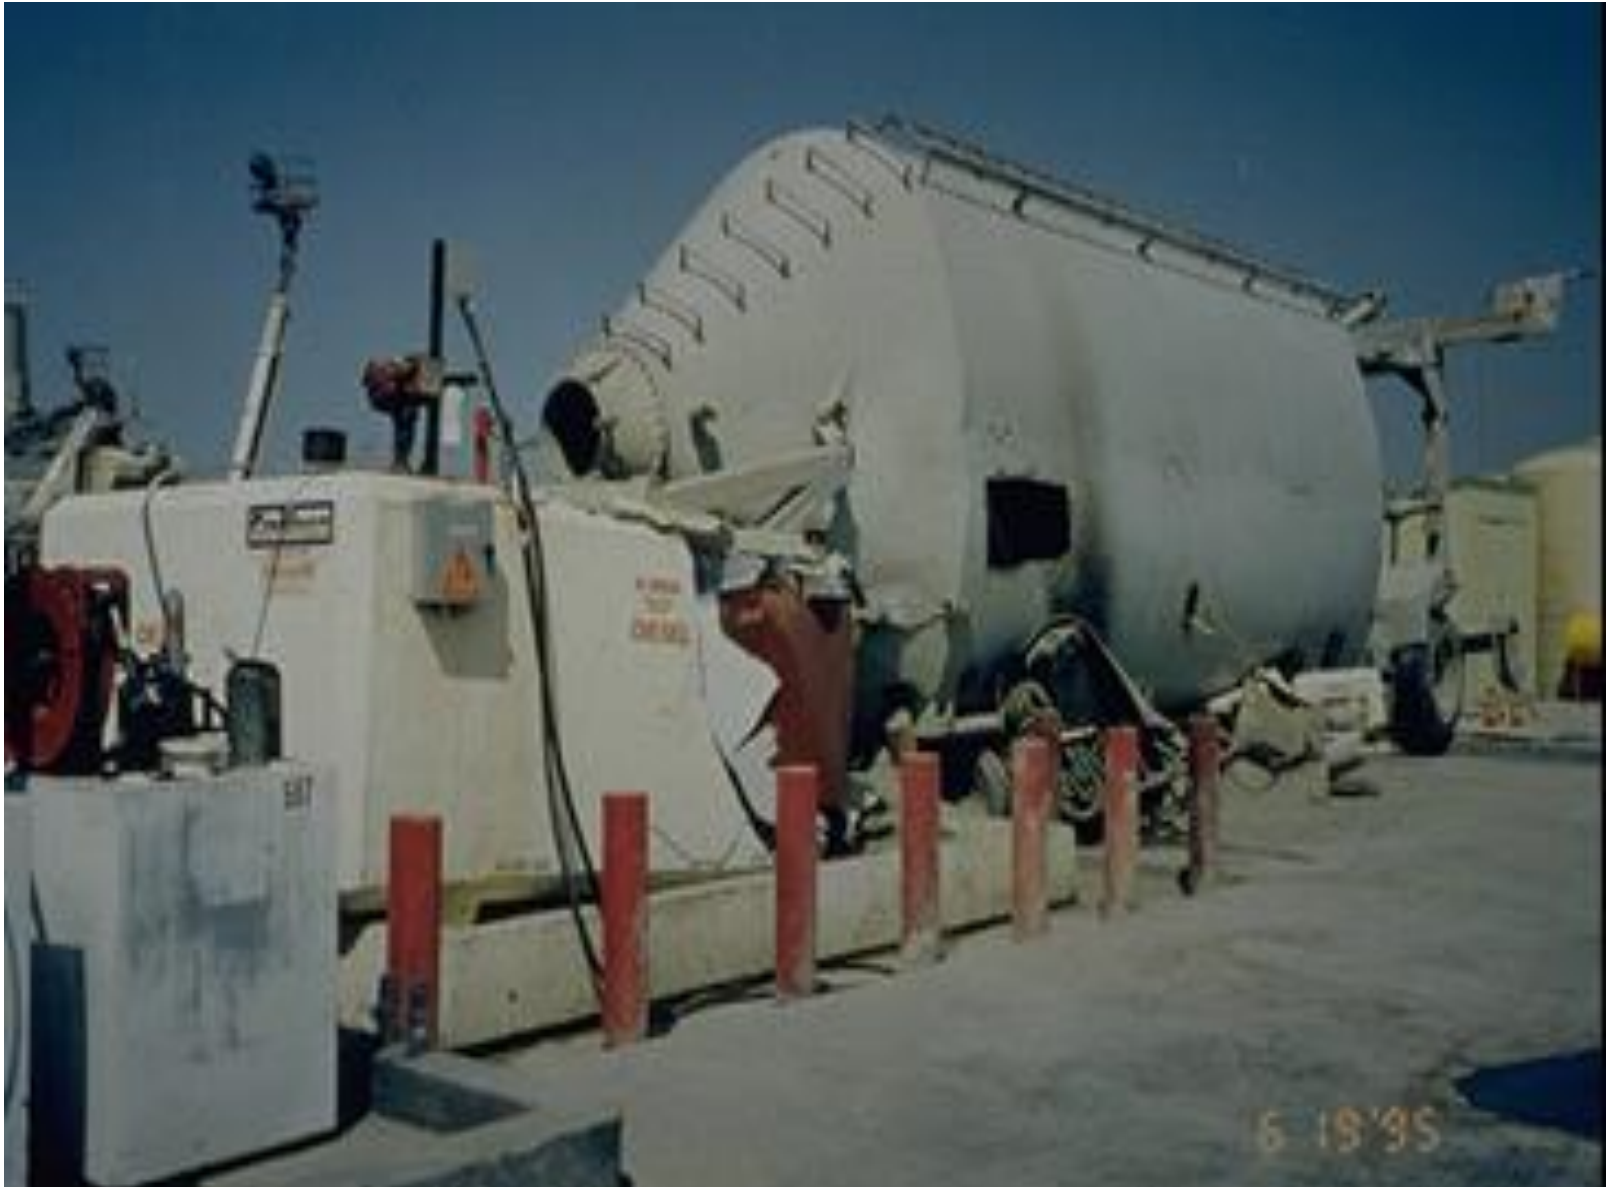
Eco-Paint

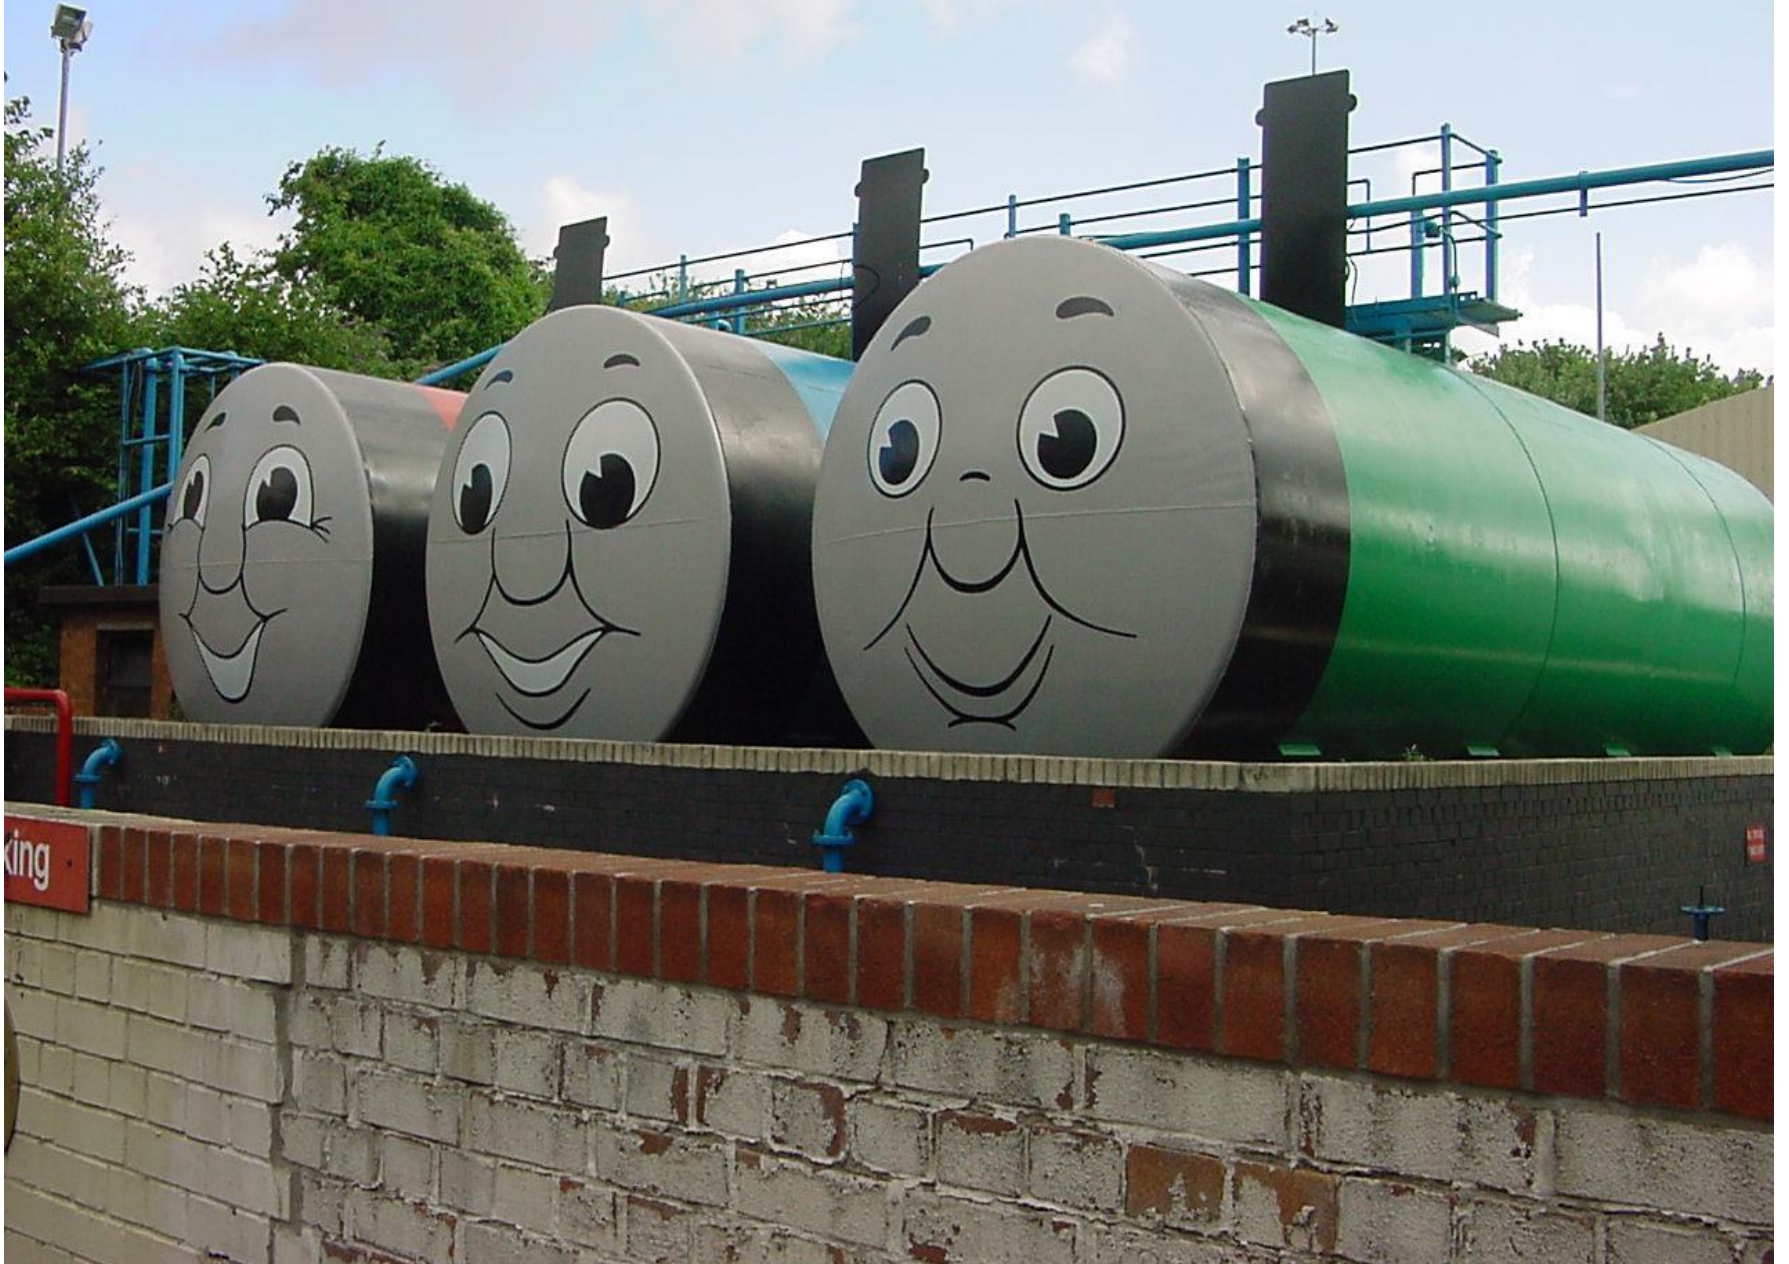
An Inconvenience Store

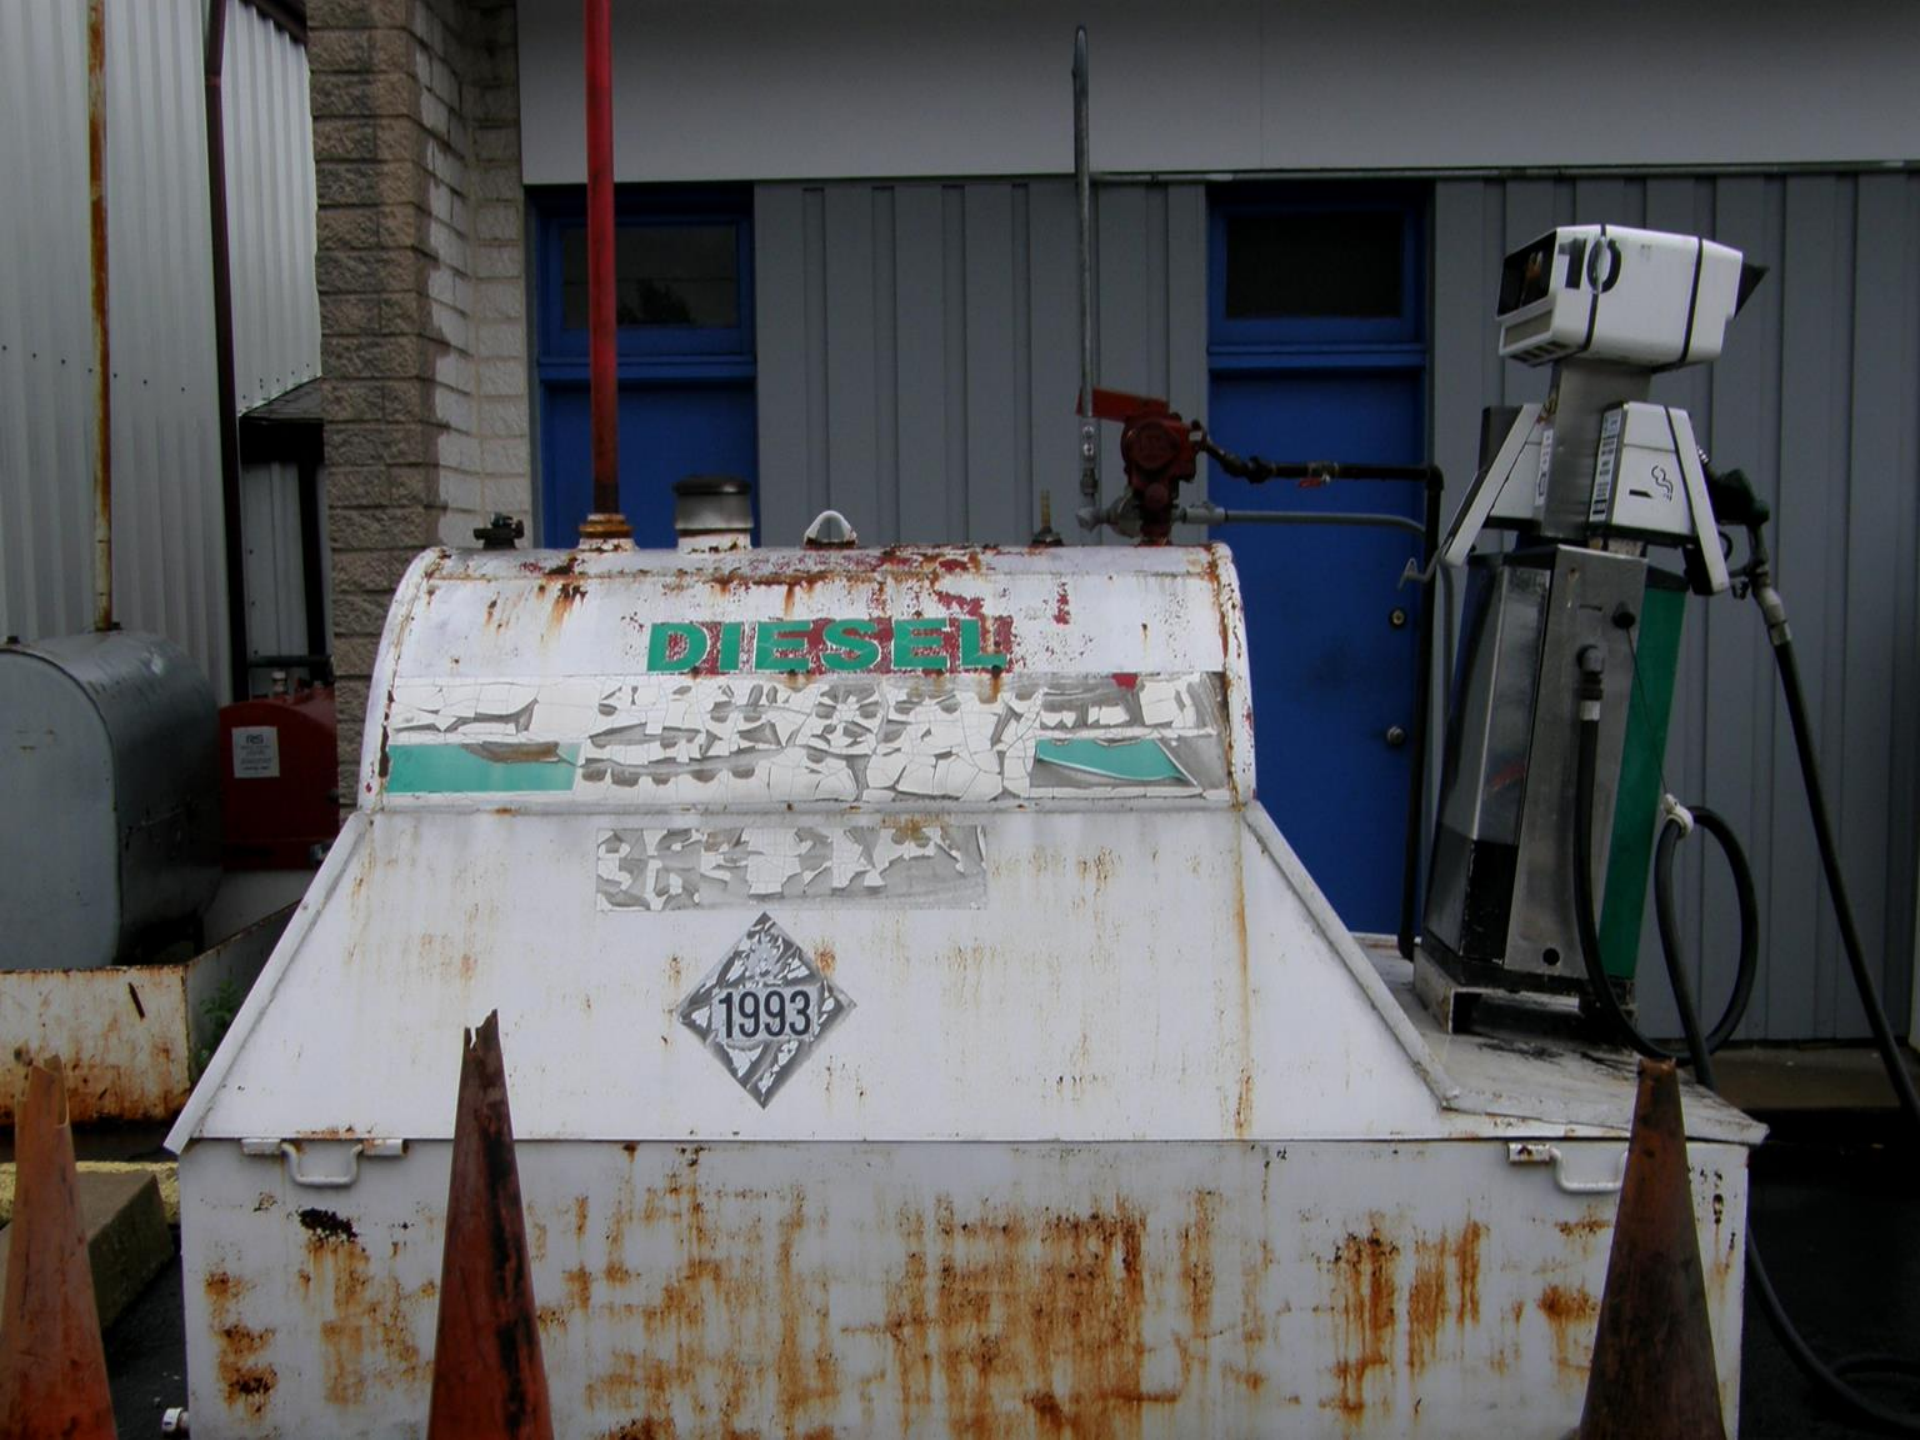
Best area for burning trash

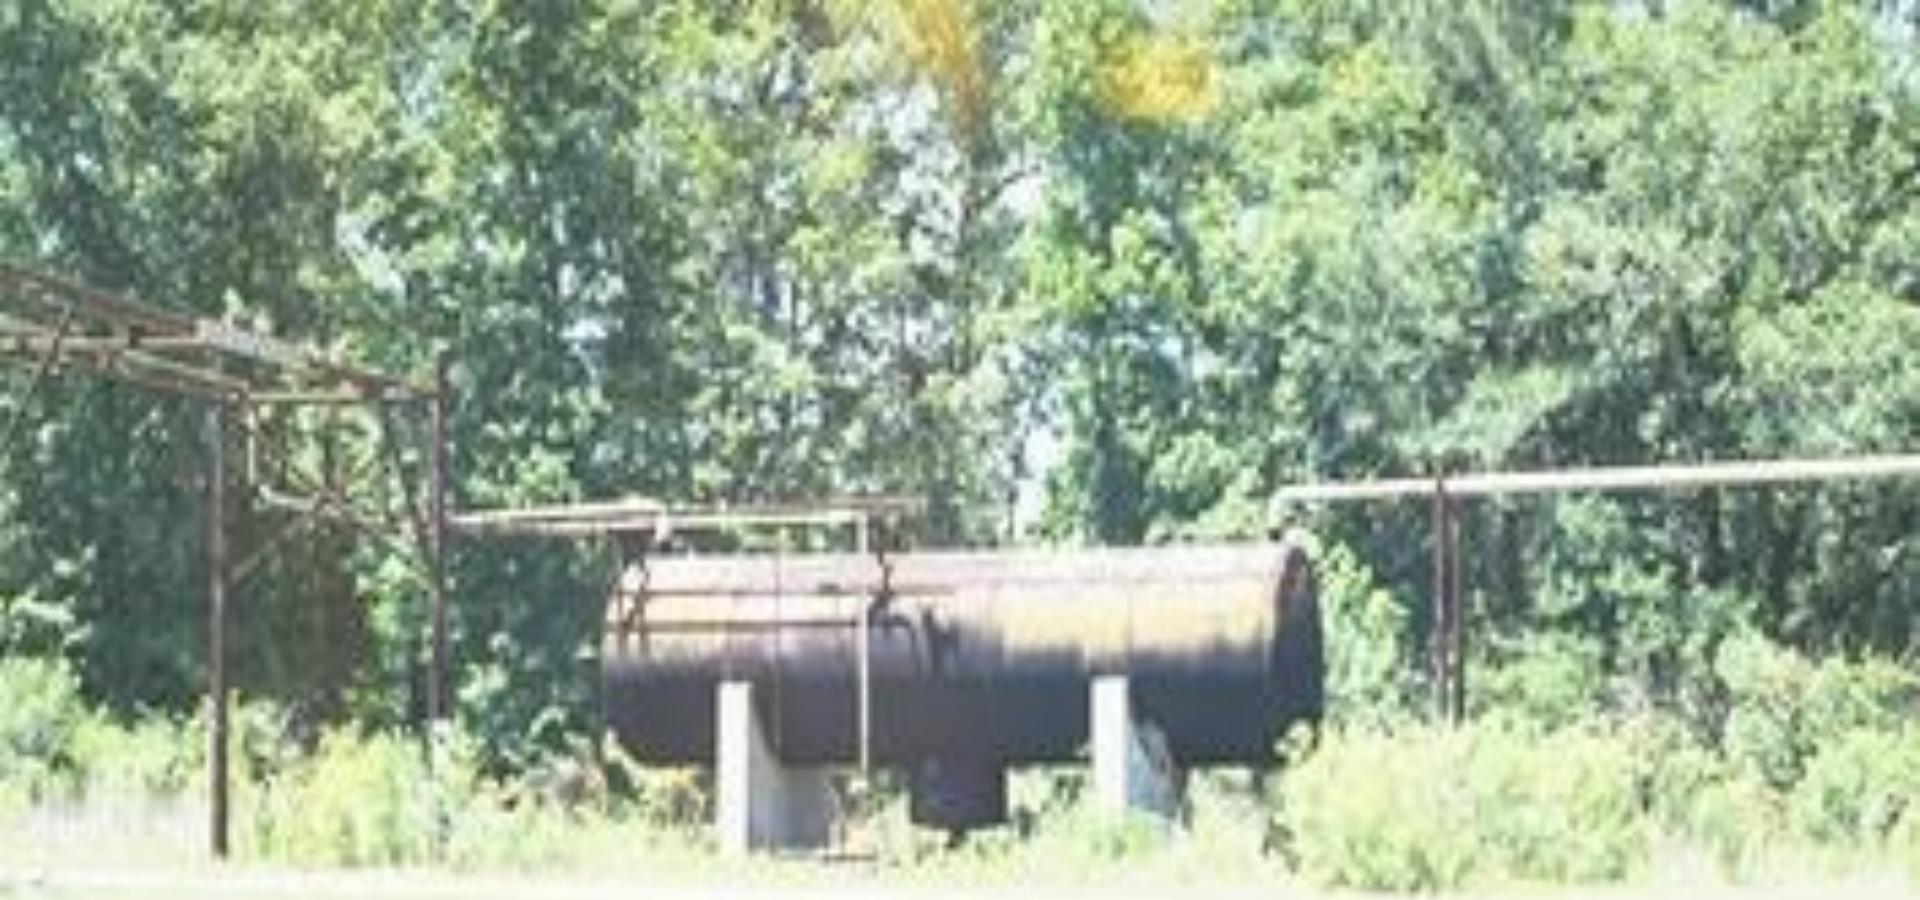
Sante Fe Inverted Single-Wall Previously
Mobile Shop-Fabricated Tank on Saddles
