Shop-Fabricated Aboveground Storage Tank Inspections – Expect the Unexpected...

Mott-Smith Consulting Group, LLC

Marshall T. Mott-Smith, President Mott-Smith Consulting Group, LLC

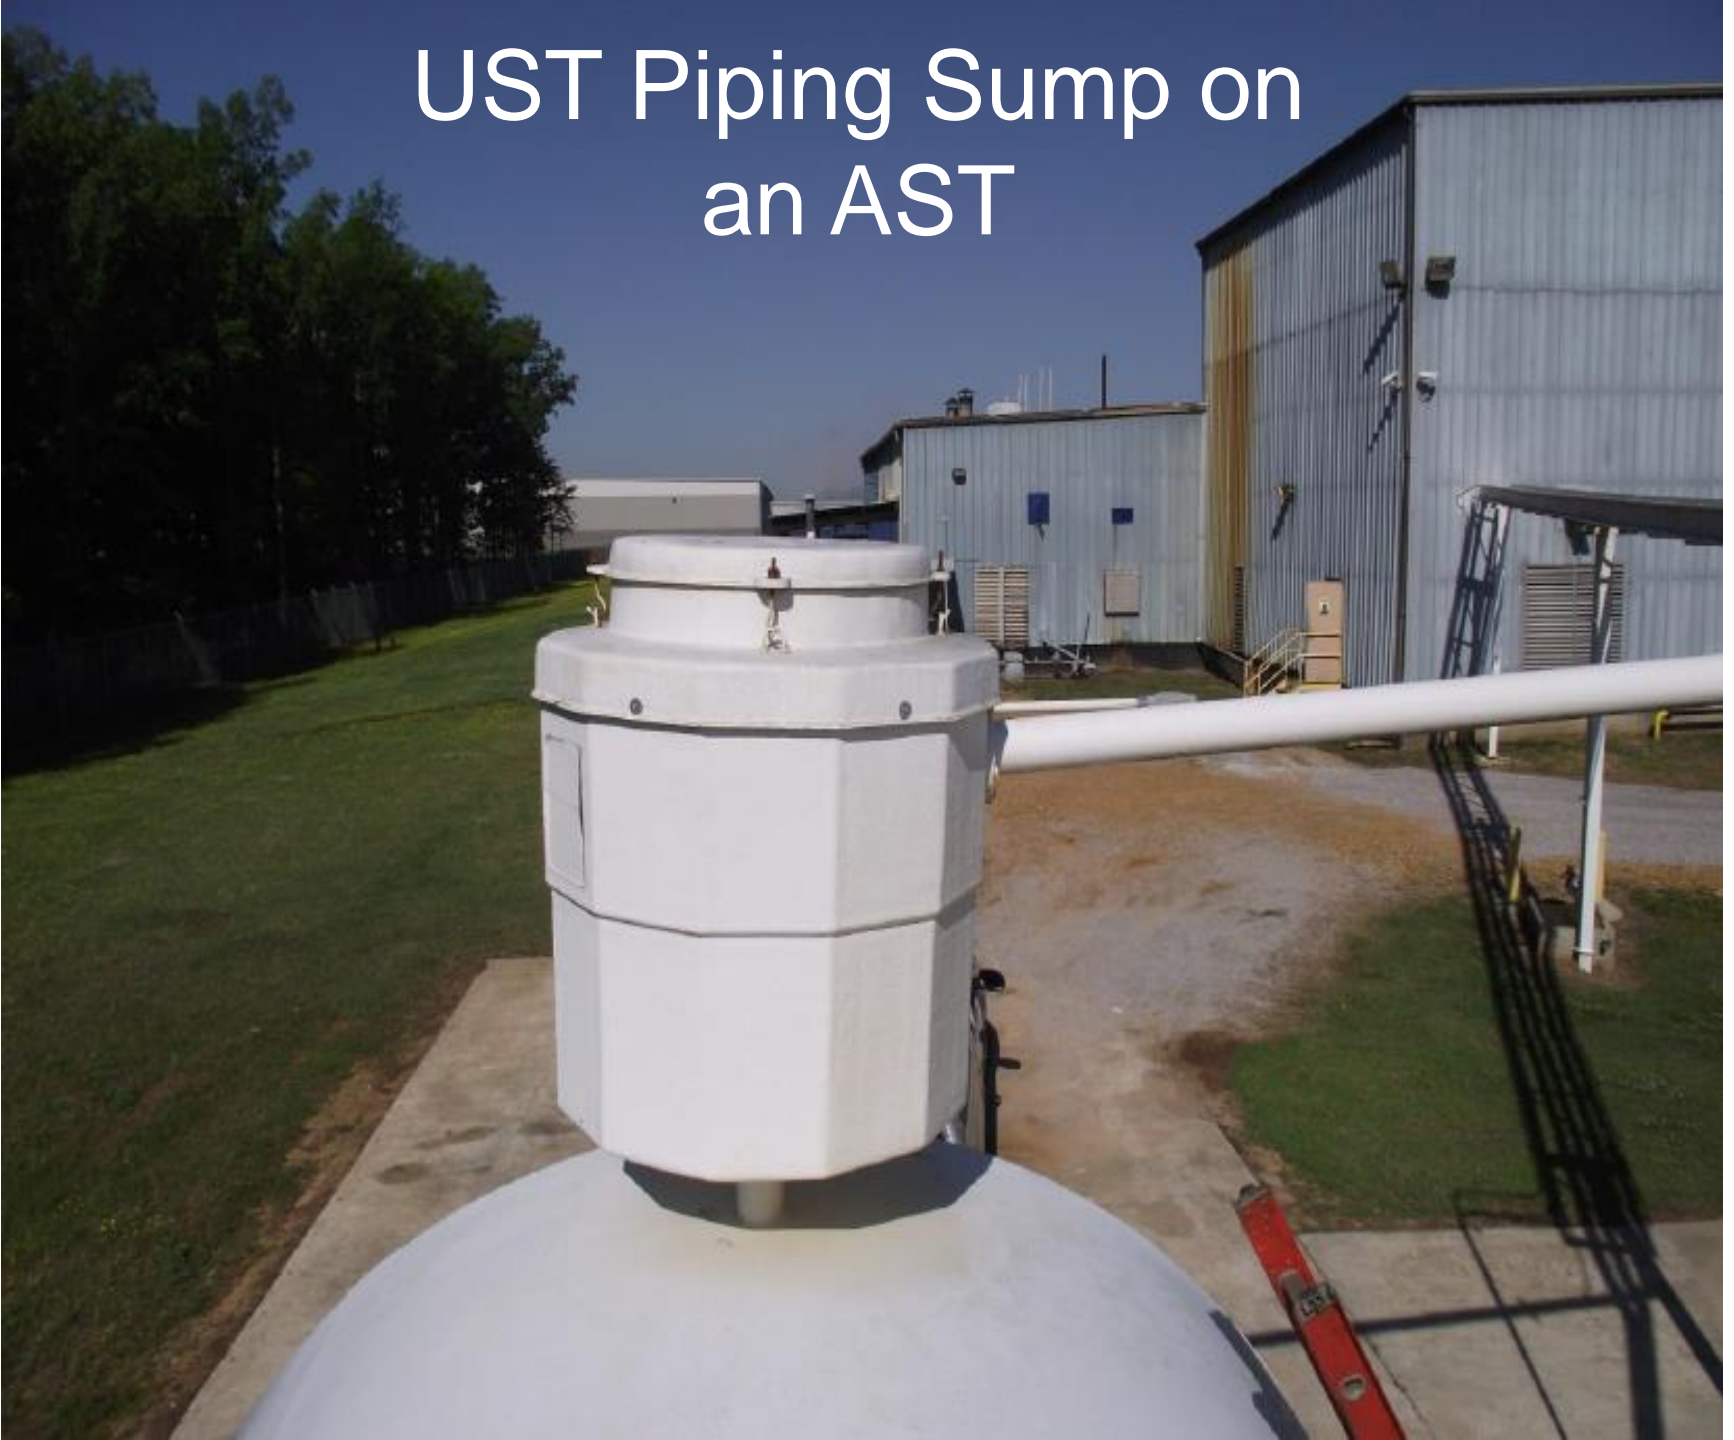
UST Piping Sump on an AST

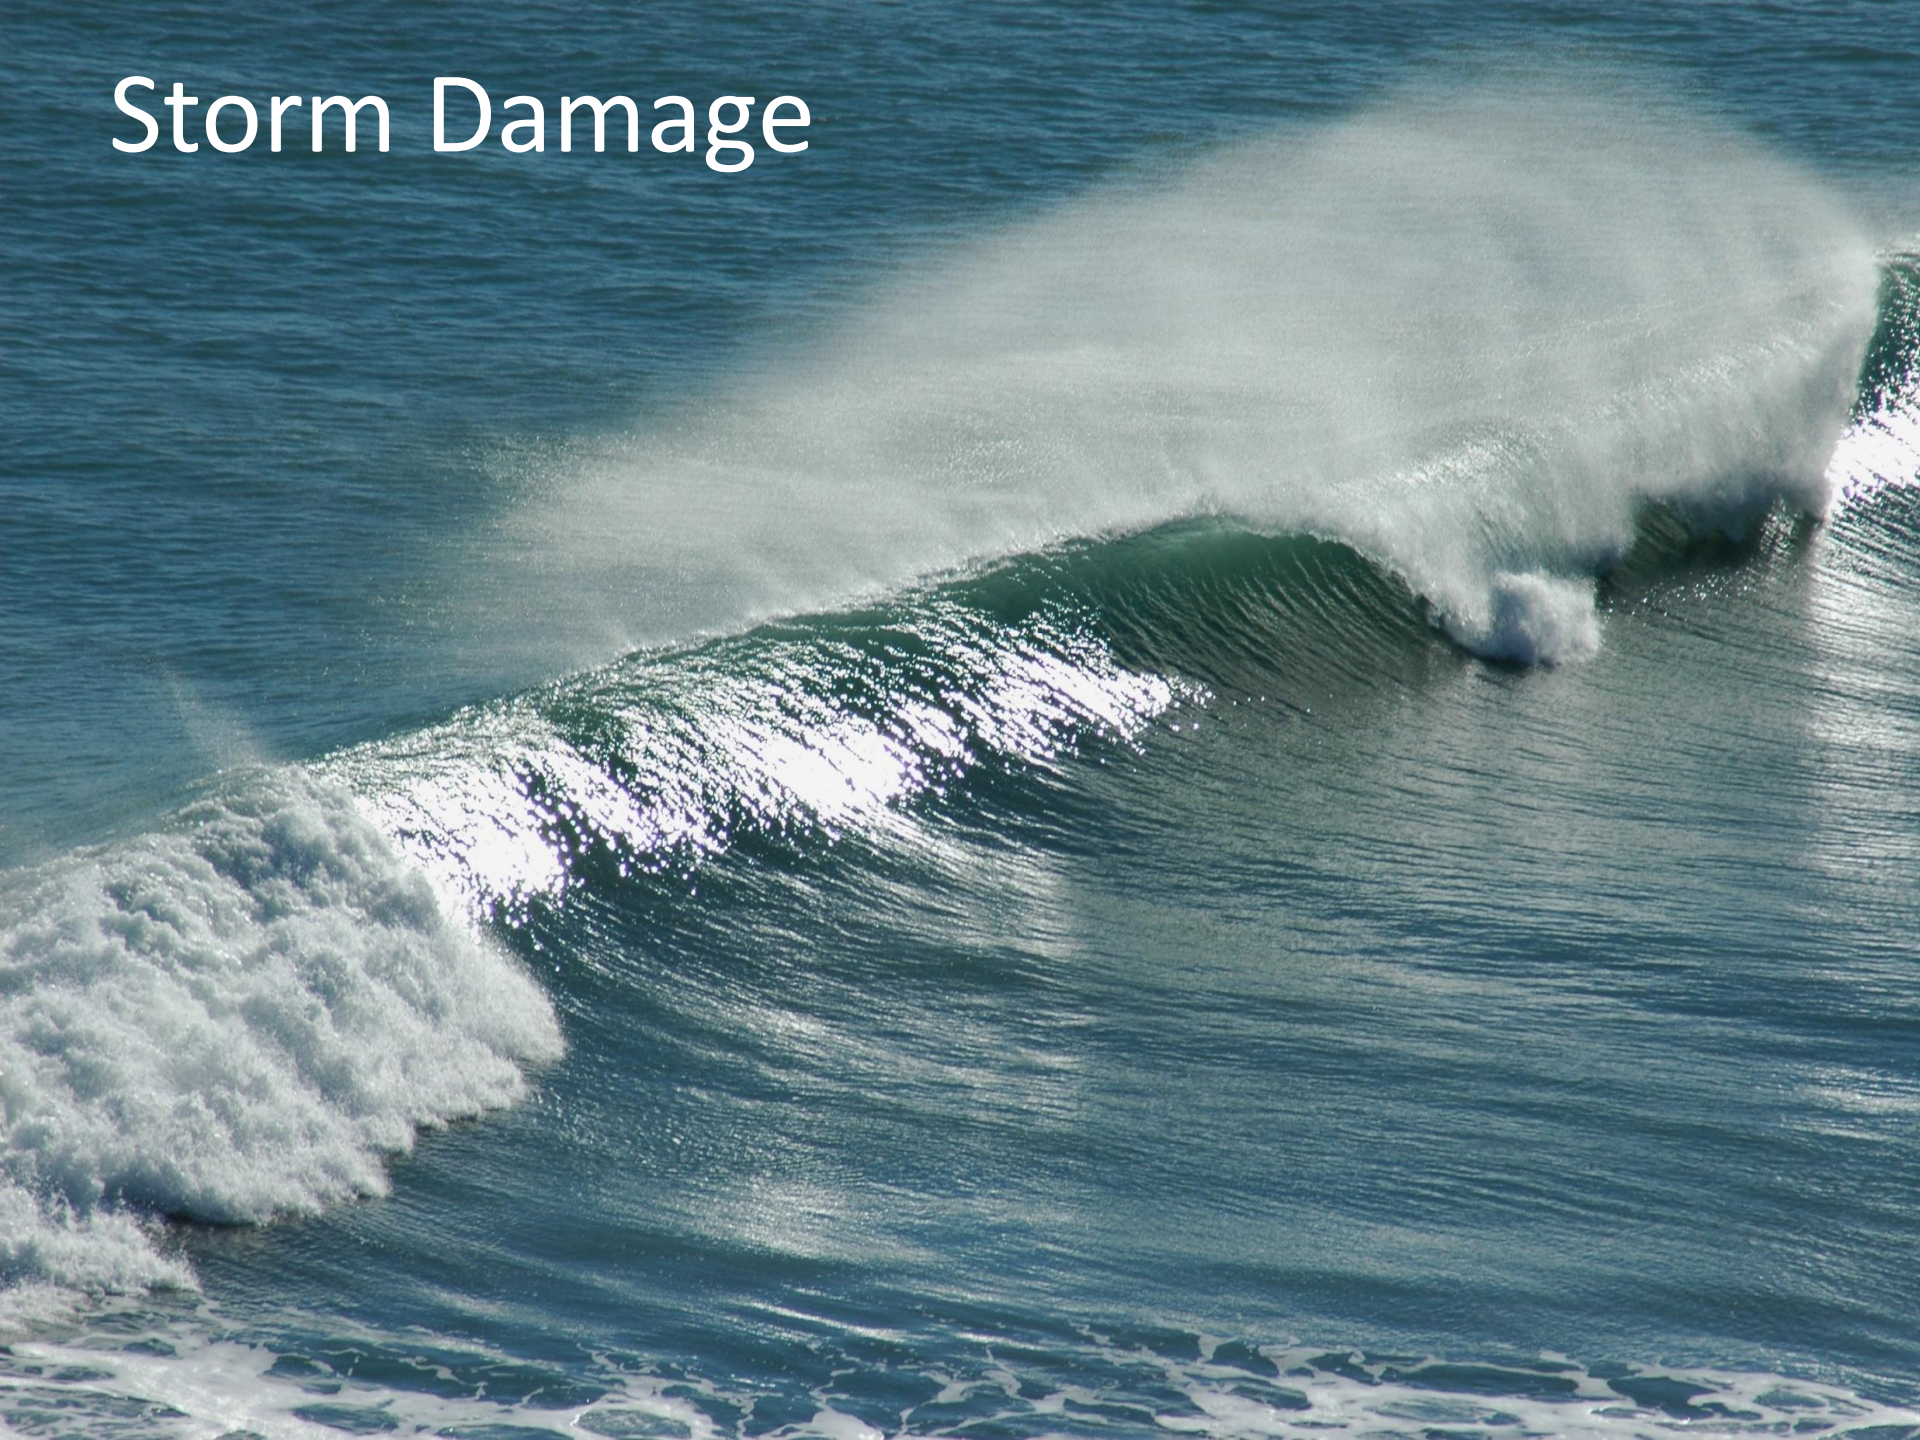
Storm Damage

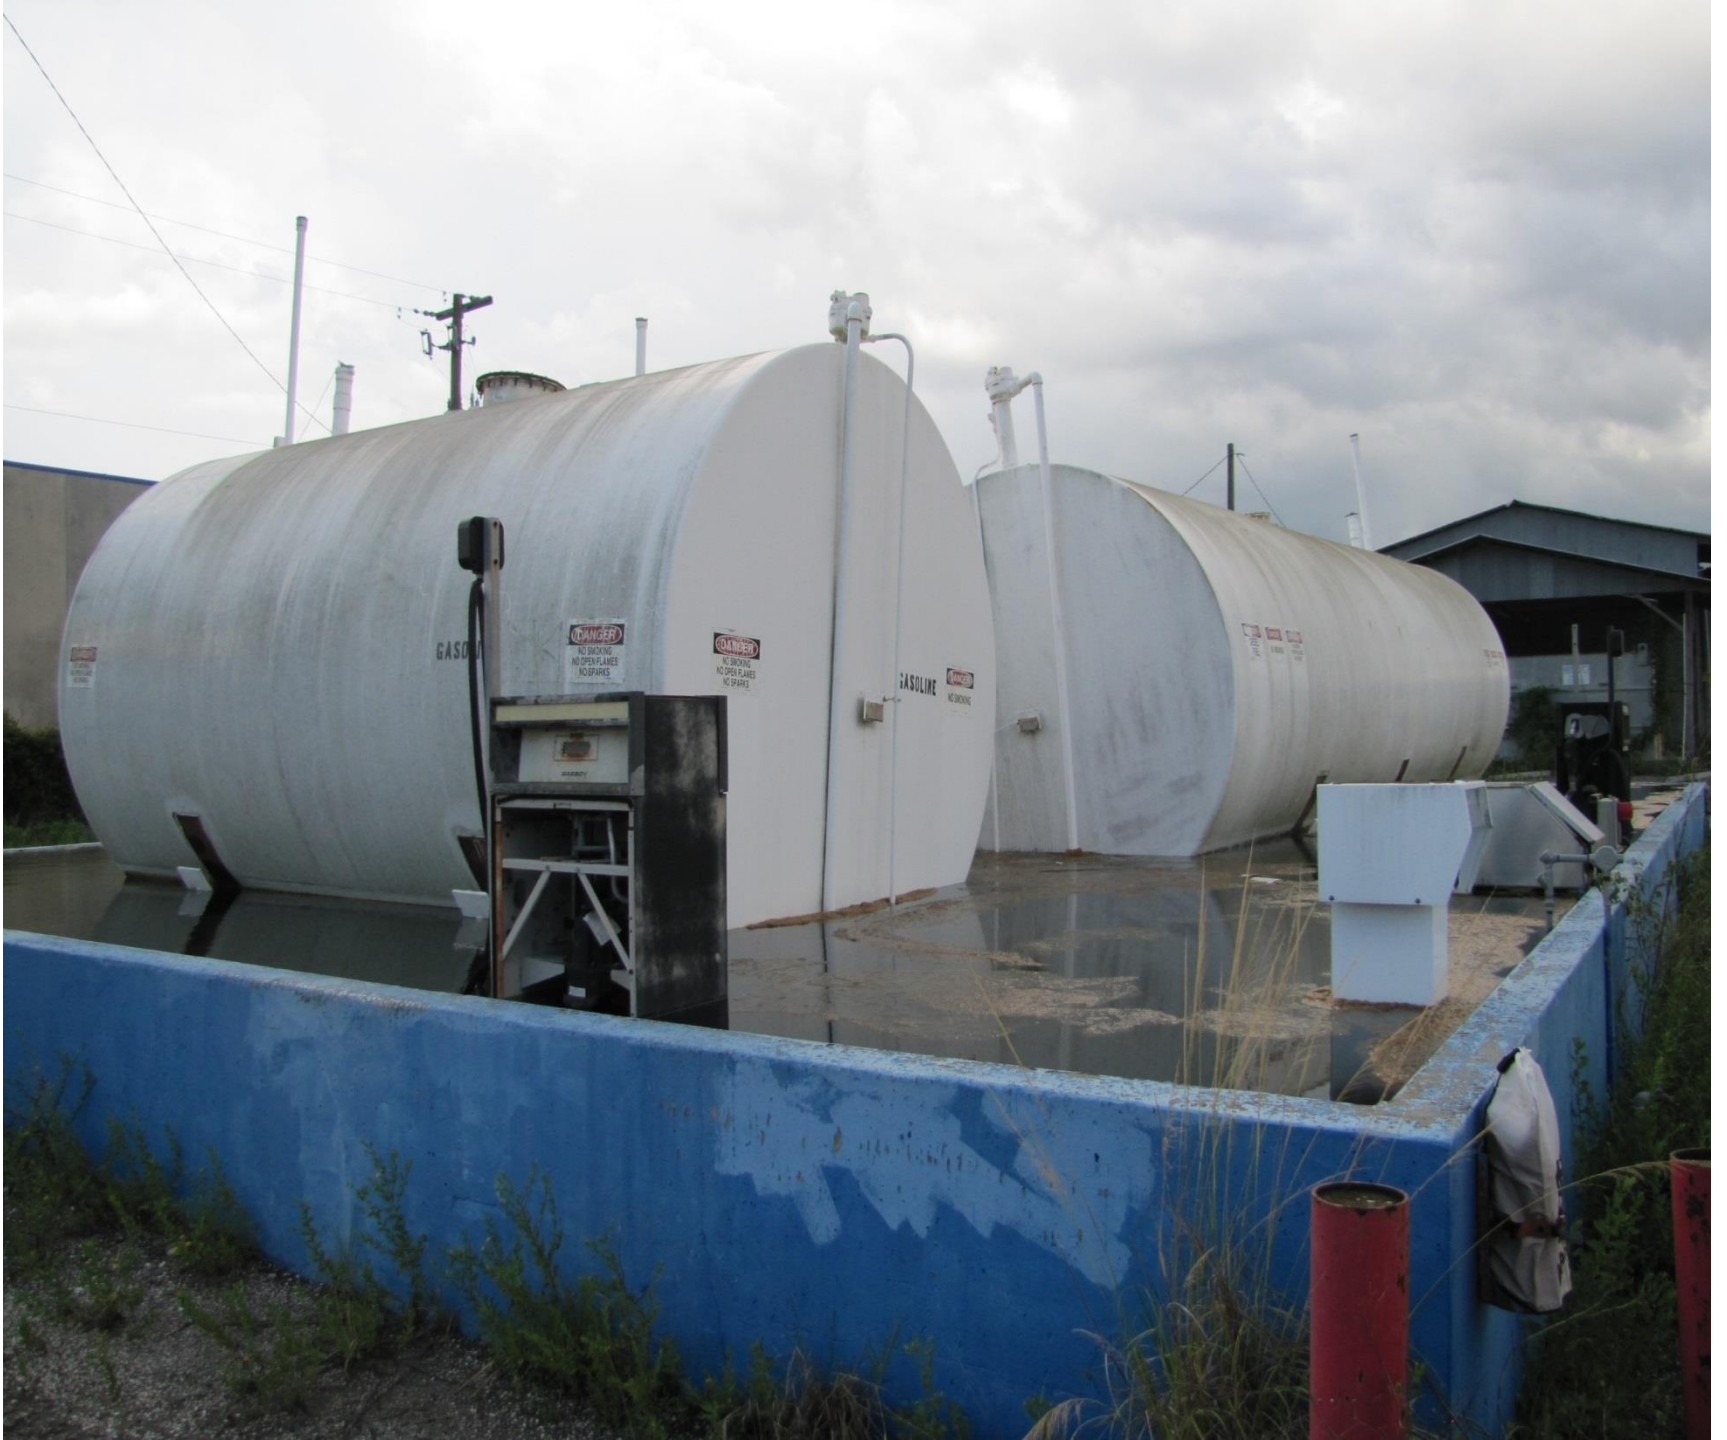
Flooding from Heavy Rainfall

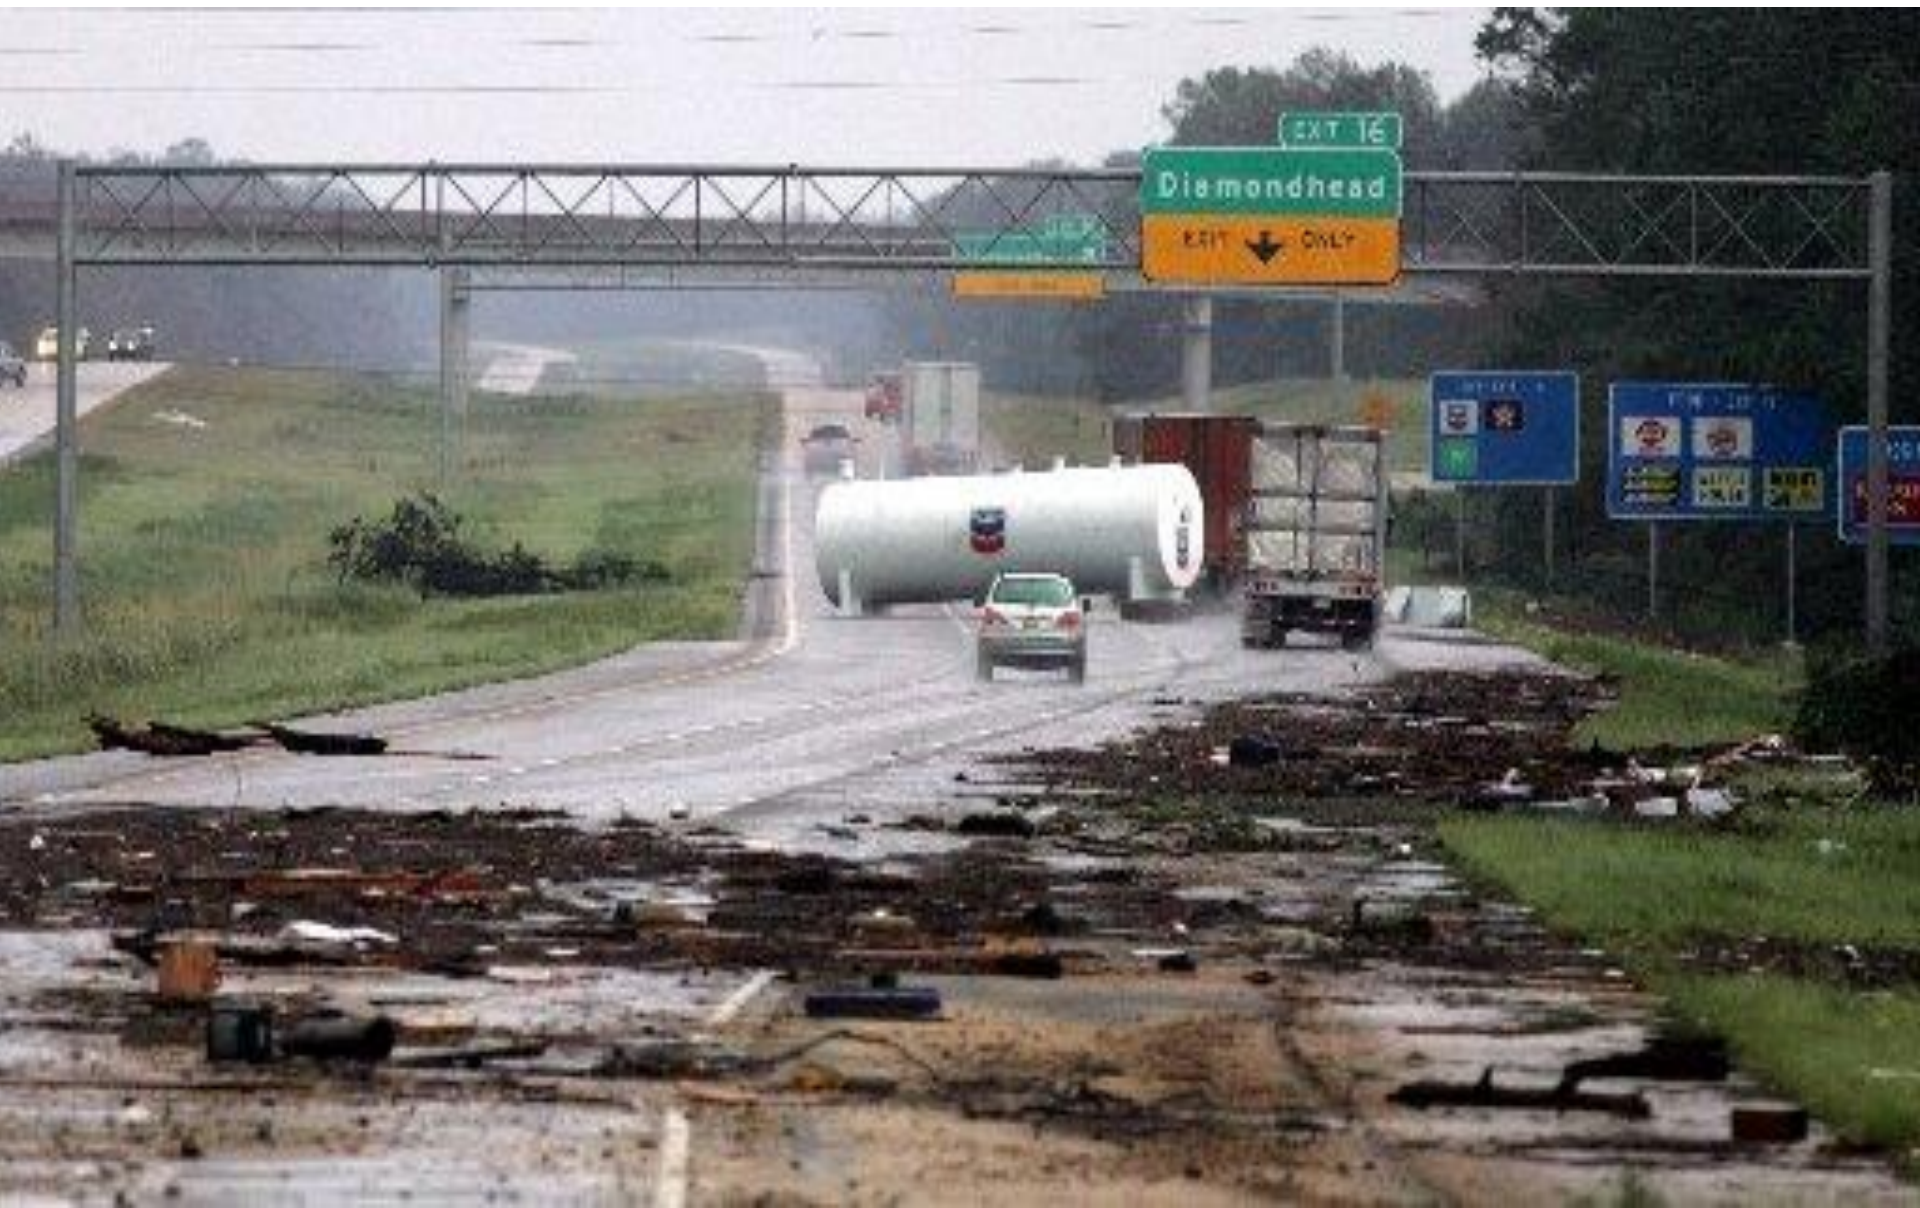
Storm Surge

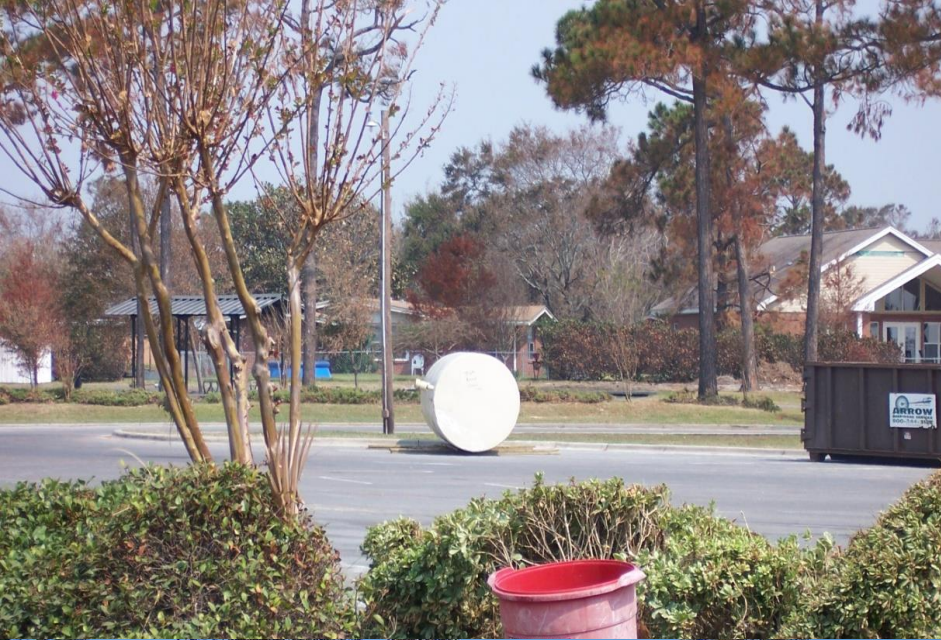
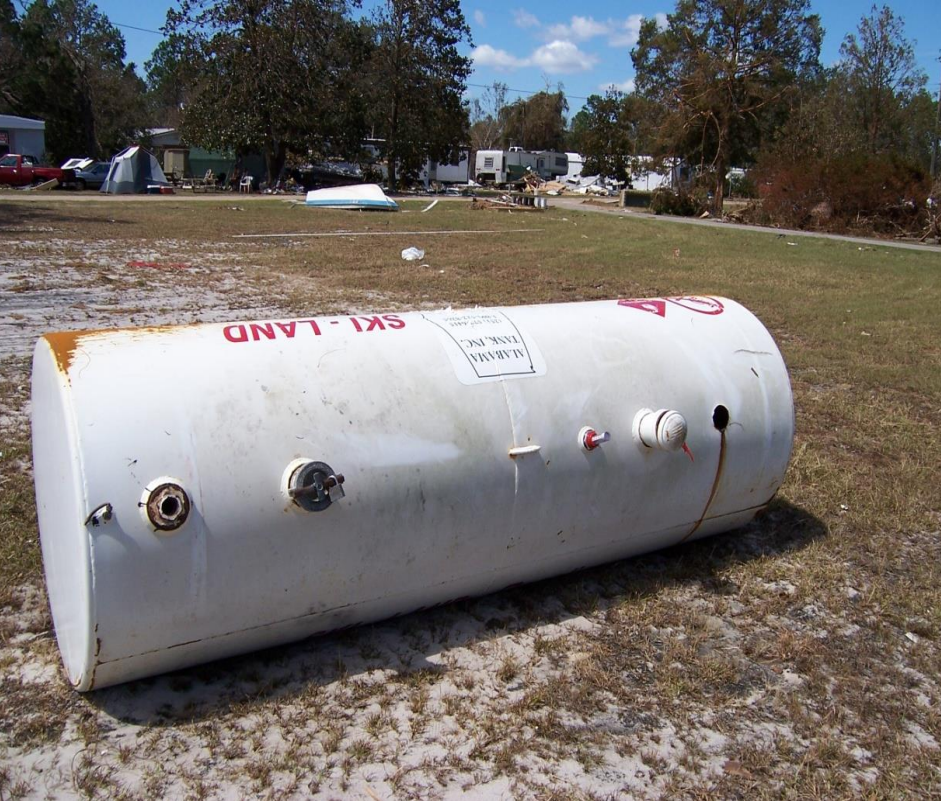
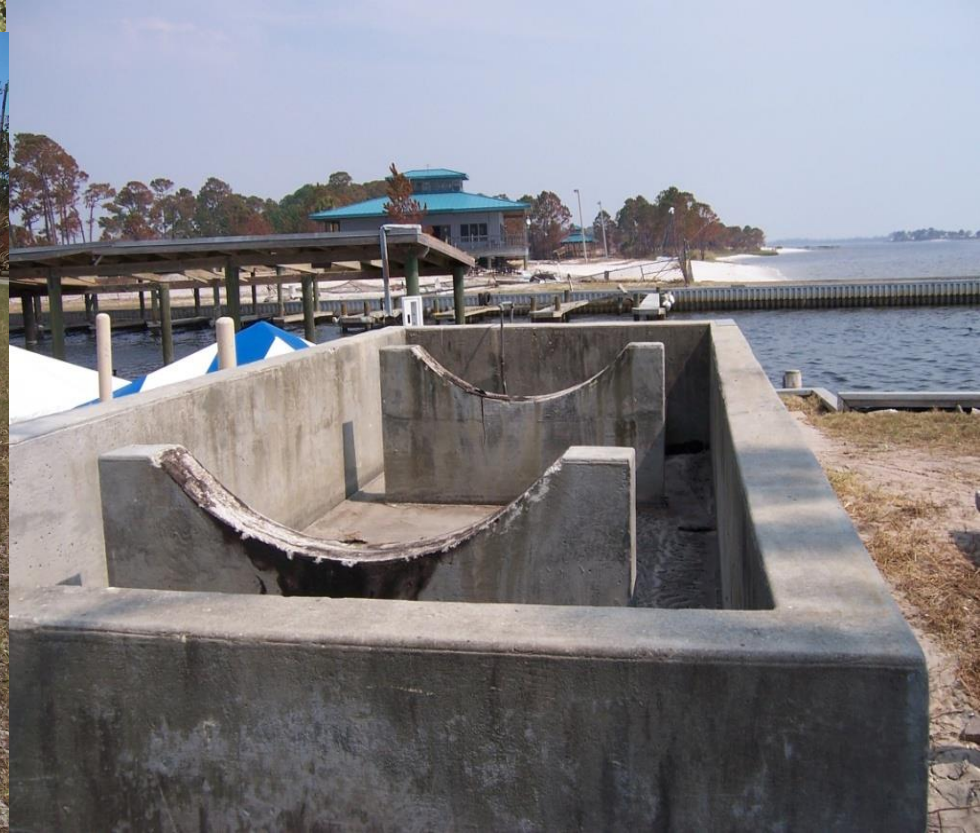
Tank Float-off

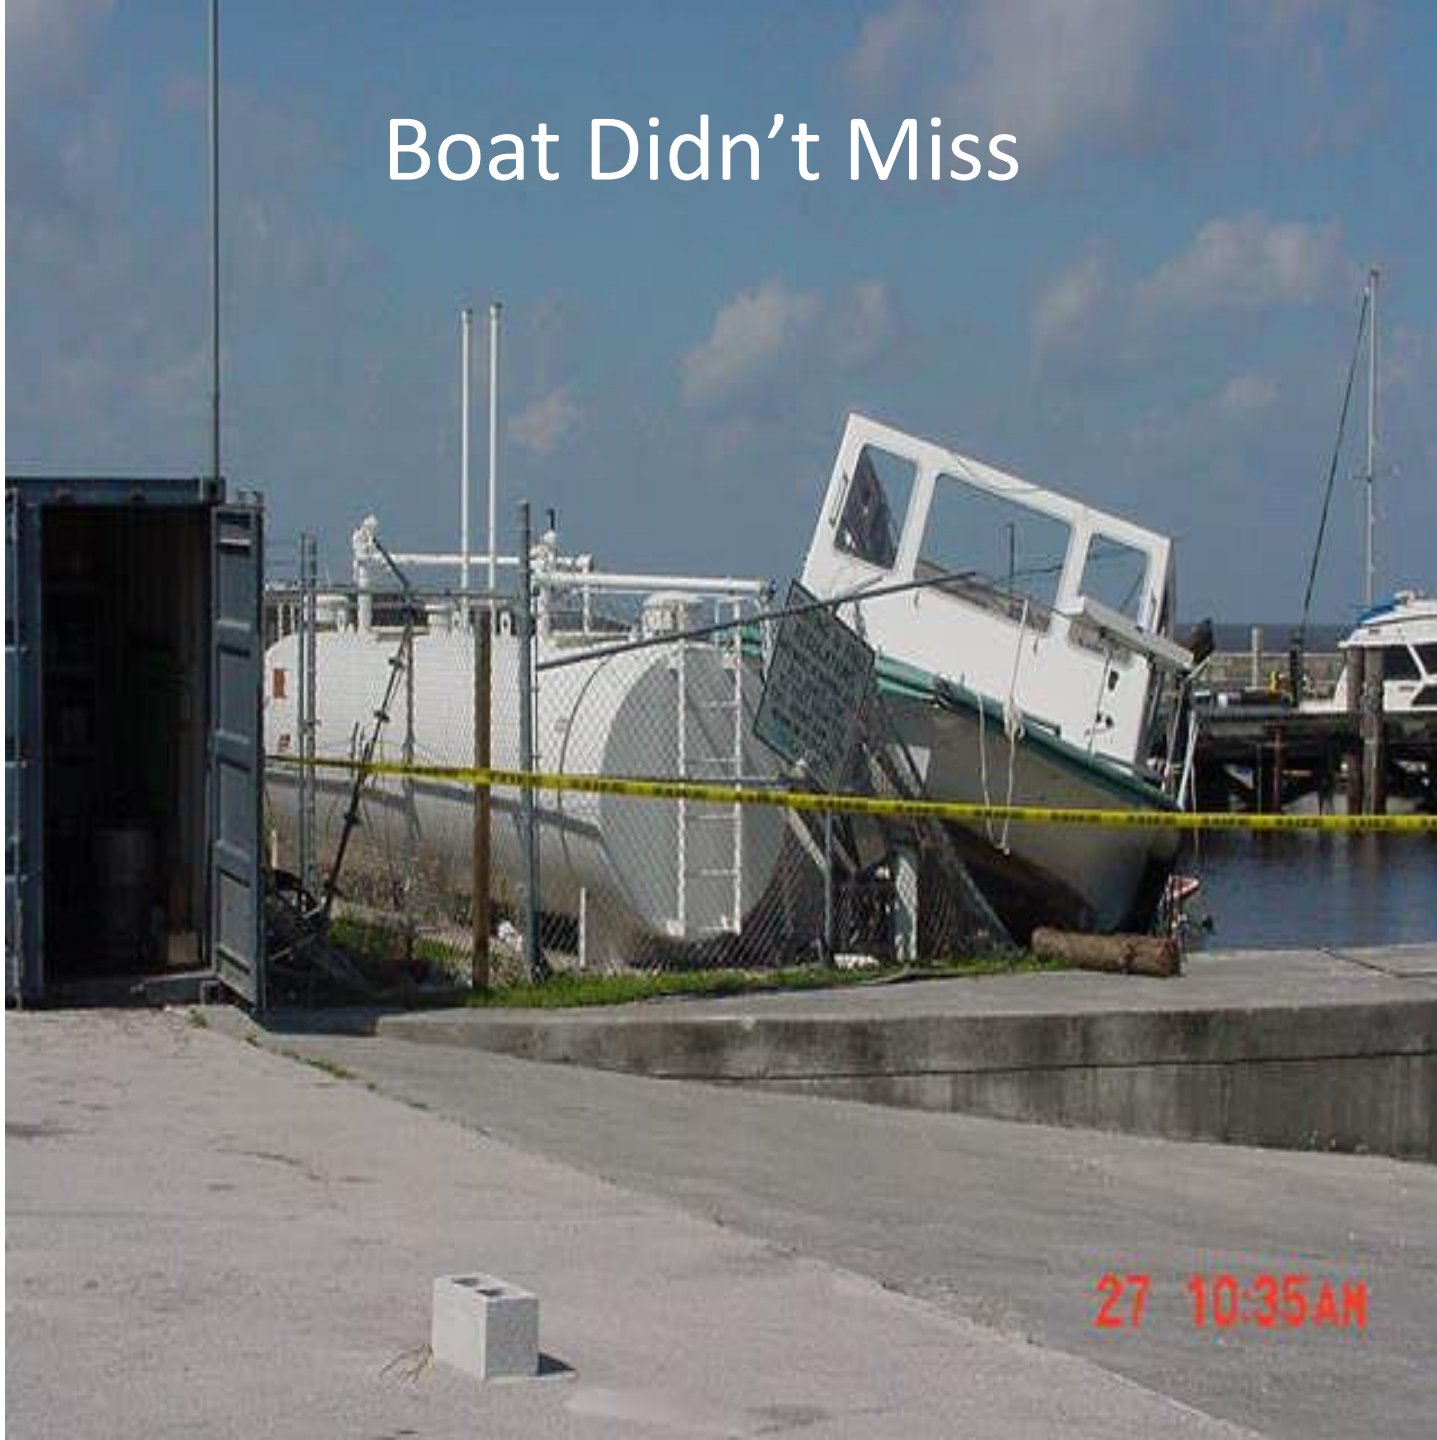
Boat Didn't Miss

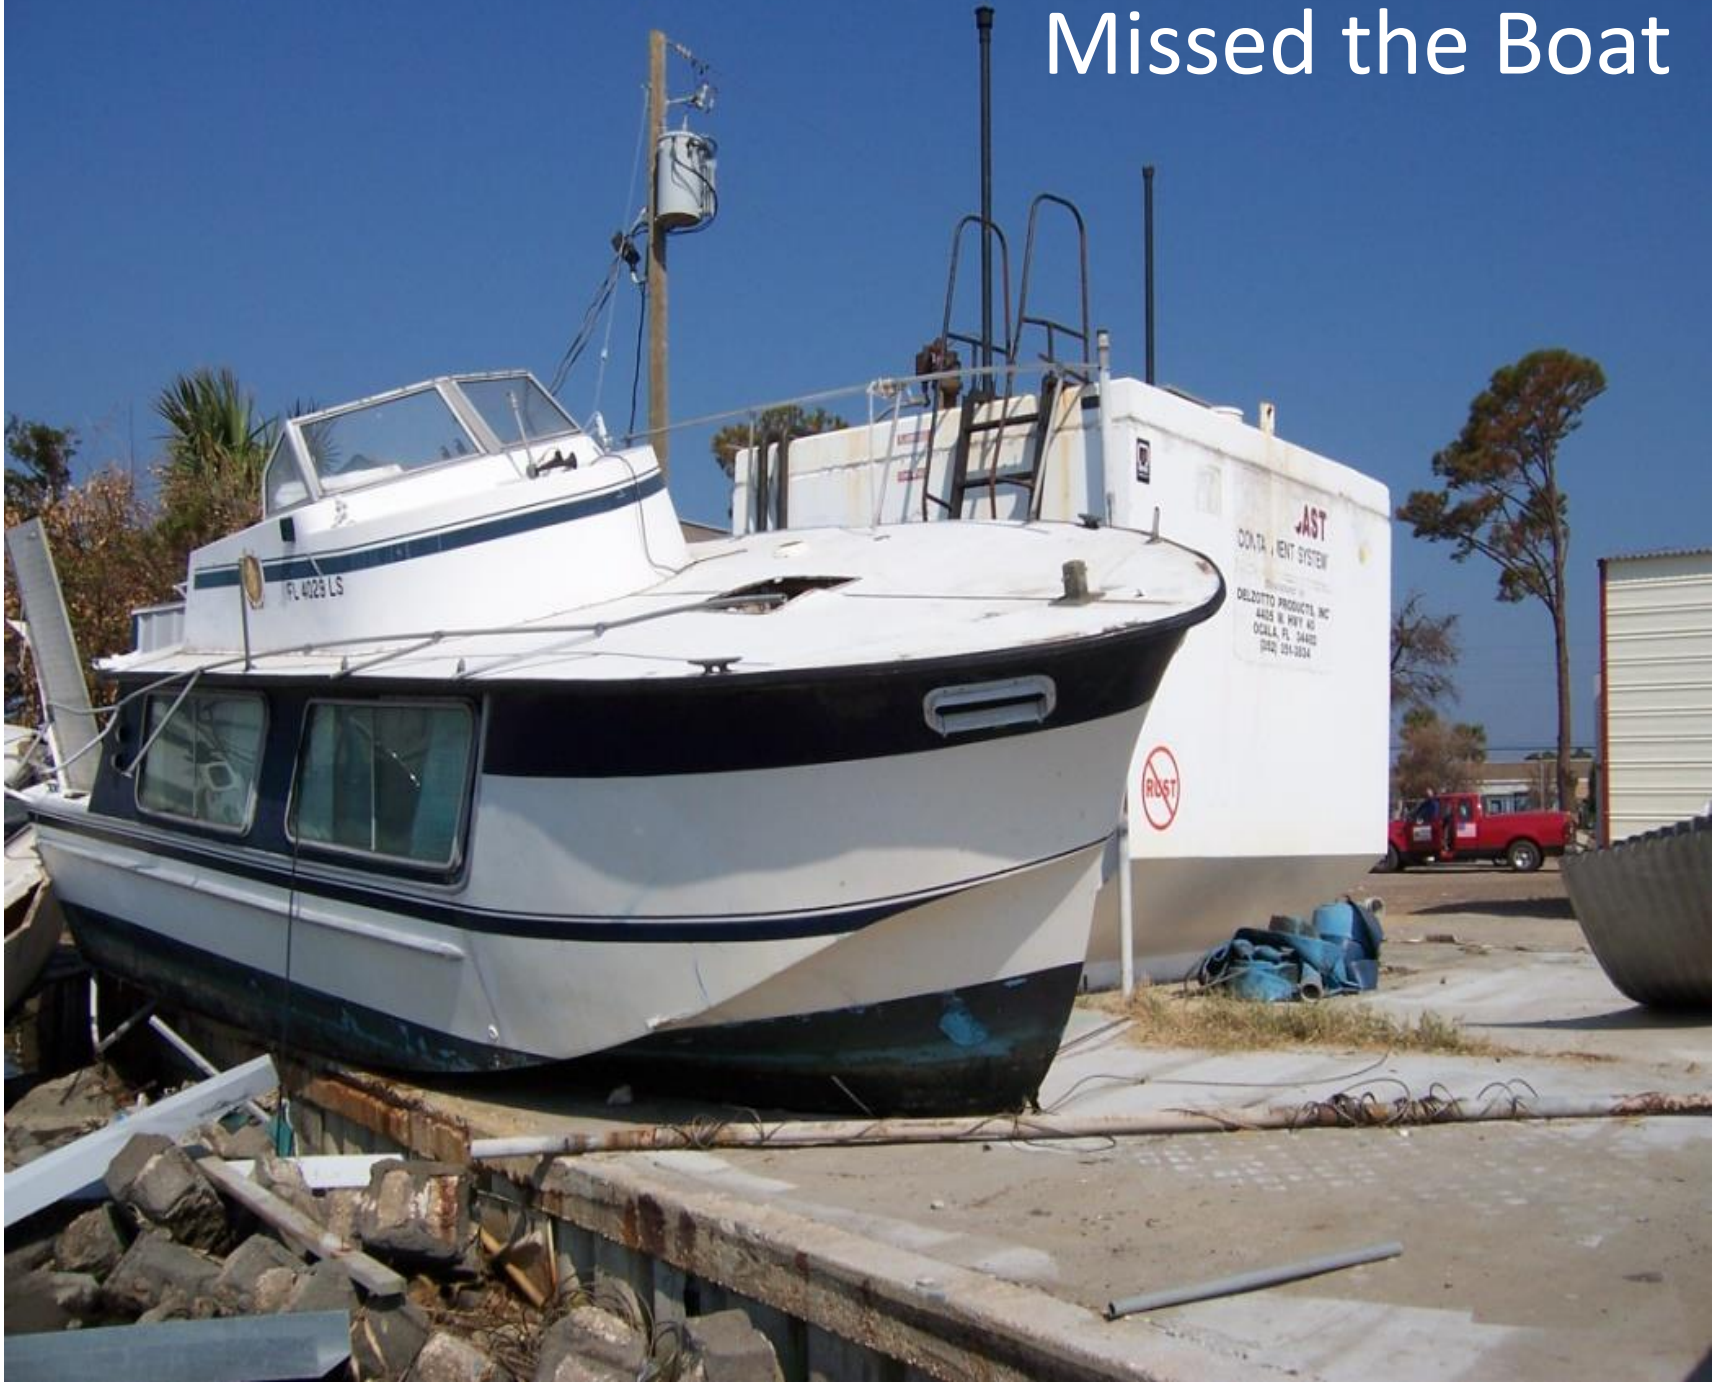
Missed the Boat
