# MISSOURI ABOVEGROUND STORAGE TANK INSPECTIONS AND REGULATIONS

MISSOURI DEPARTMENT OF  
AGRICULTURE

Weights, Measures &  
Consumer Protection  
Petroleum/Propane/Nh3

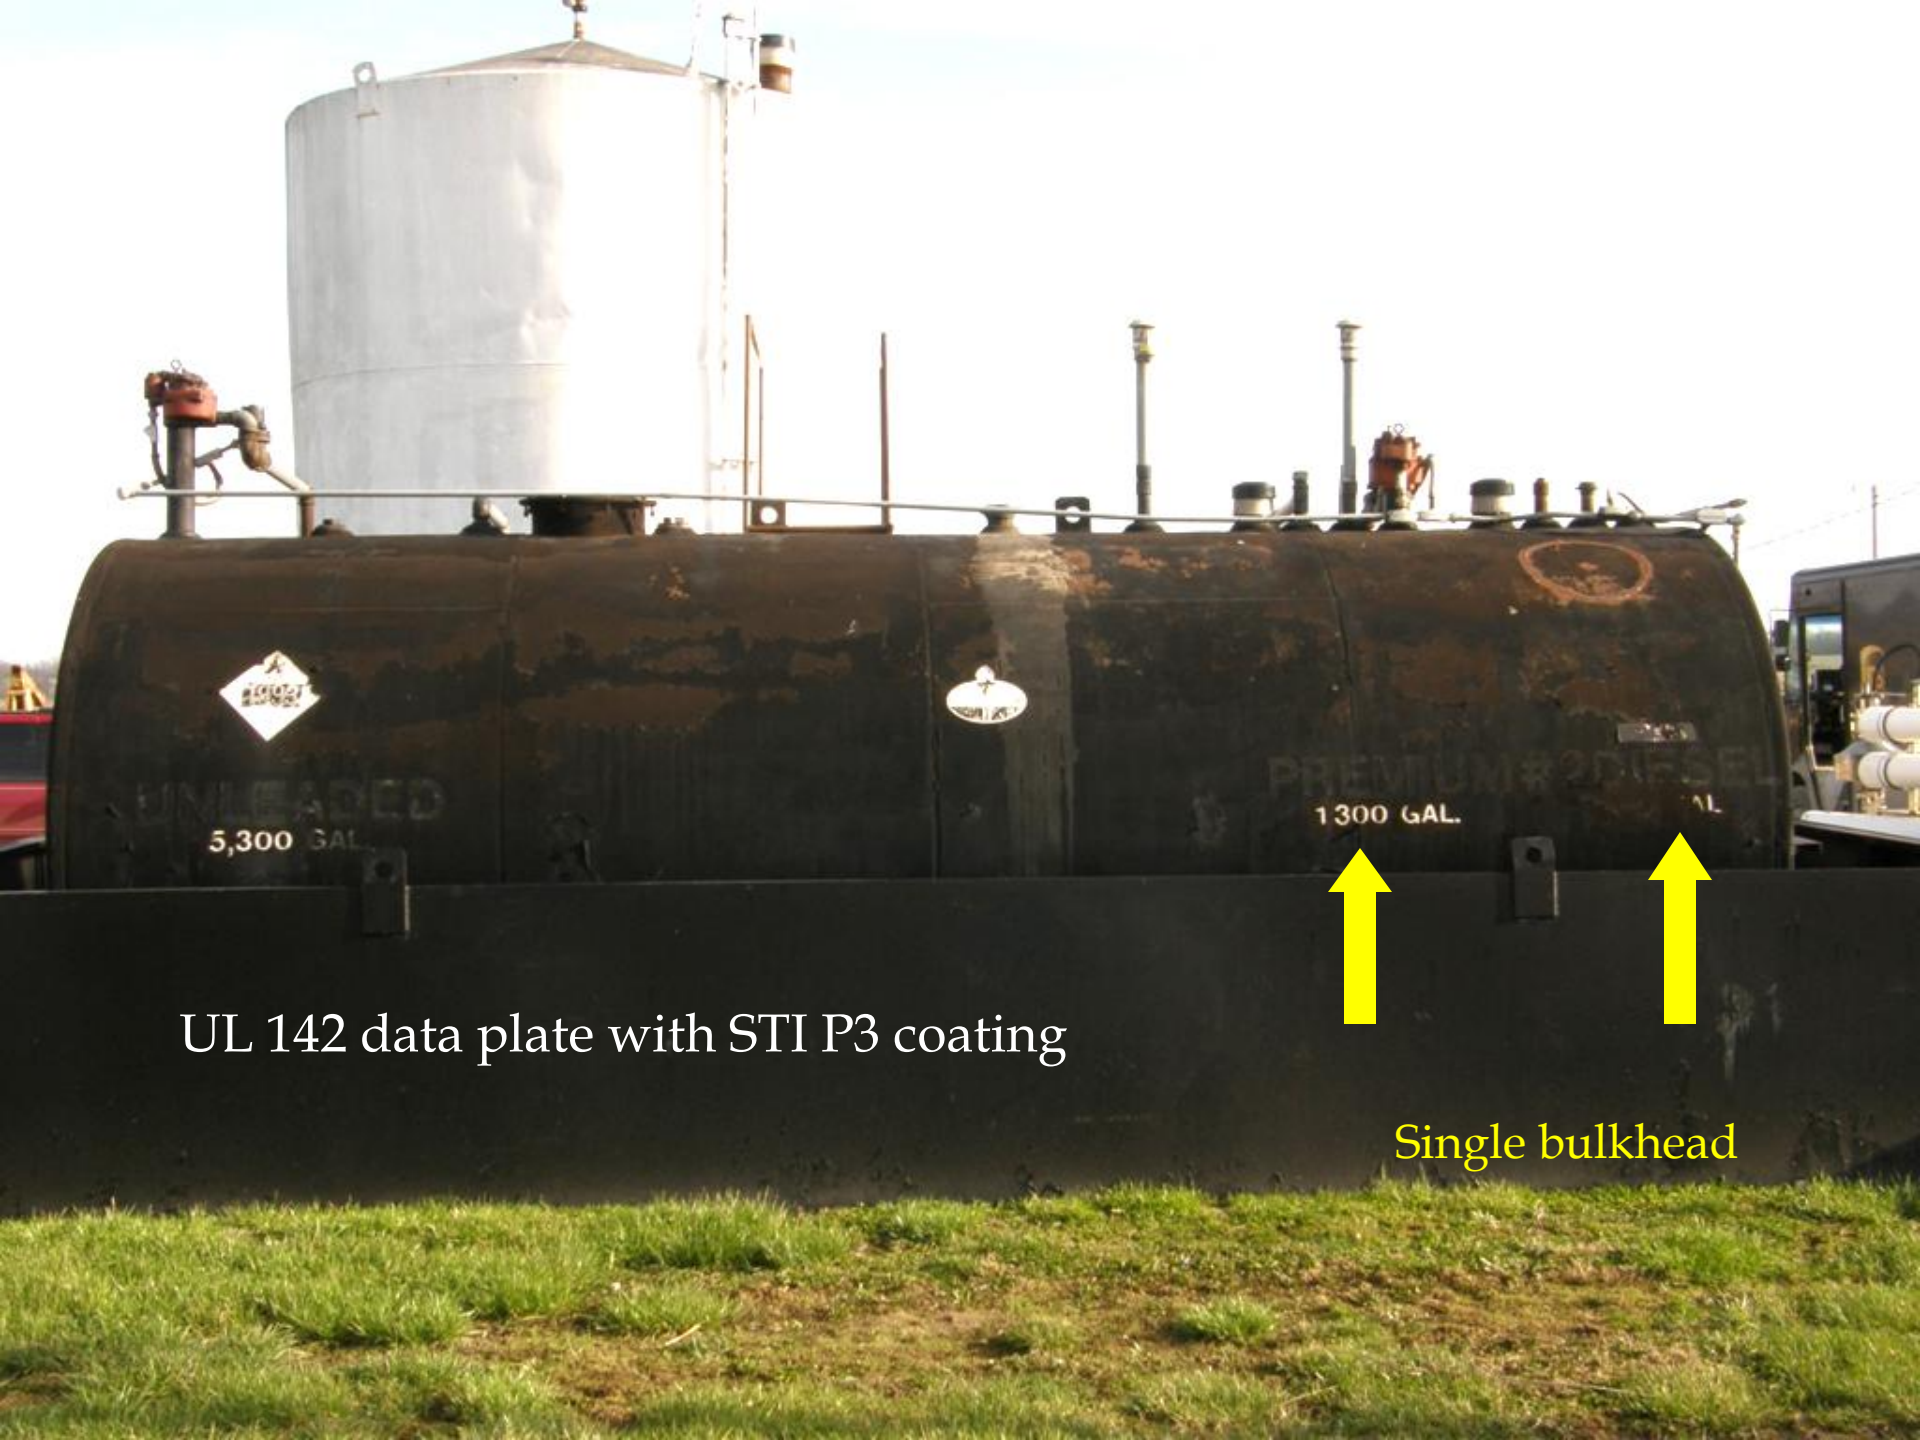
UL 142 data plate with STI P3 coating

Single bulkhead

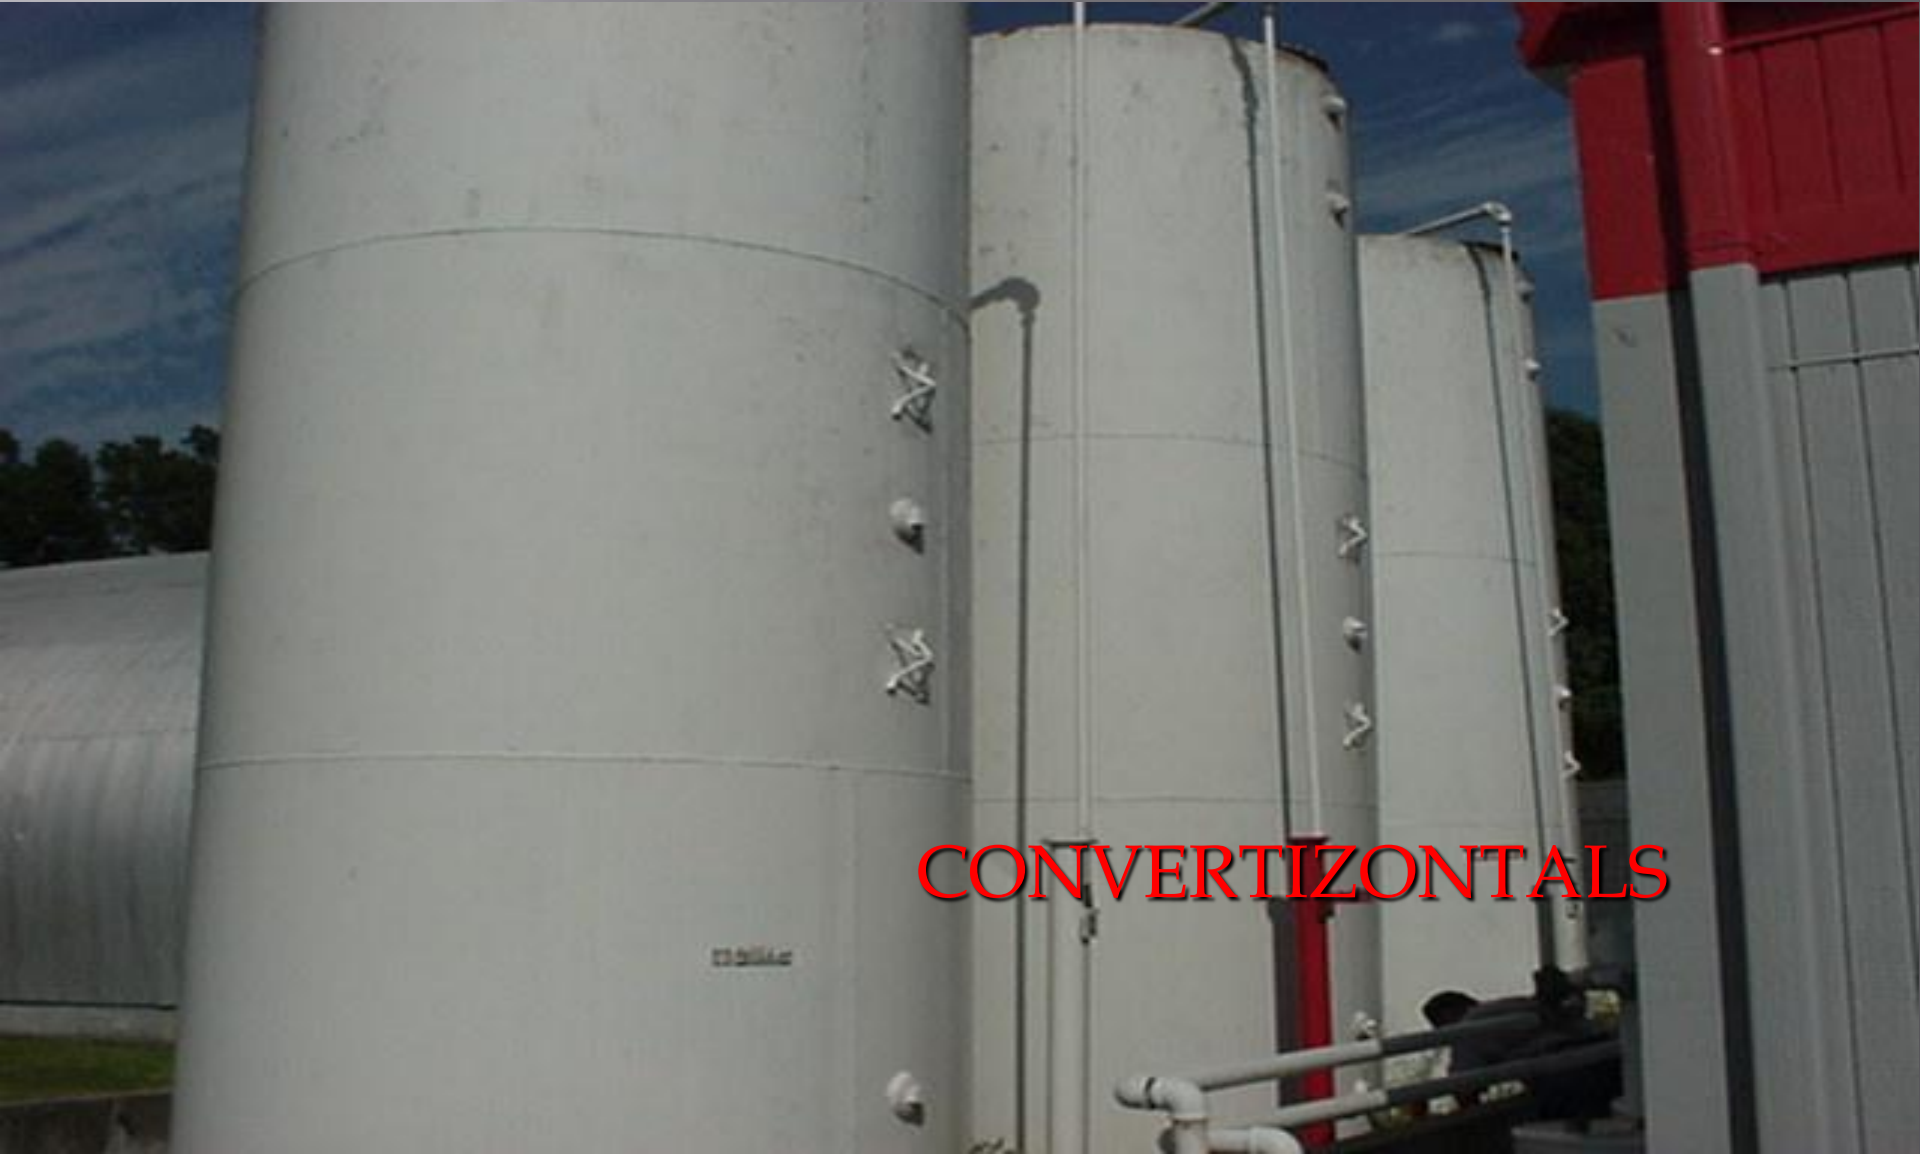
# NO UNDERGROUND TANKS ABOVEGROUND

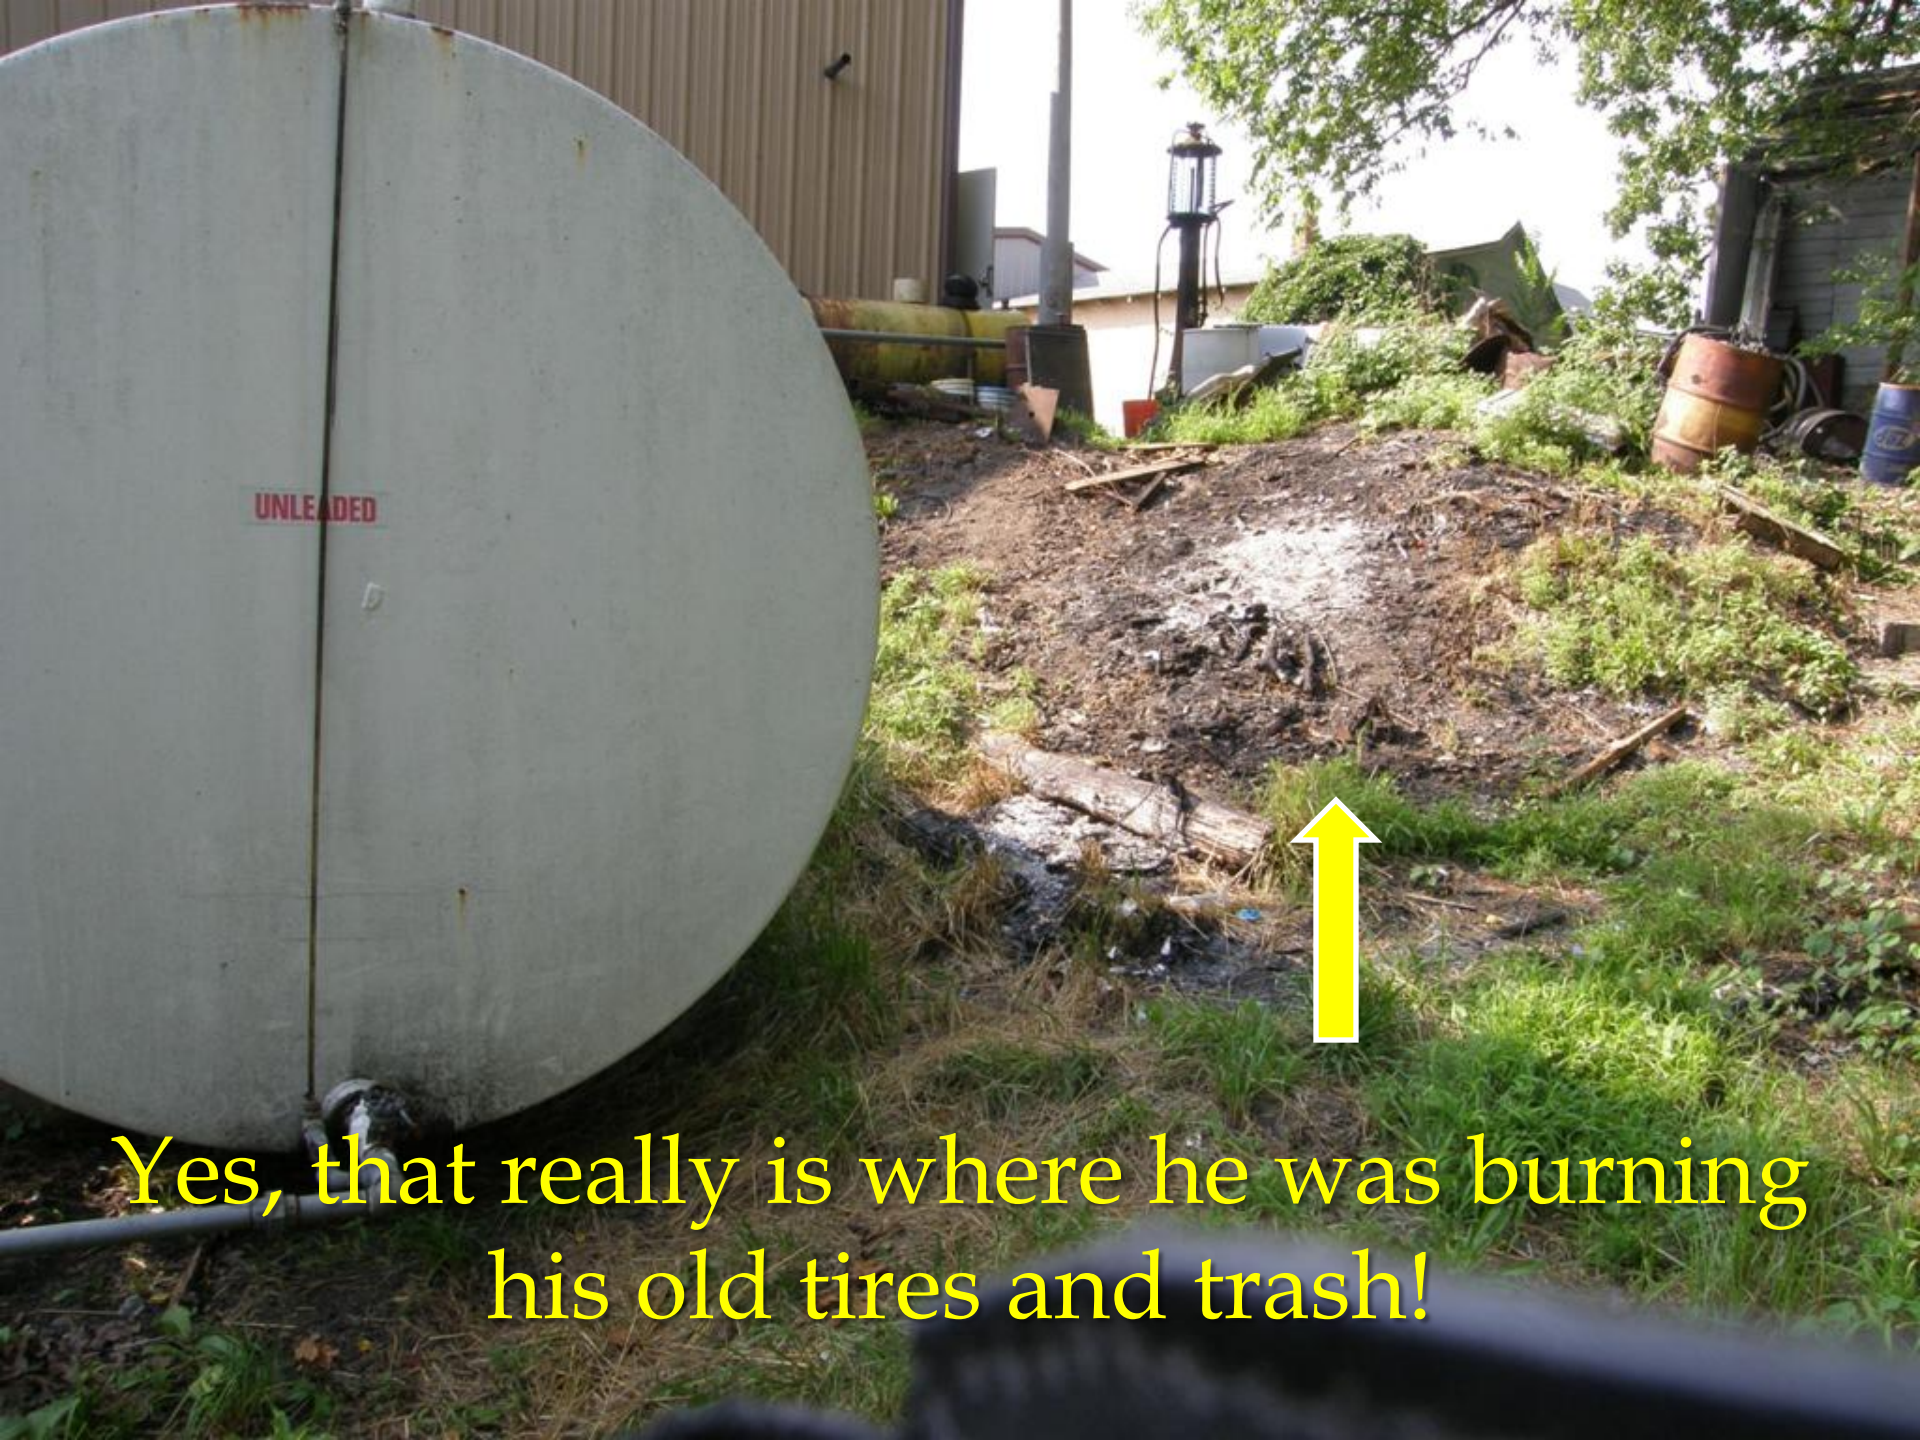
Yes, that really is where he was burning his old tires and trash!

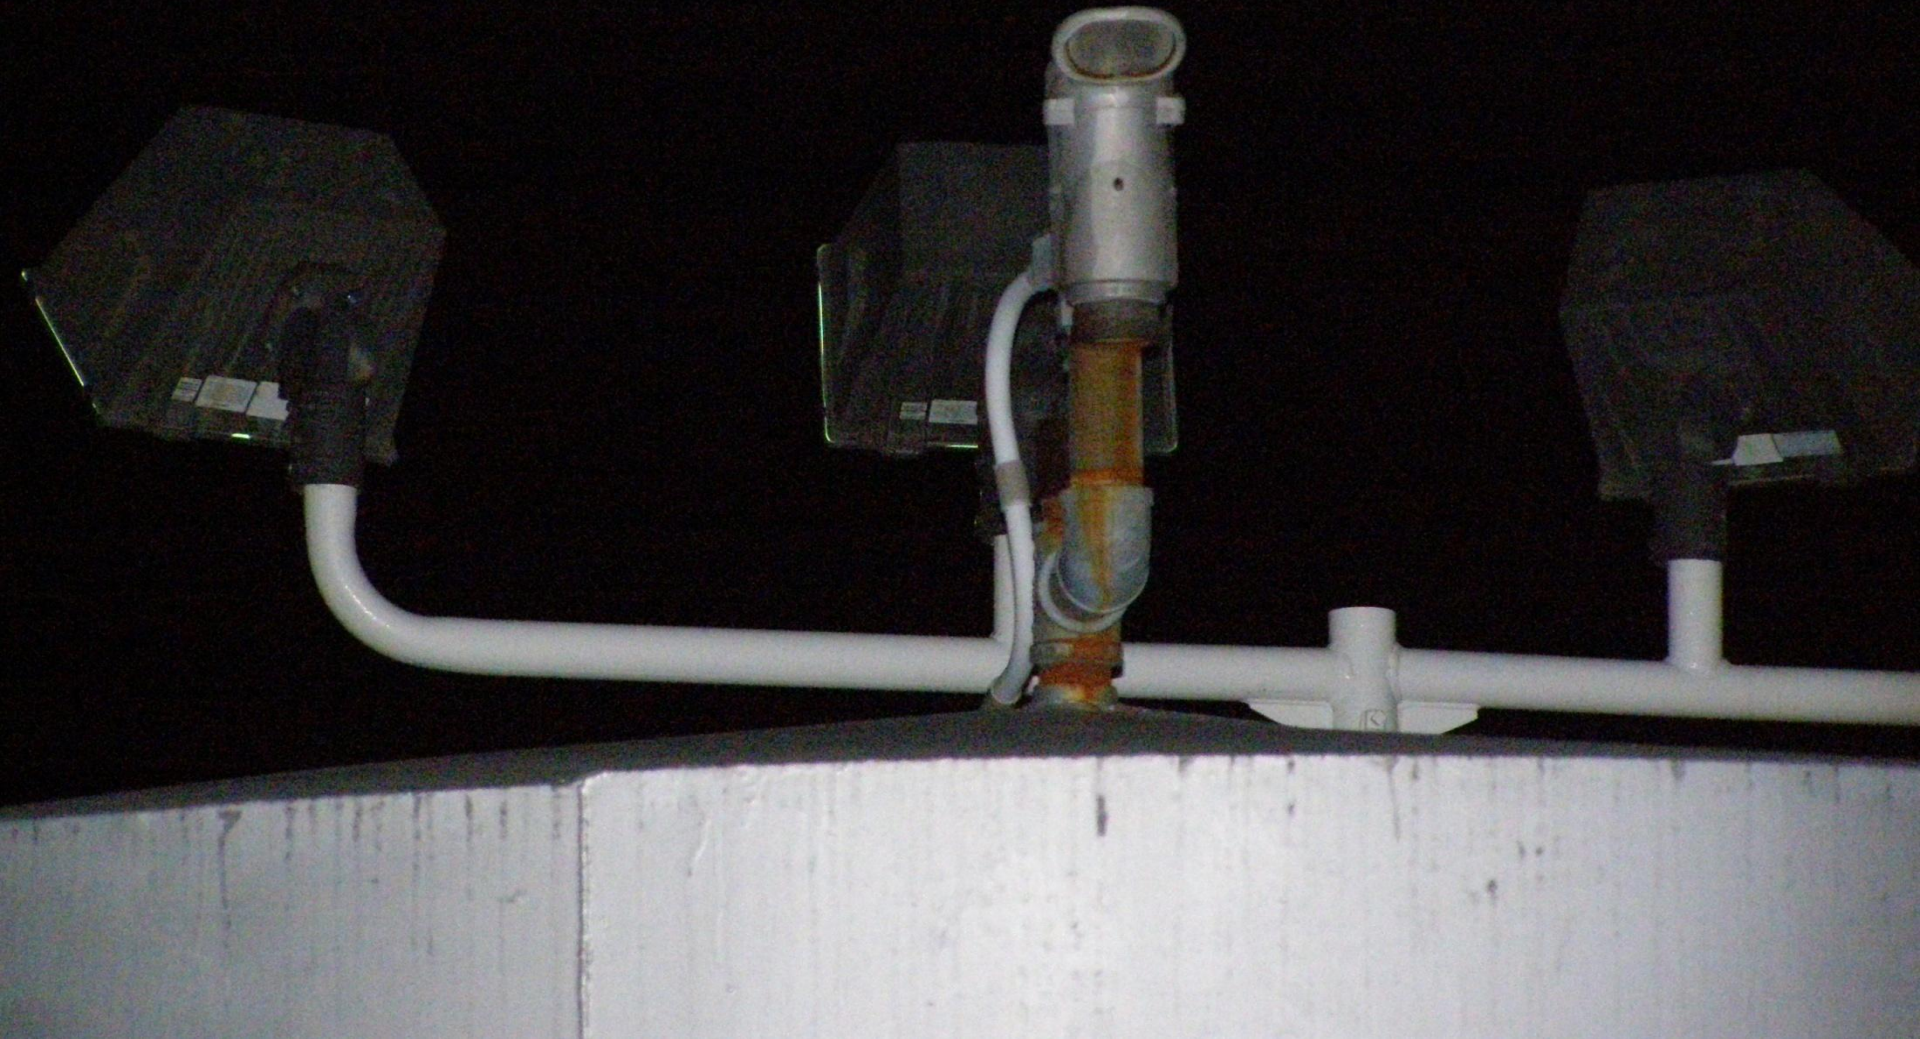
Areas subject to flooding

Directional vents must discharge away from ignition sources. This includes the transport delivery area

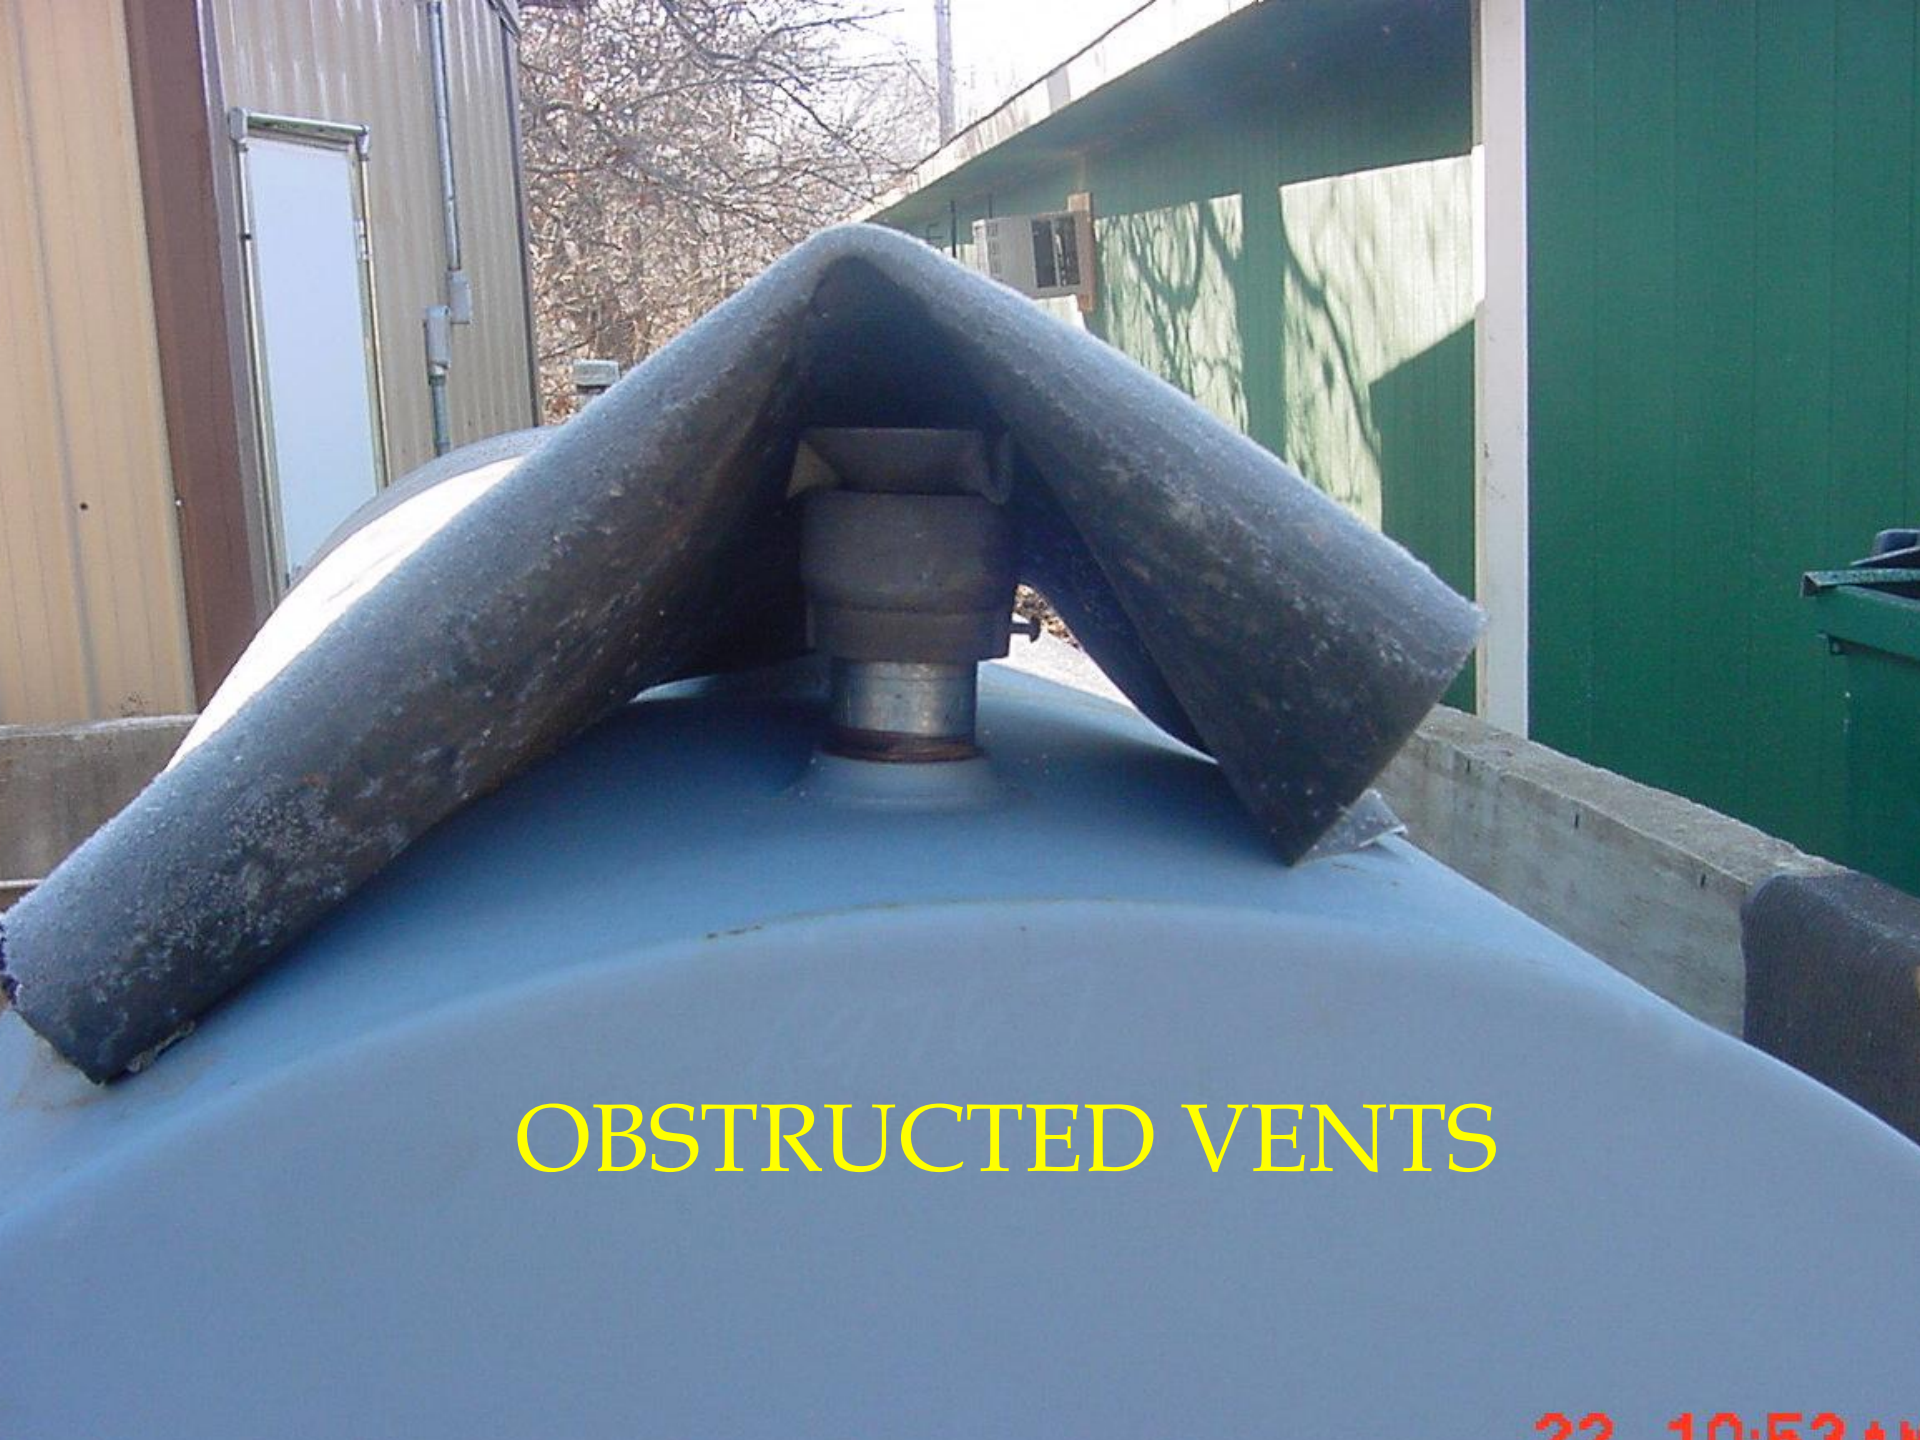
OBSTRUCTED VENTS

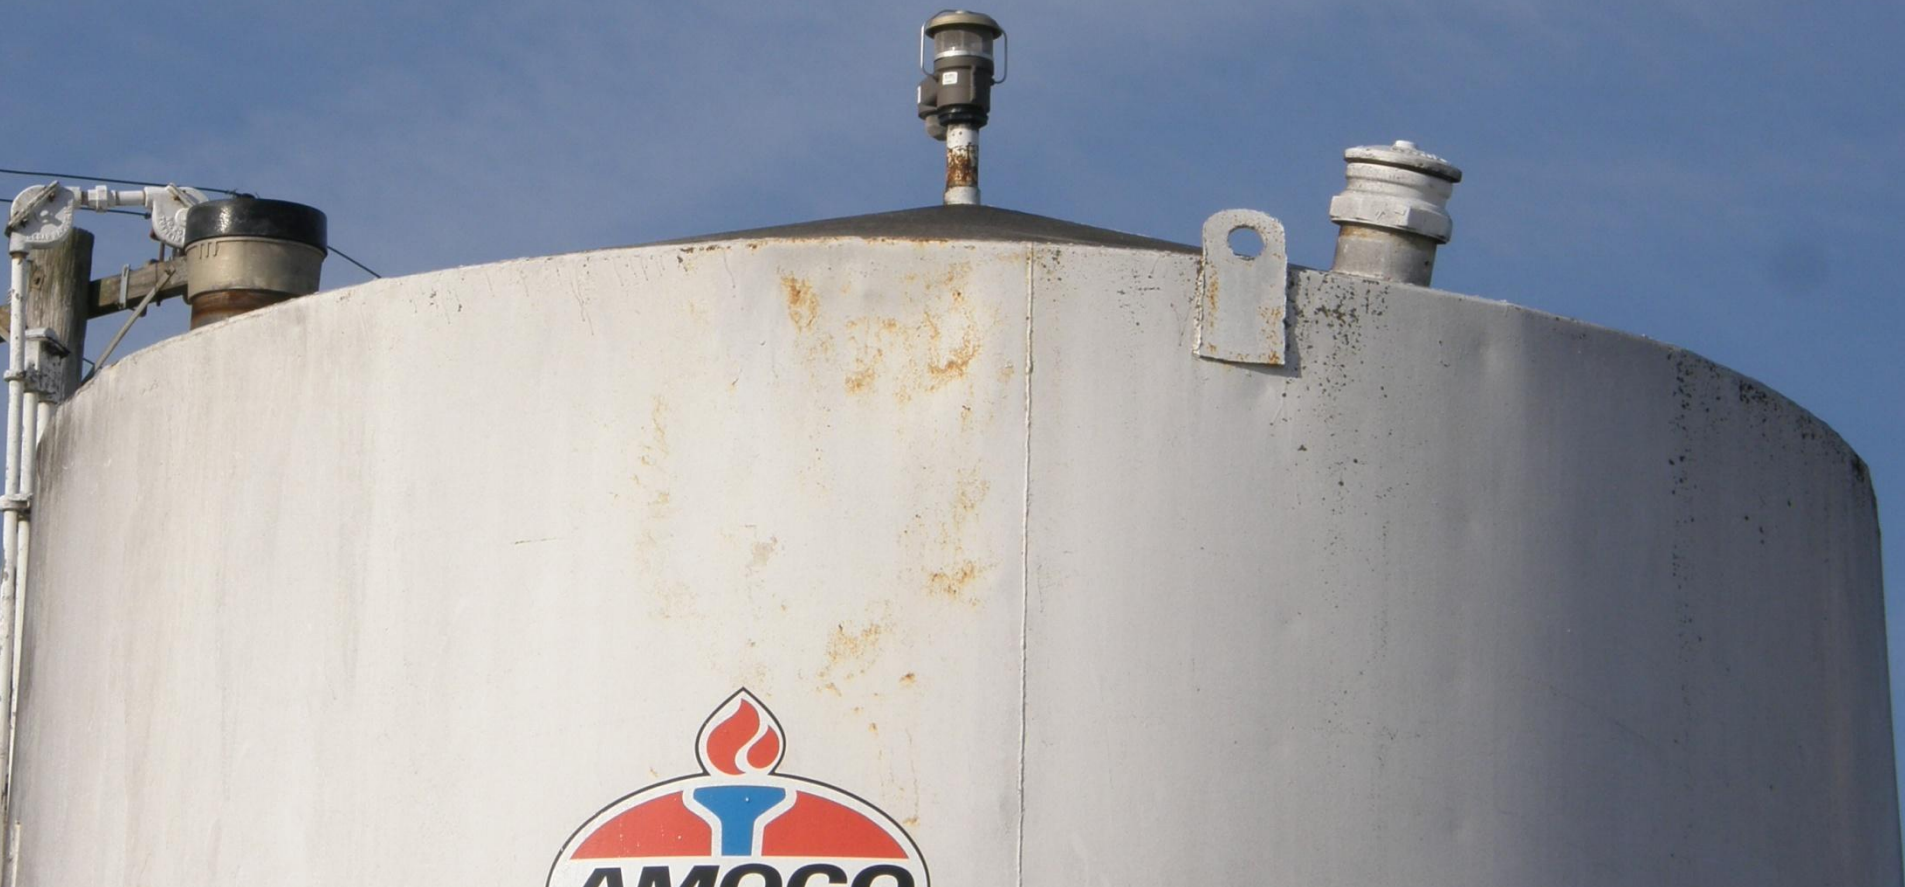
Vent is restricted down from  
it's nominal size.

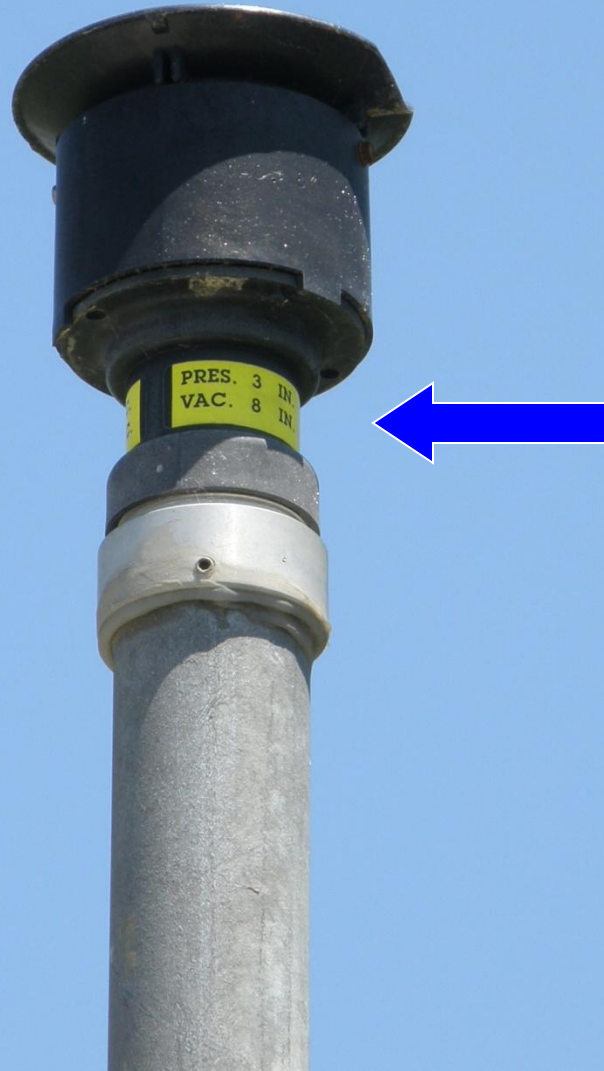
Some of the new CARB  
approved vents are restricted  
down.

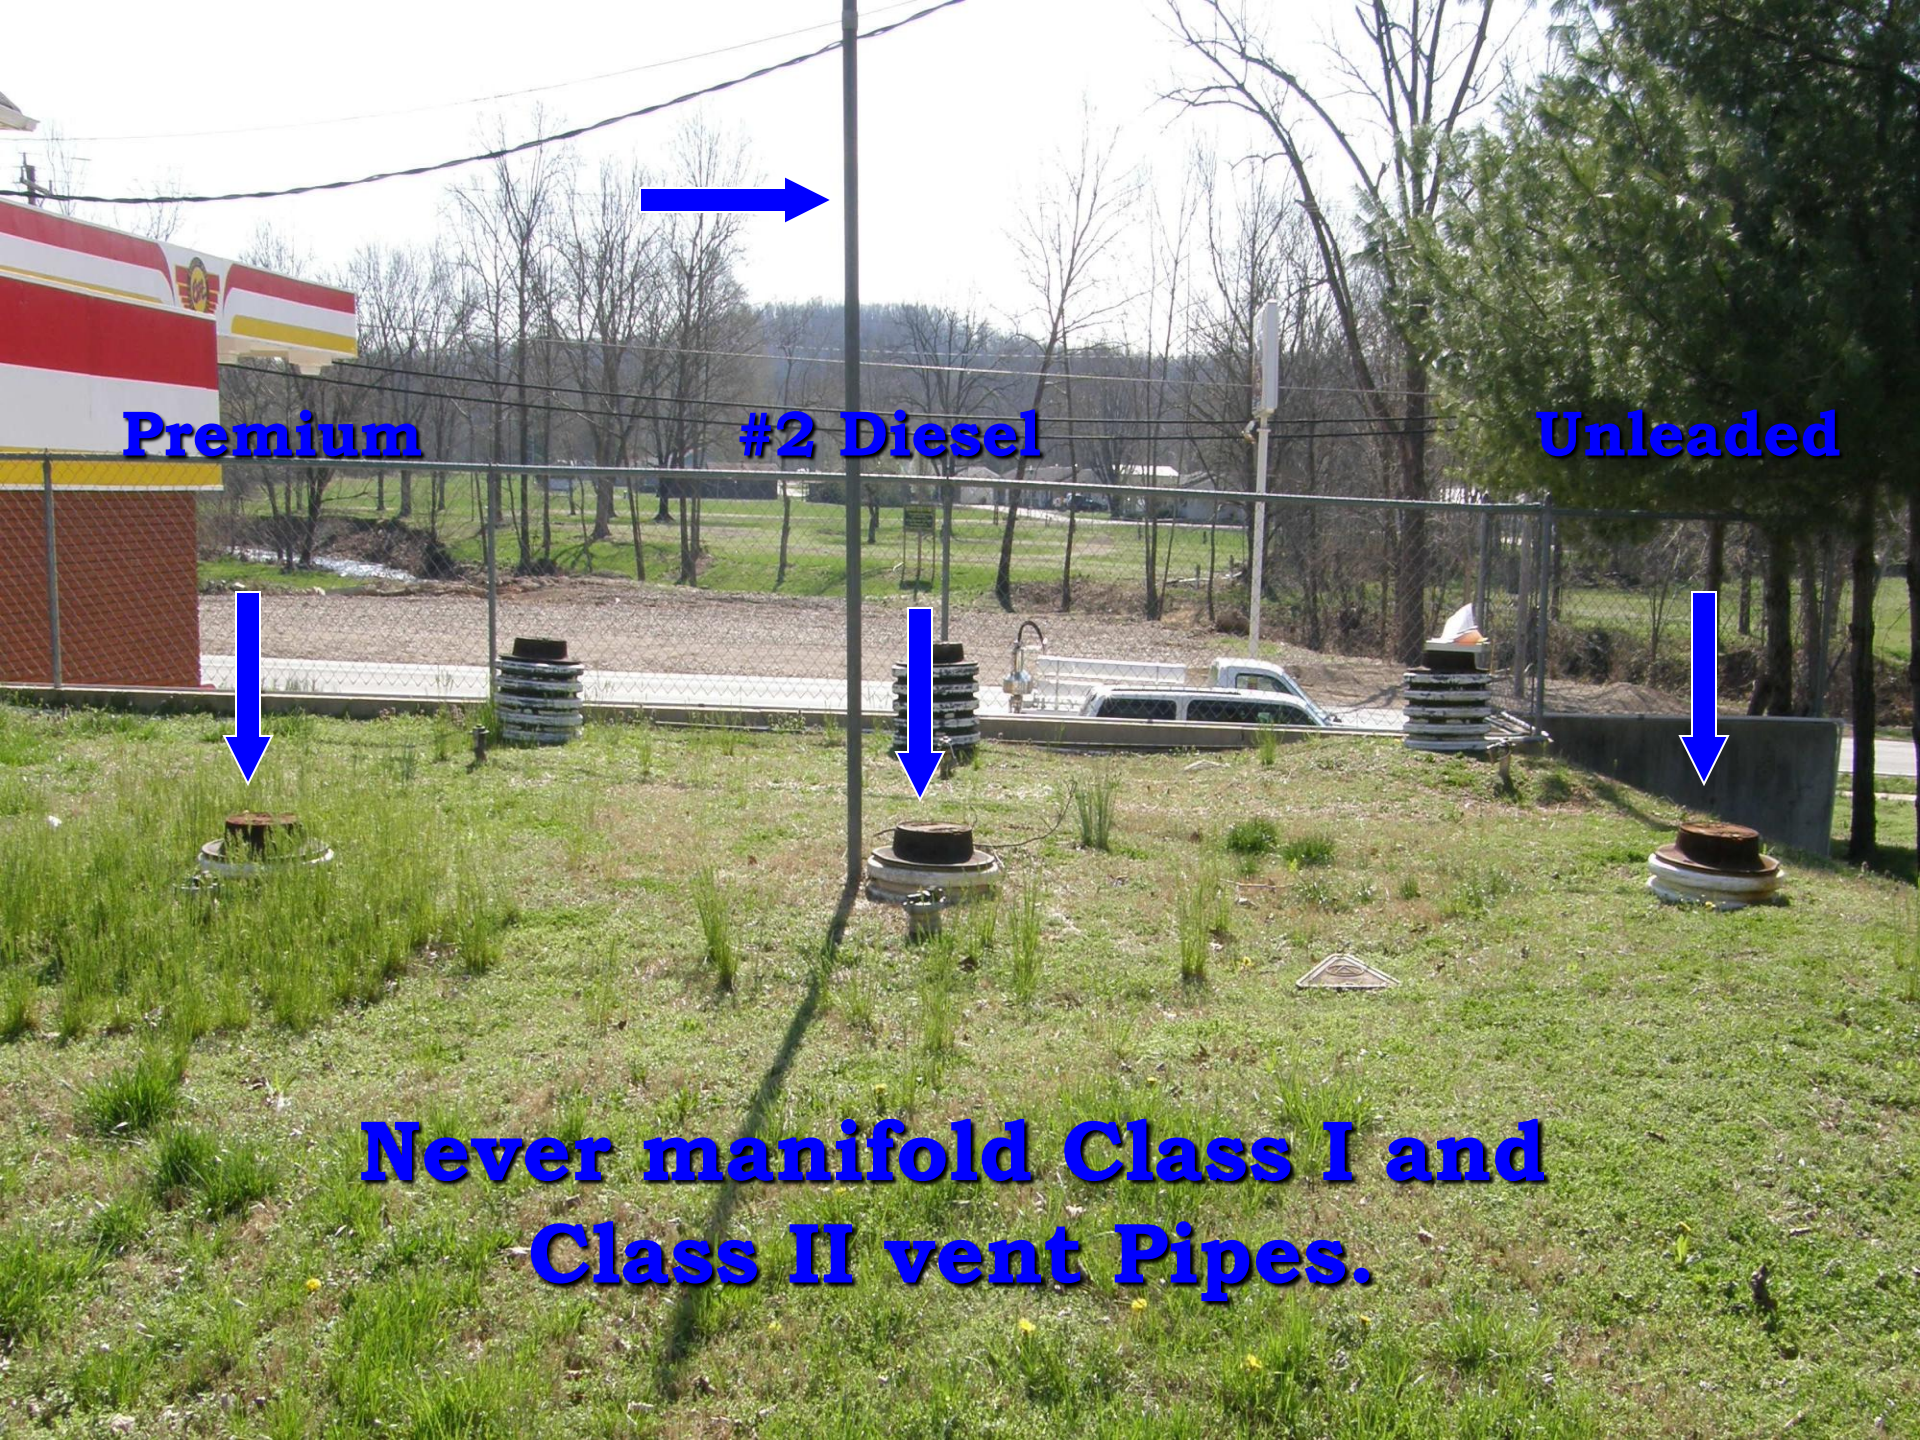
**Never manifold Class I and  
Class II vent Pipes.**

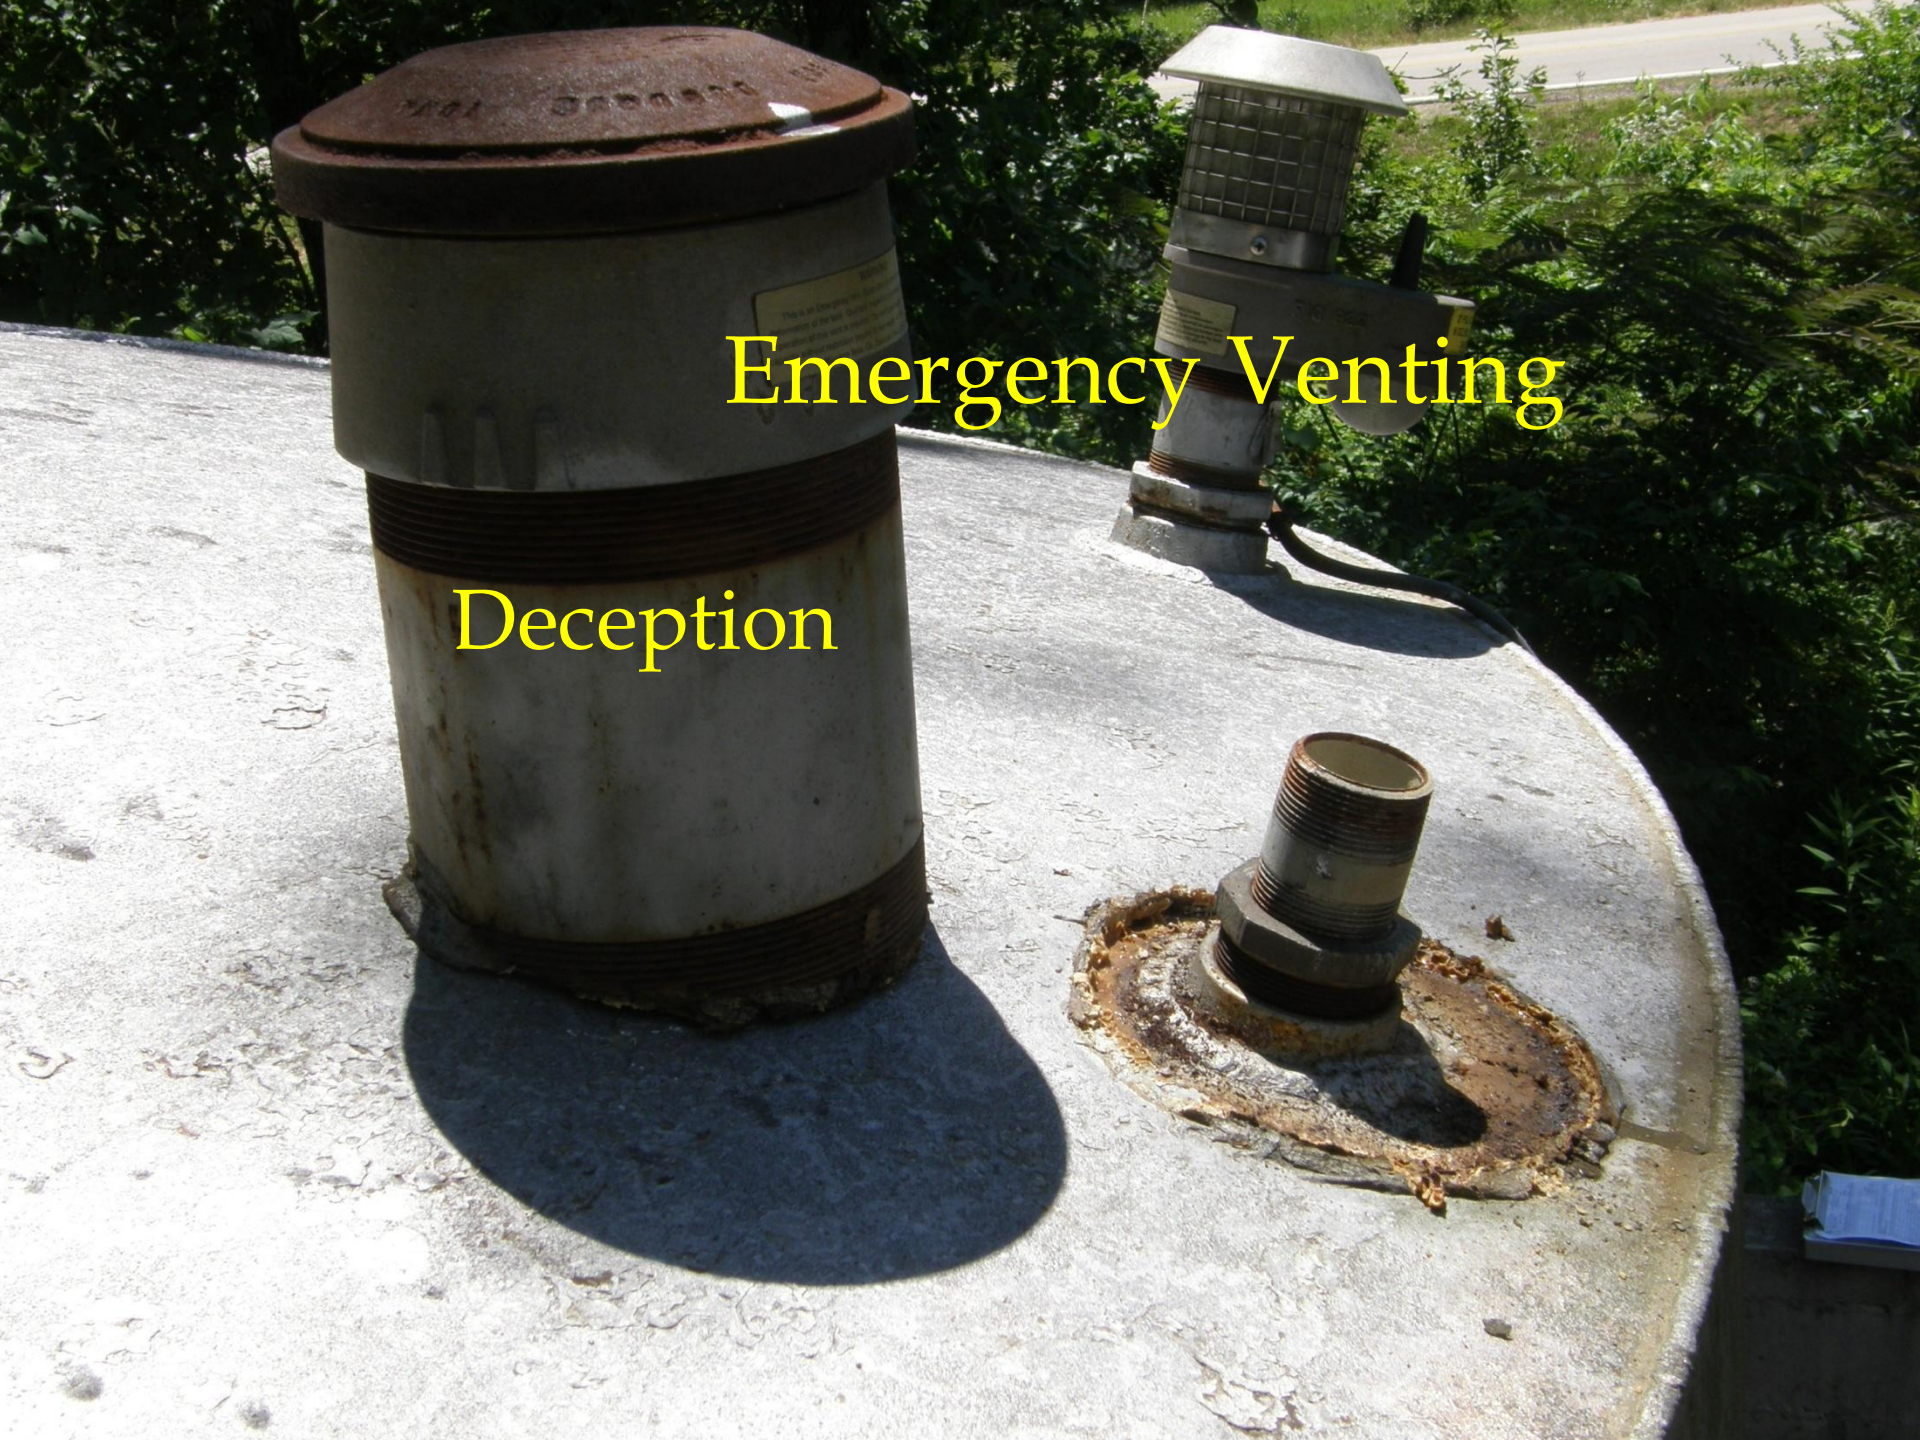
Deception

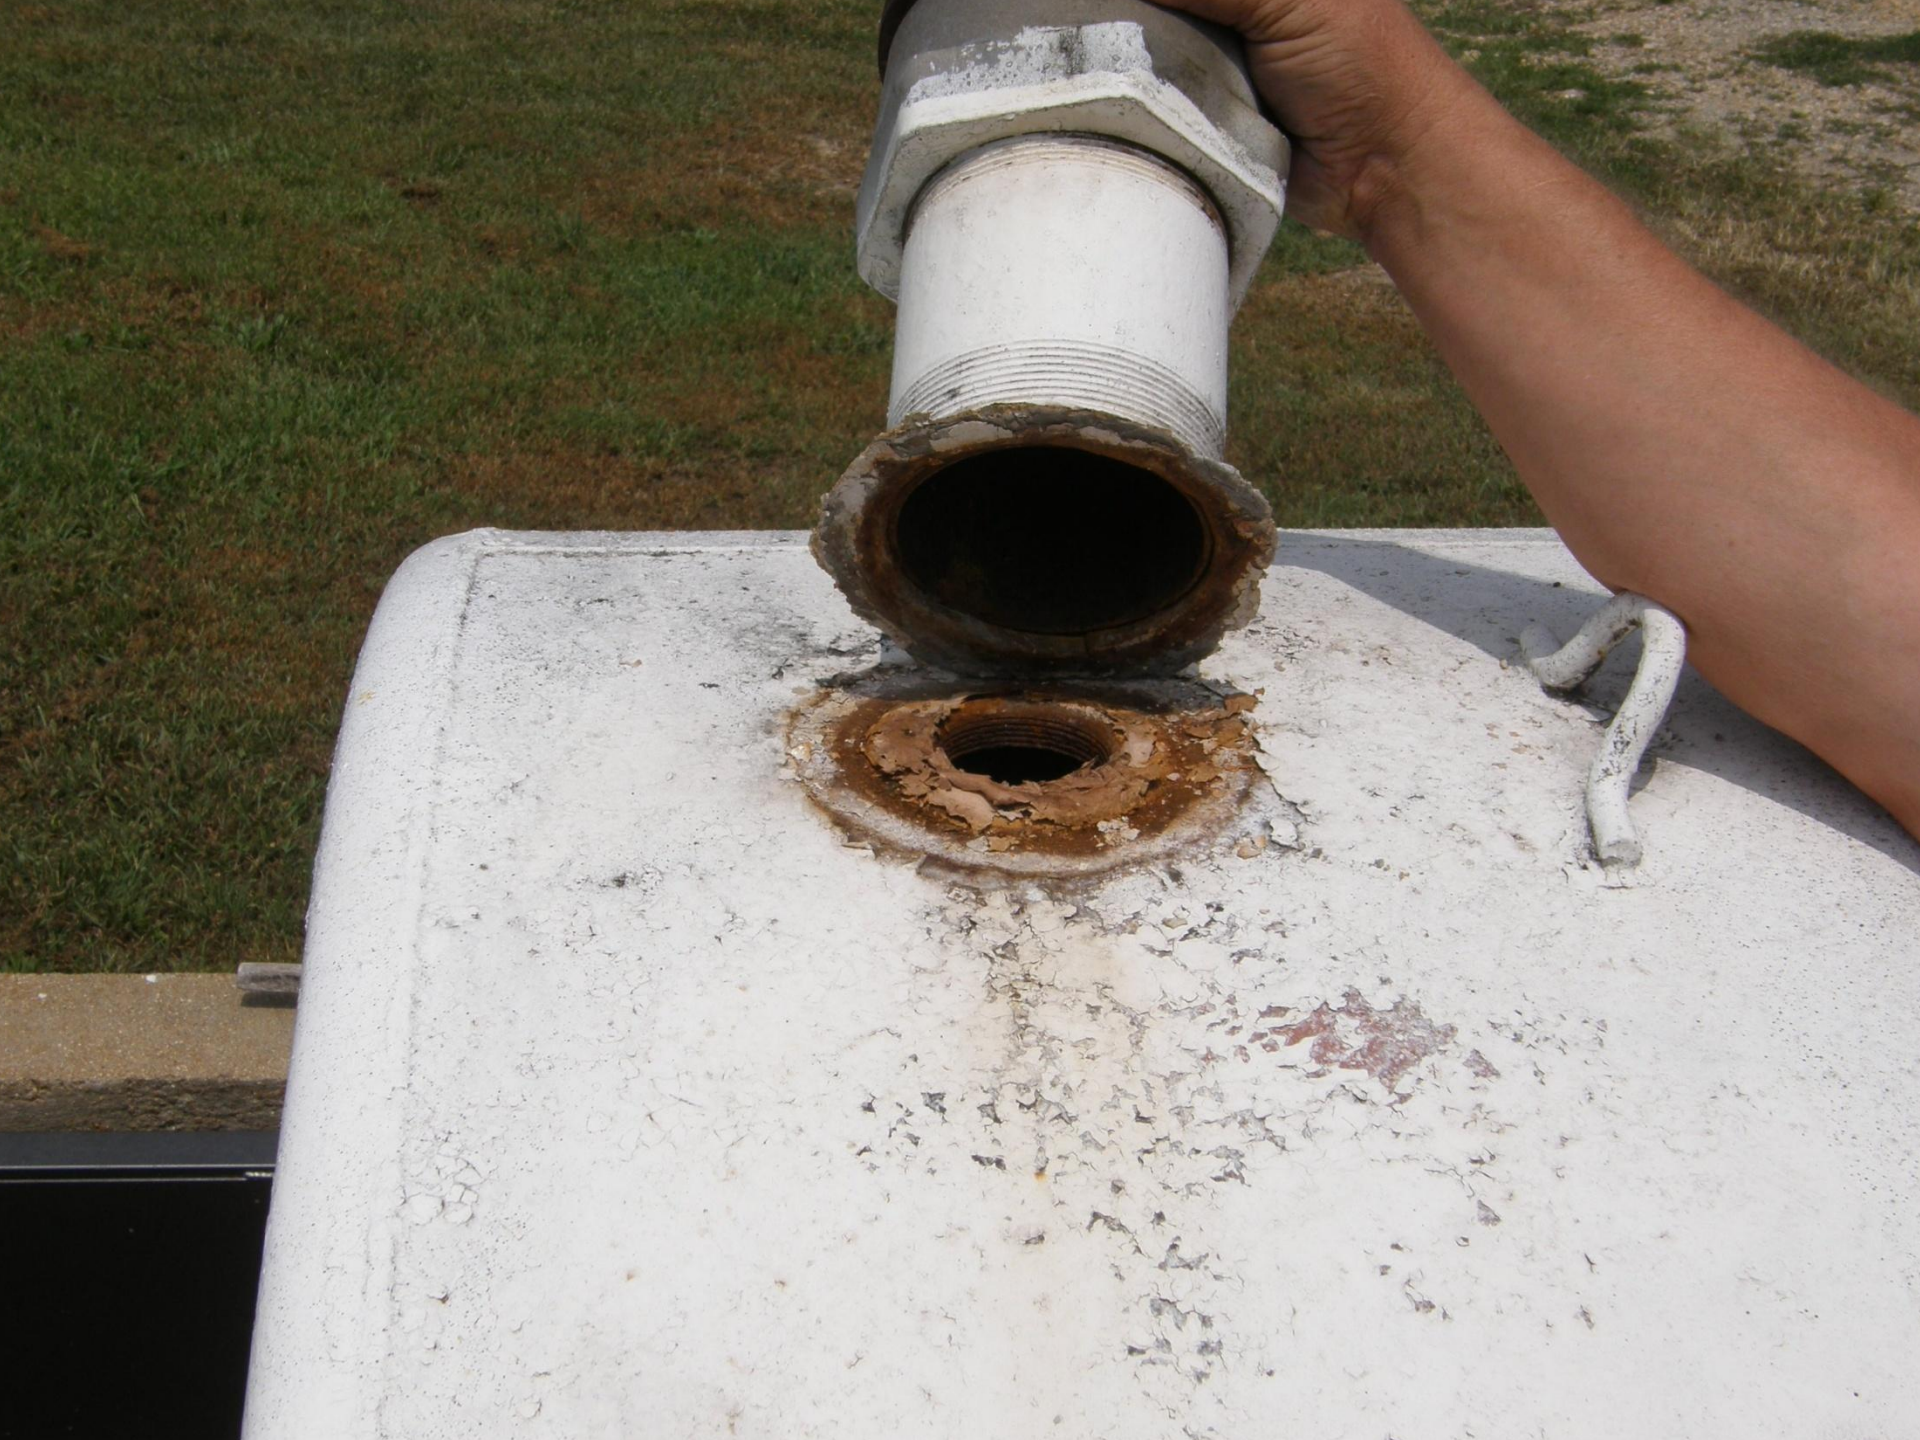
Zip tie method
