# MISSOURI ABOVEGROUND STORAGE TANK INSPECTIONS AND REGULATIONS

MISSOURI DEPARTMENT OF  
AGRICULTURE

Weights, Measures &  
Consumer Protection  
Petroleum/Propane/Nh3

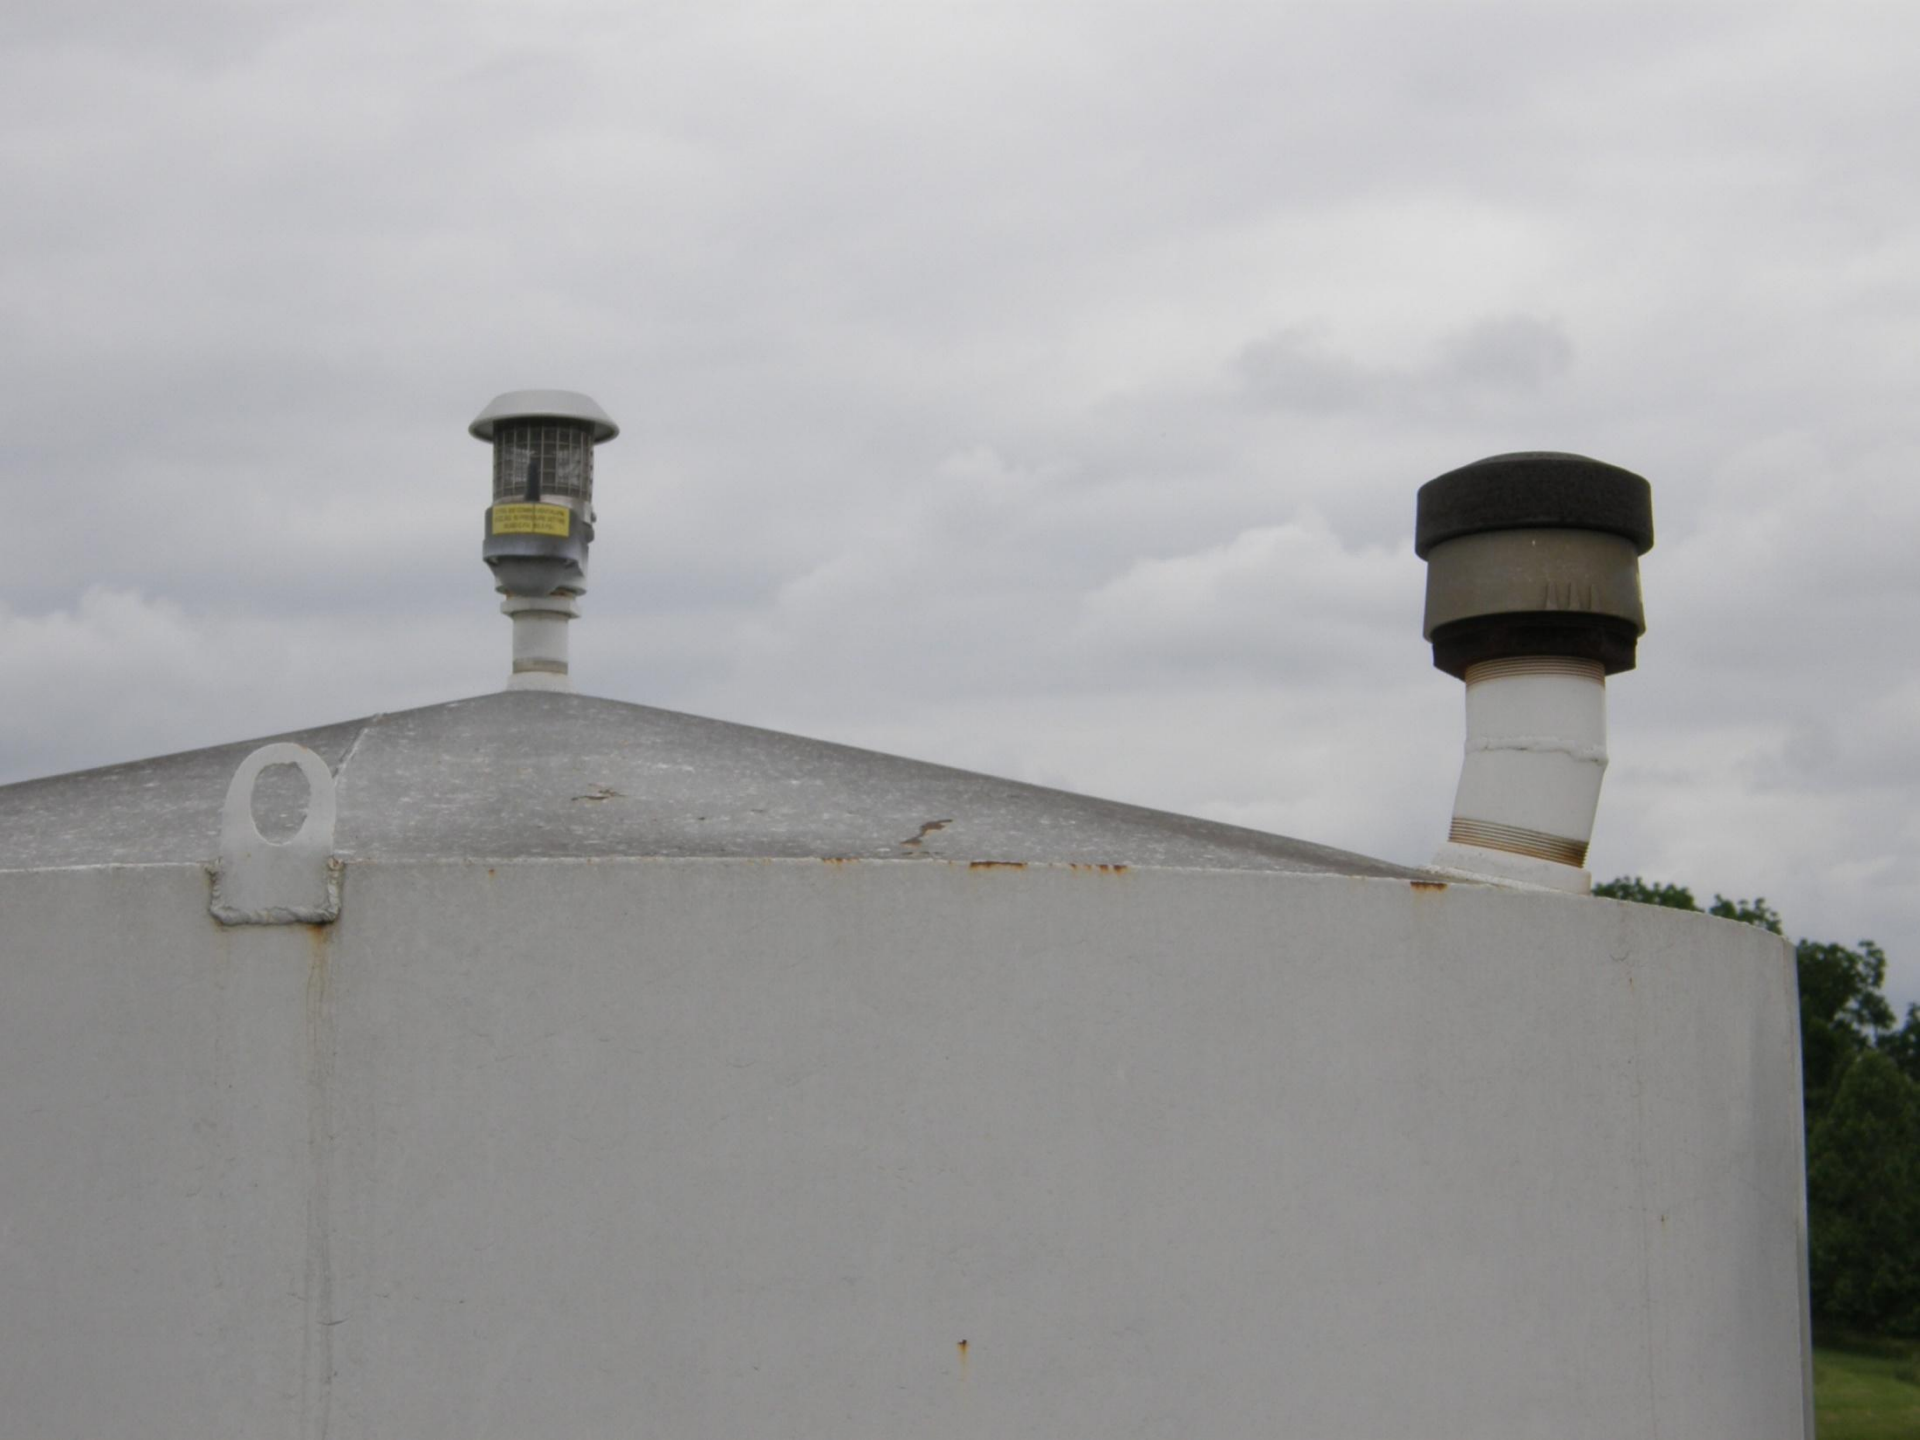
ENARDO  
LEVER TYPE  
STACK VALVE

**Shim can affect the operation of the vent and allow fugitive emissions.**

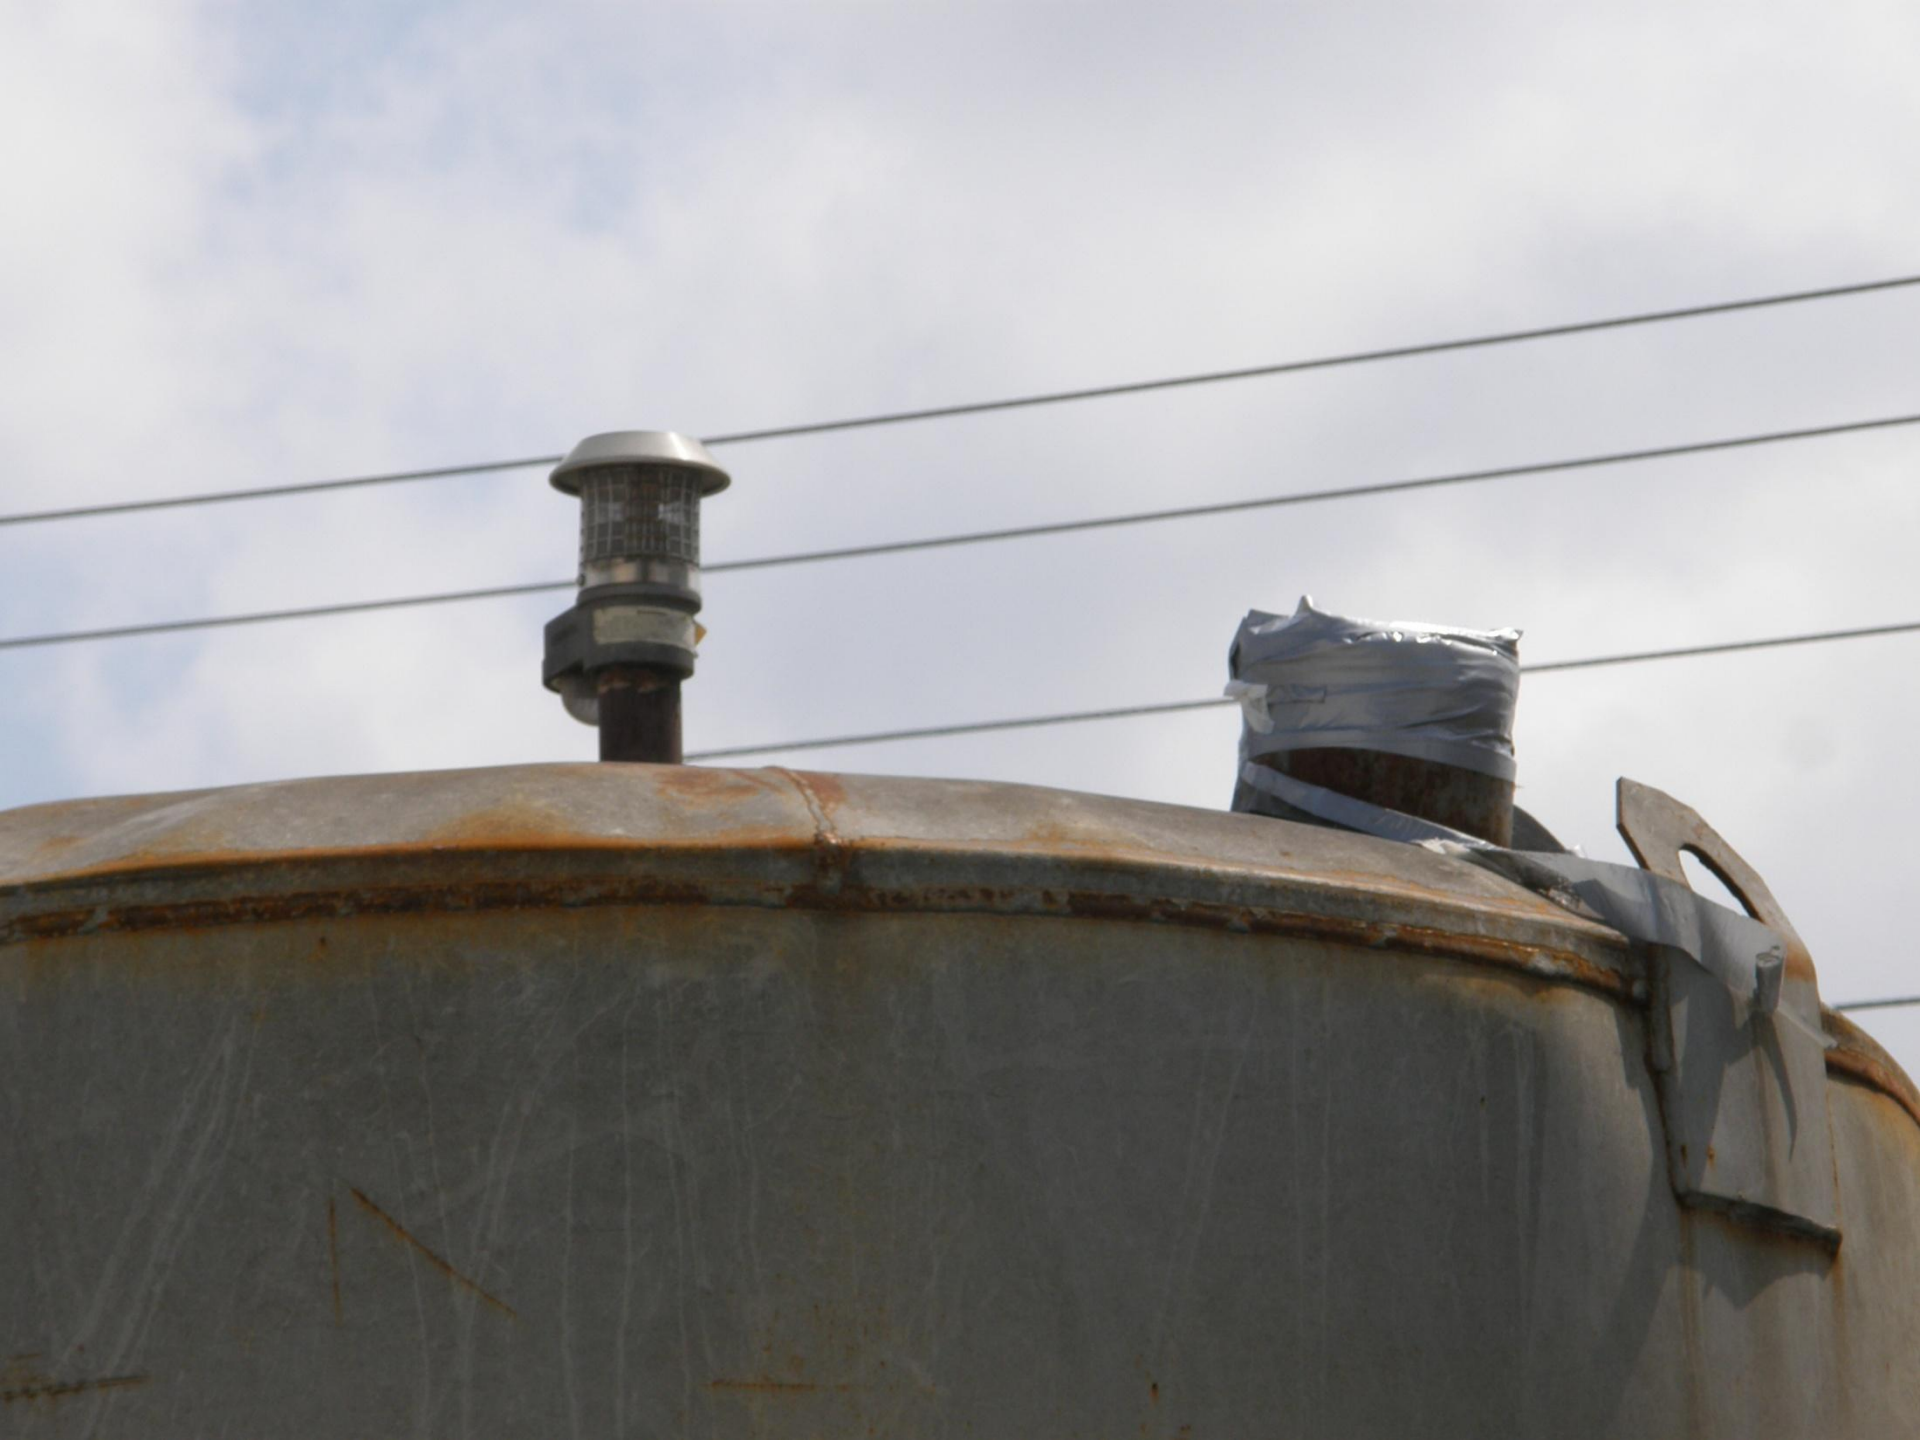
Damage

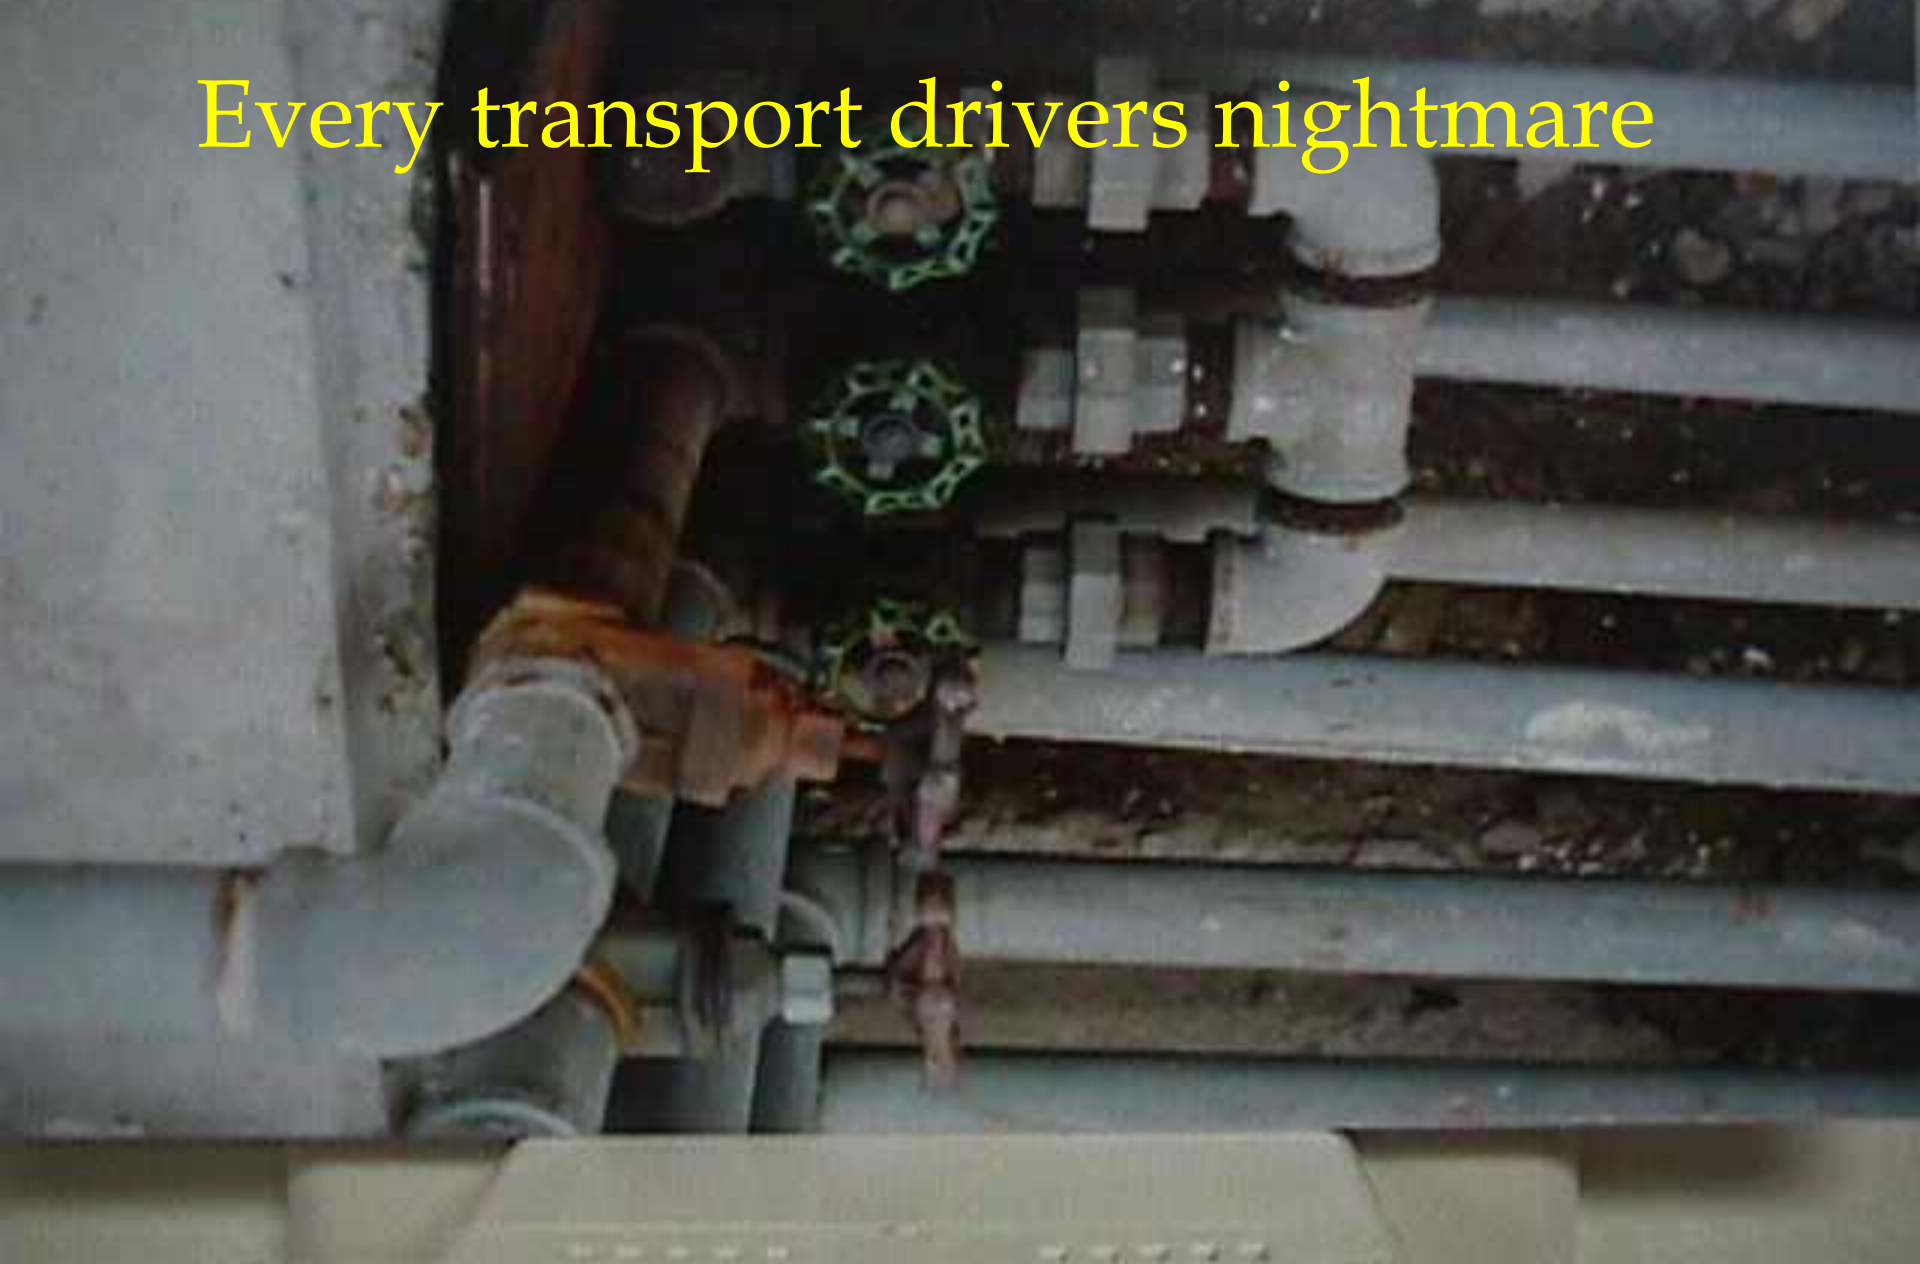
Every transport drivers nightmare

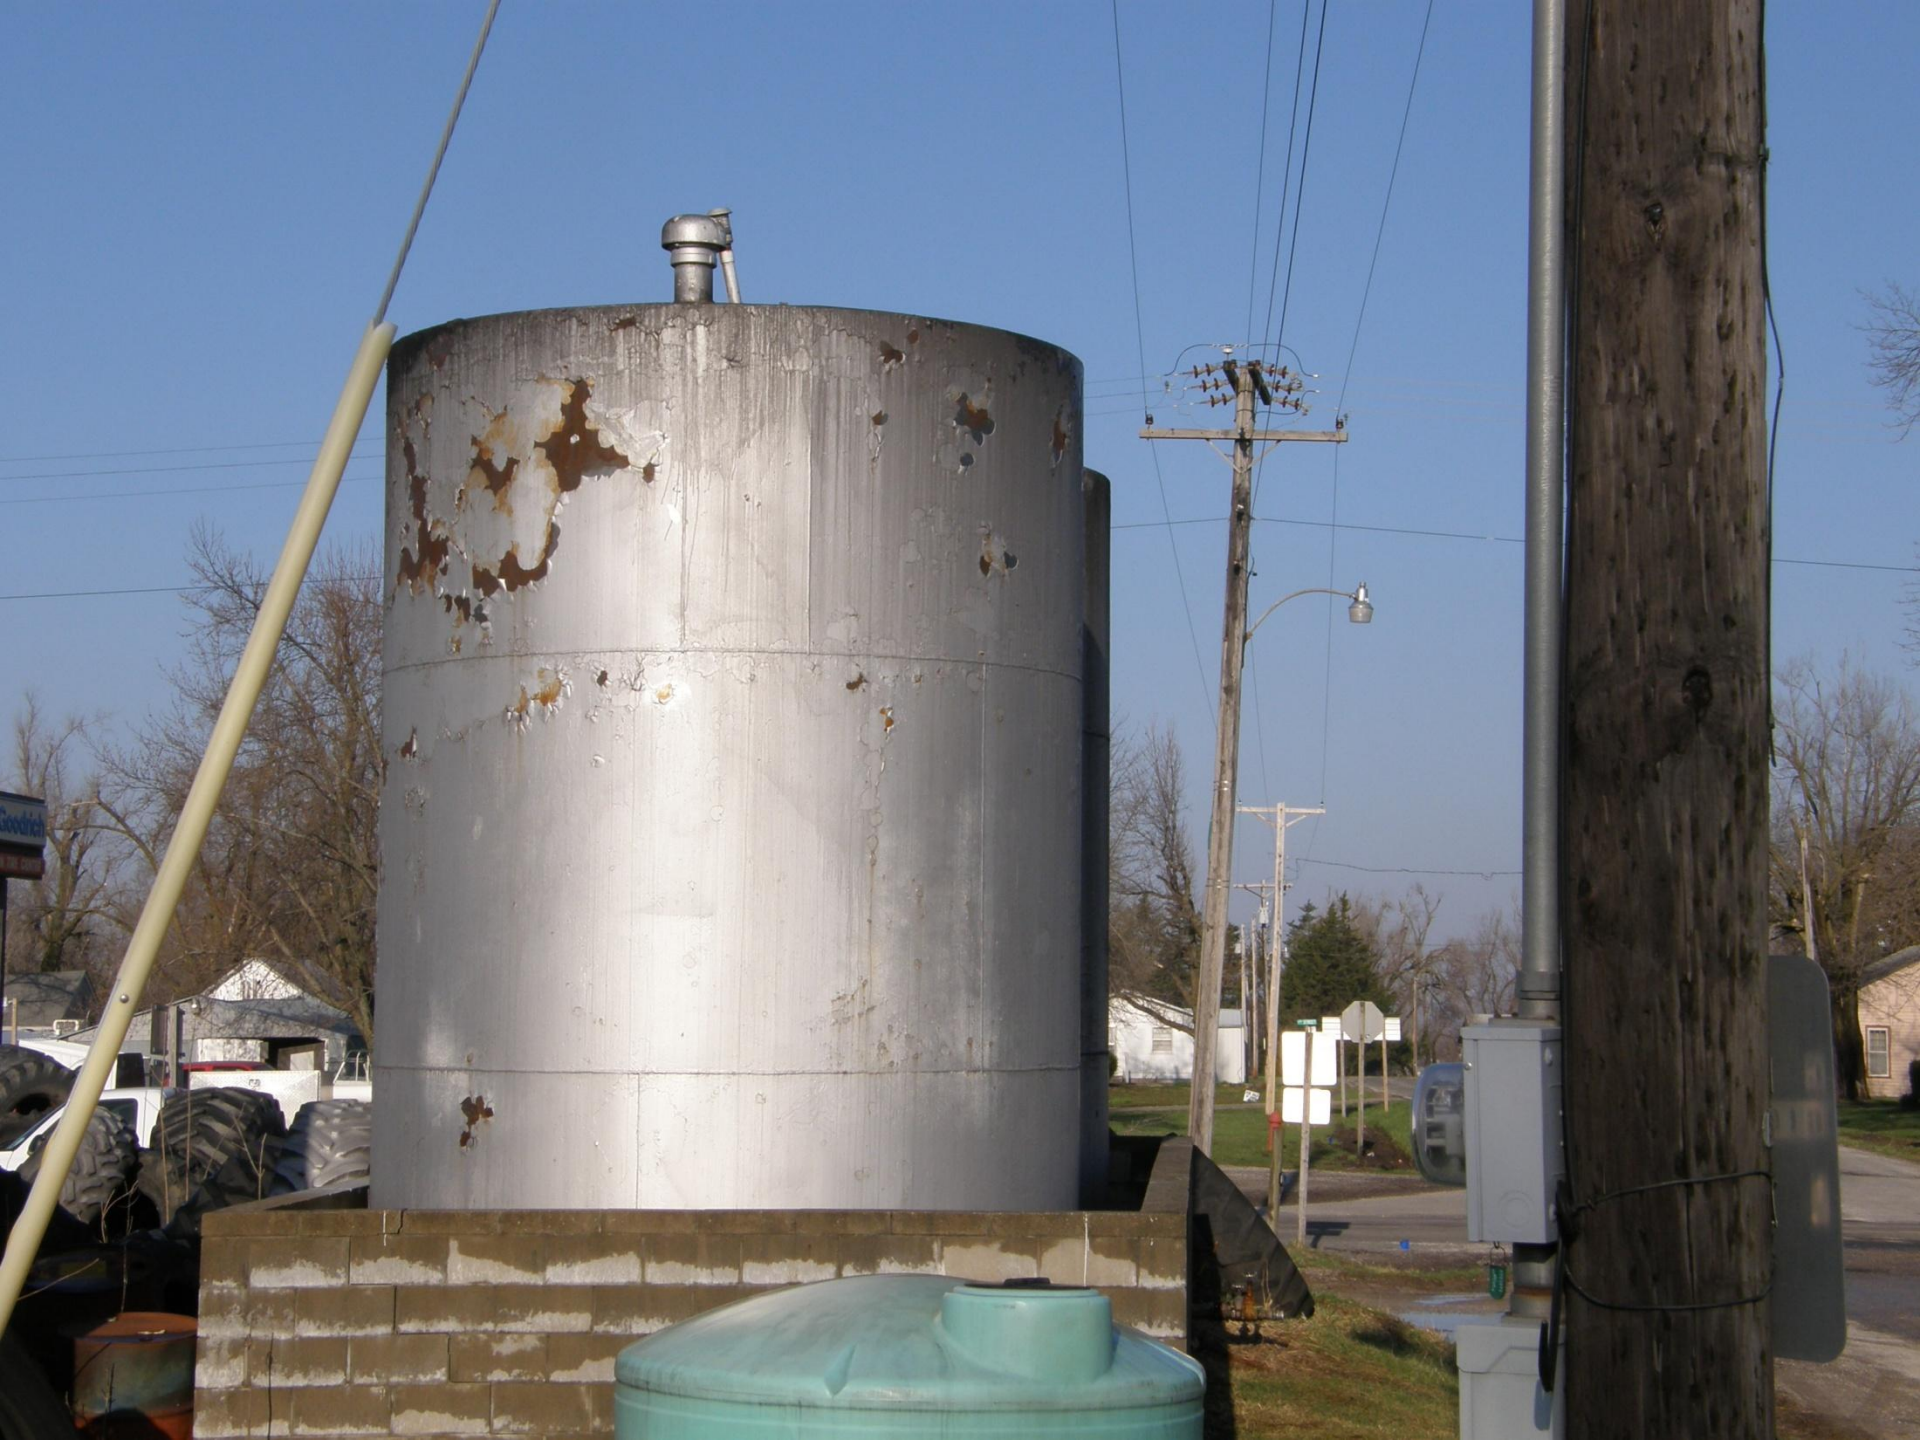
Tape/float gauges must enter tank vertically.

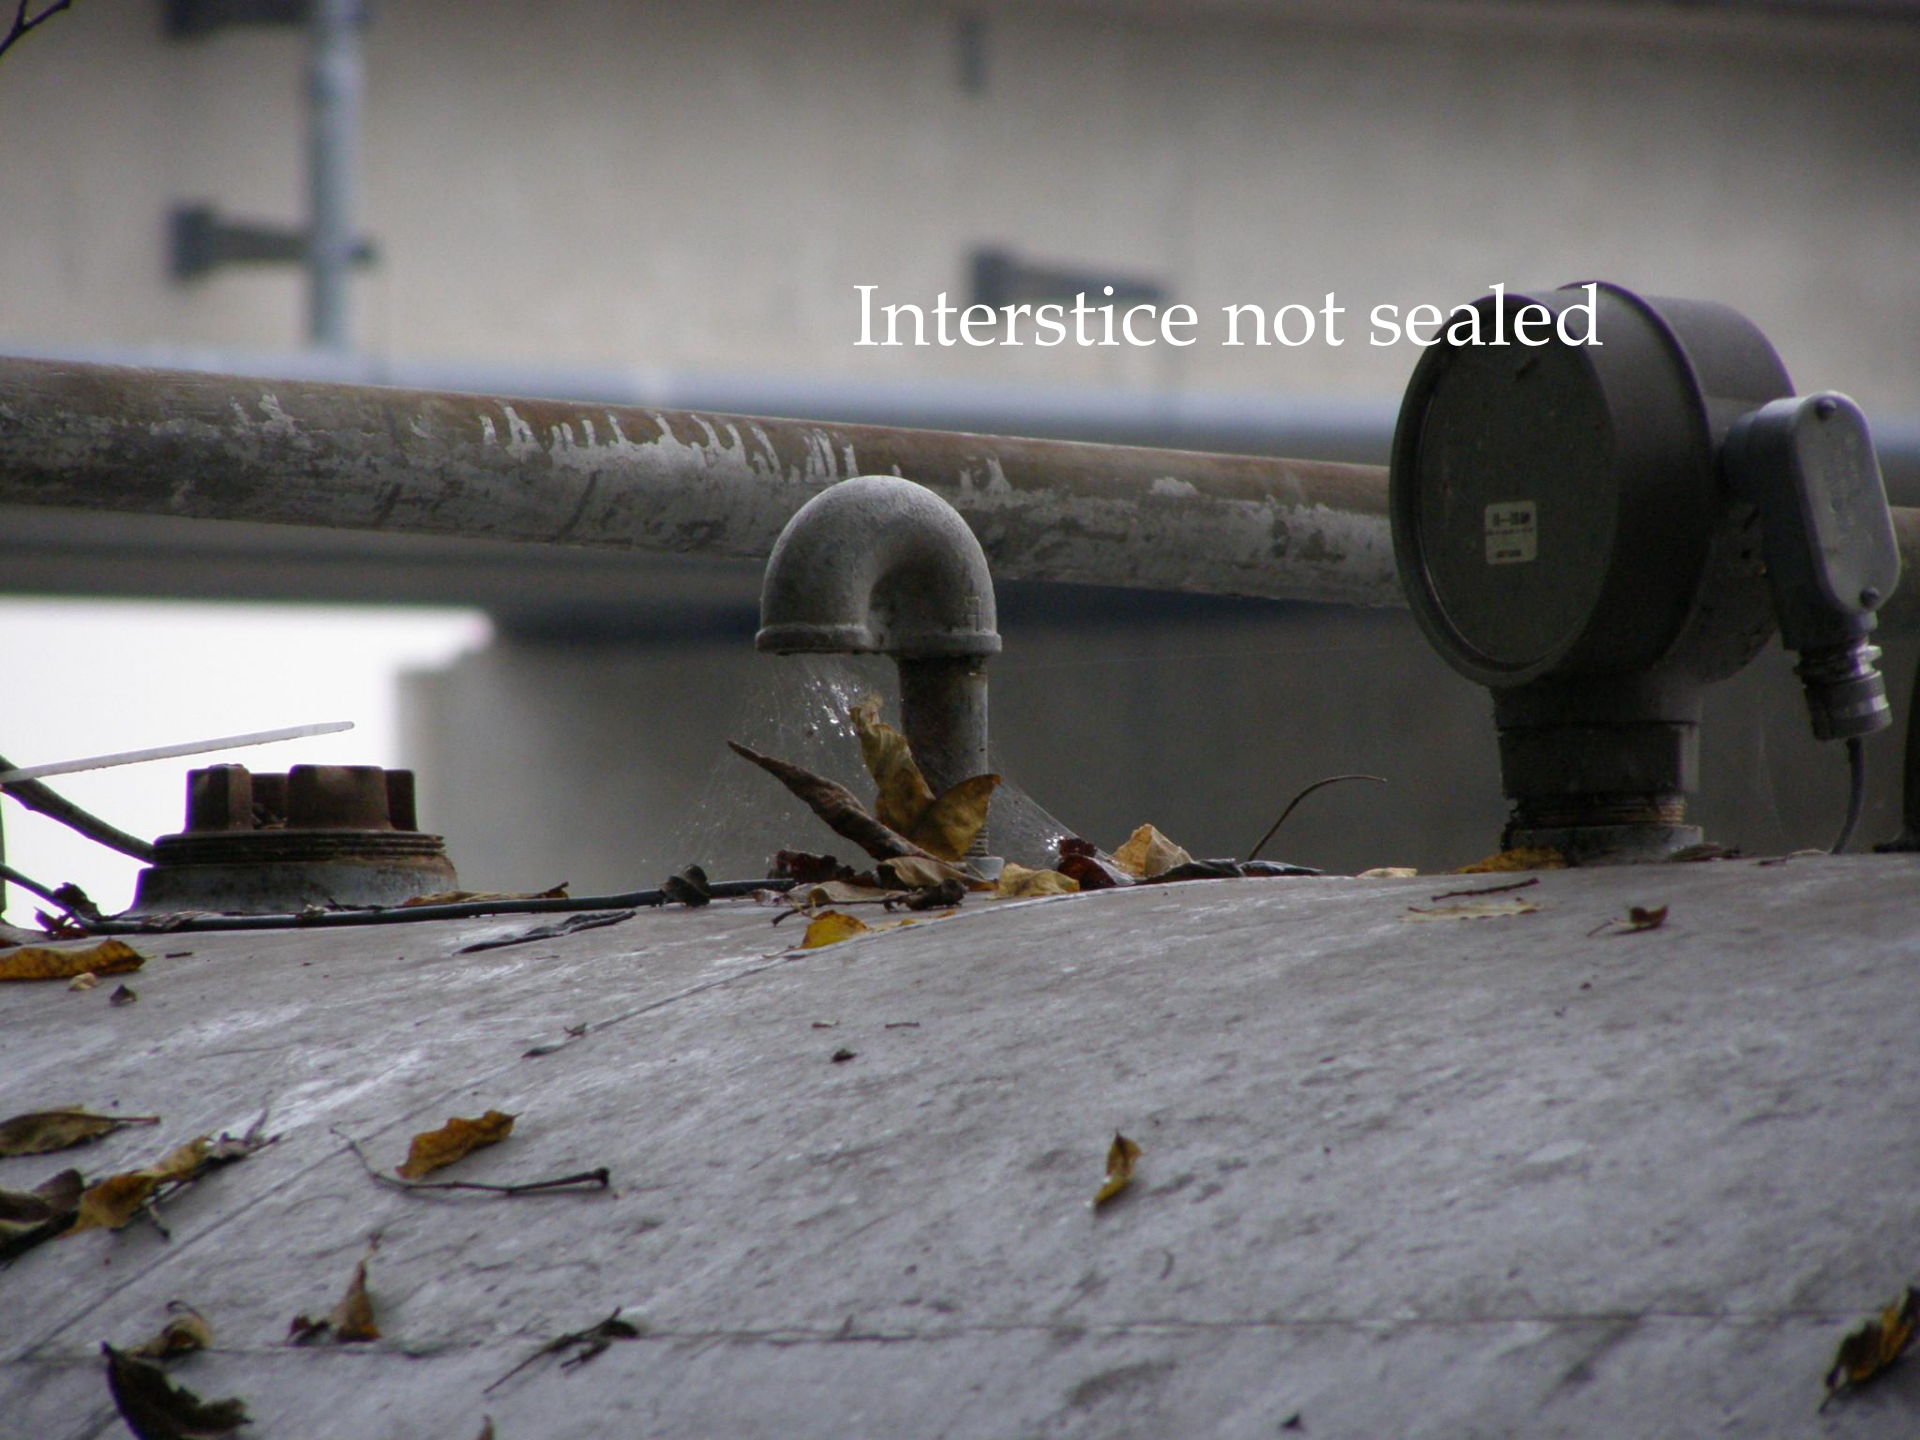
Missing interstitial plug!

Interstice not sealed

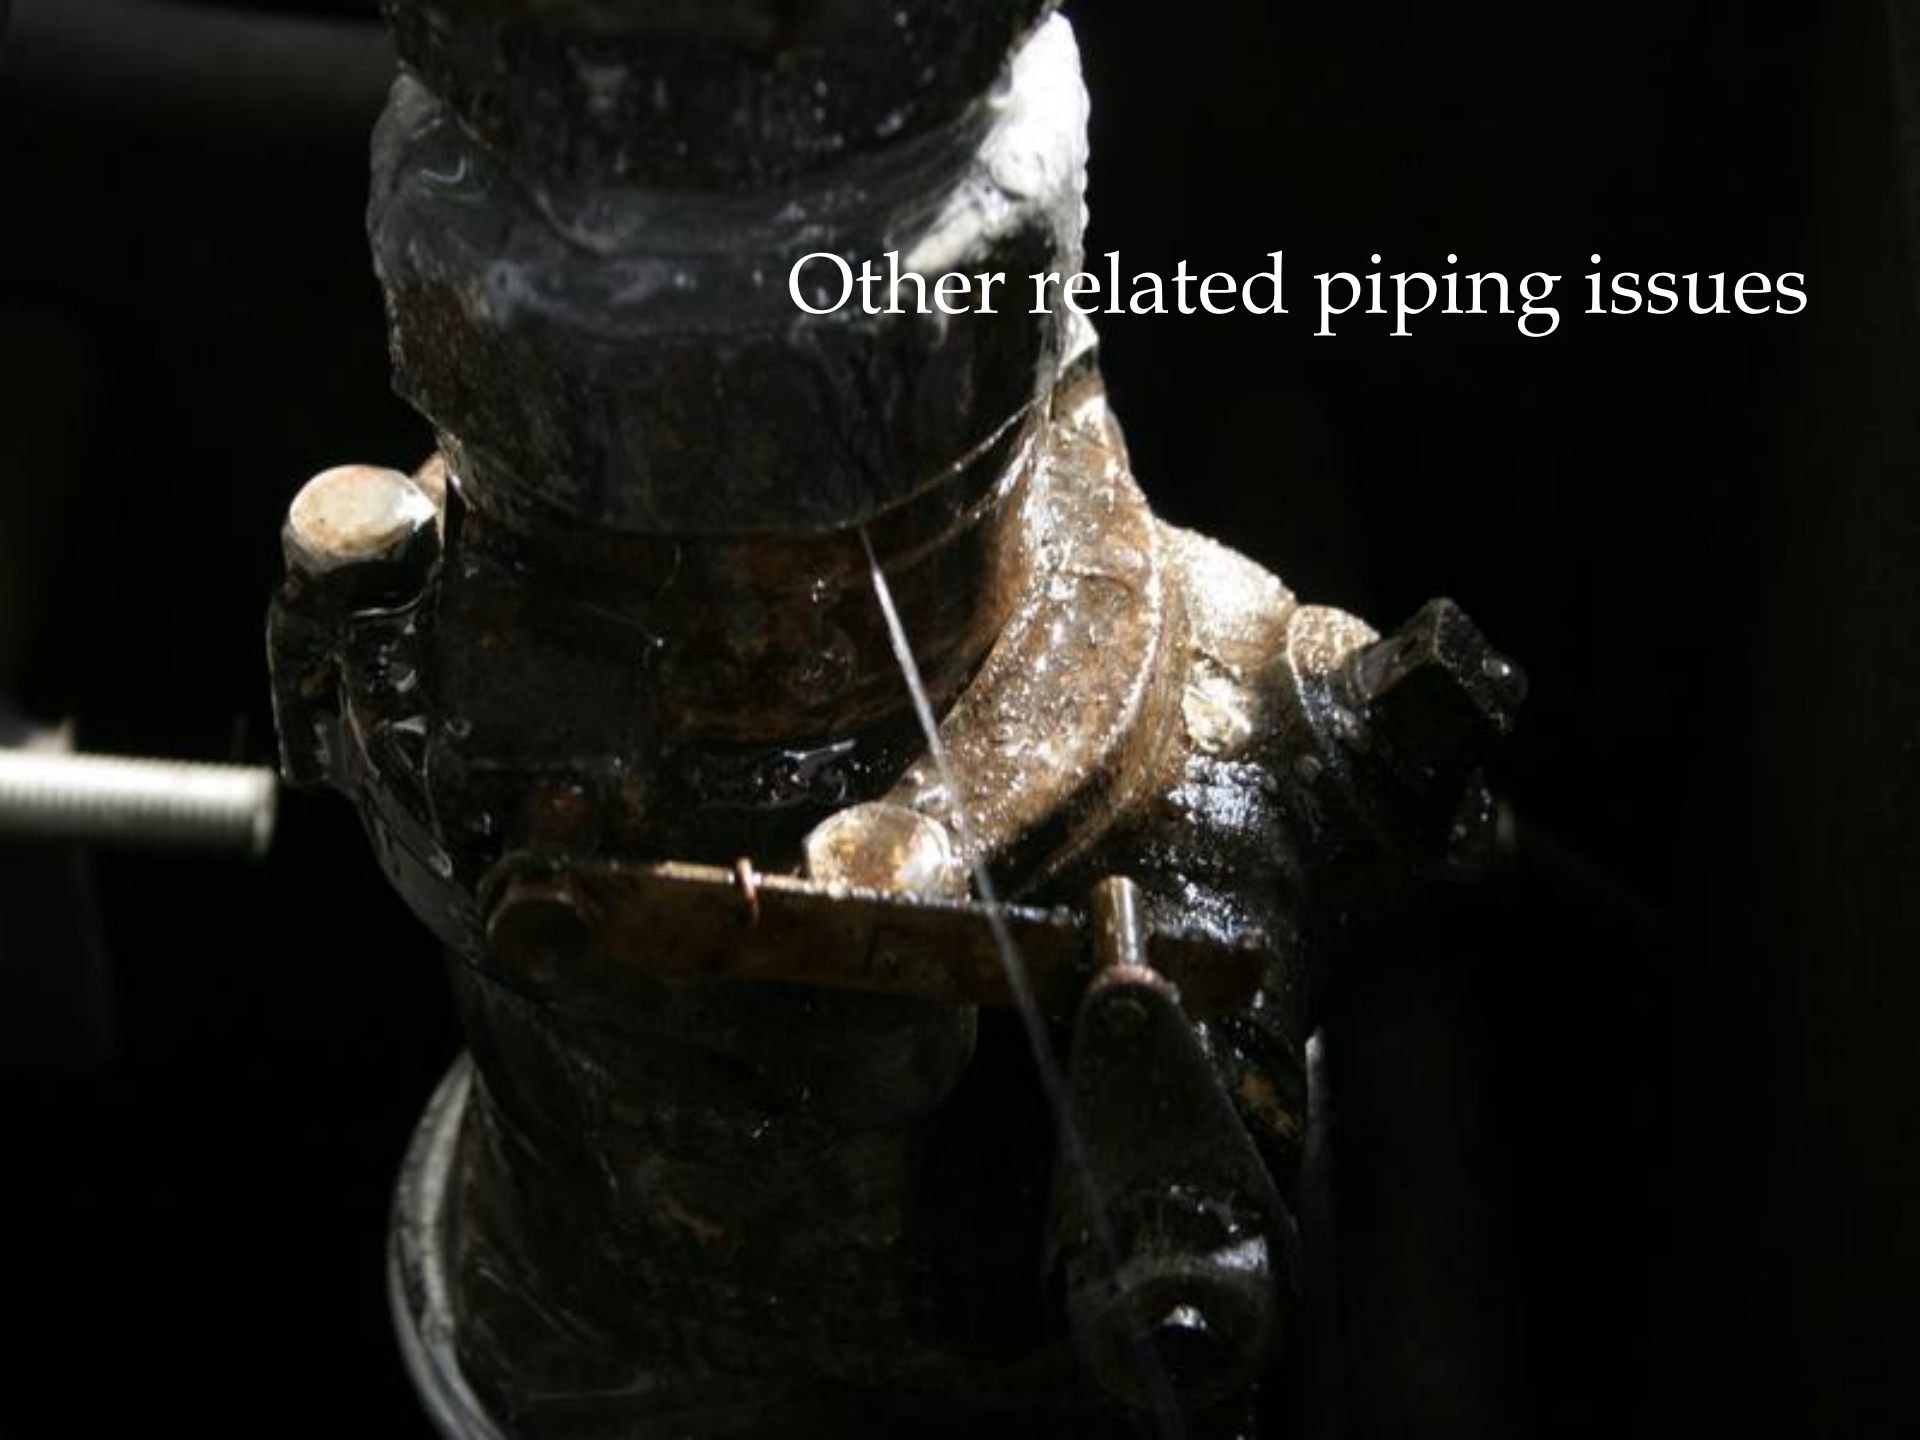
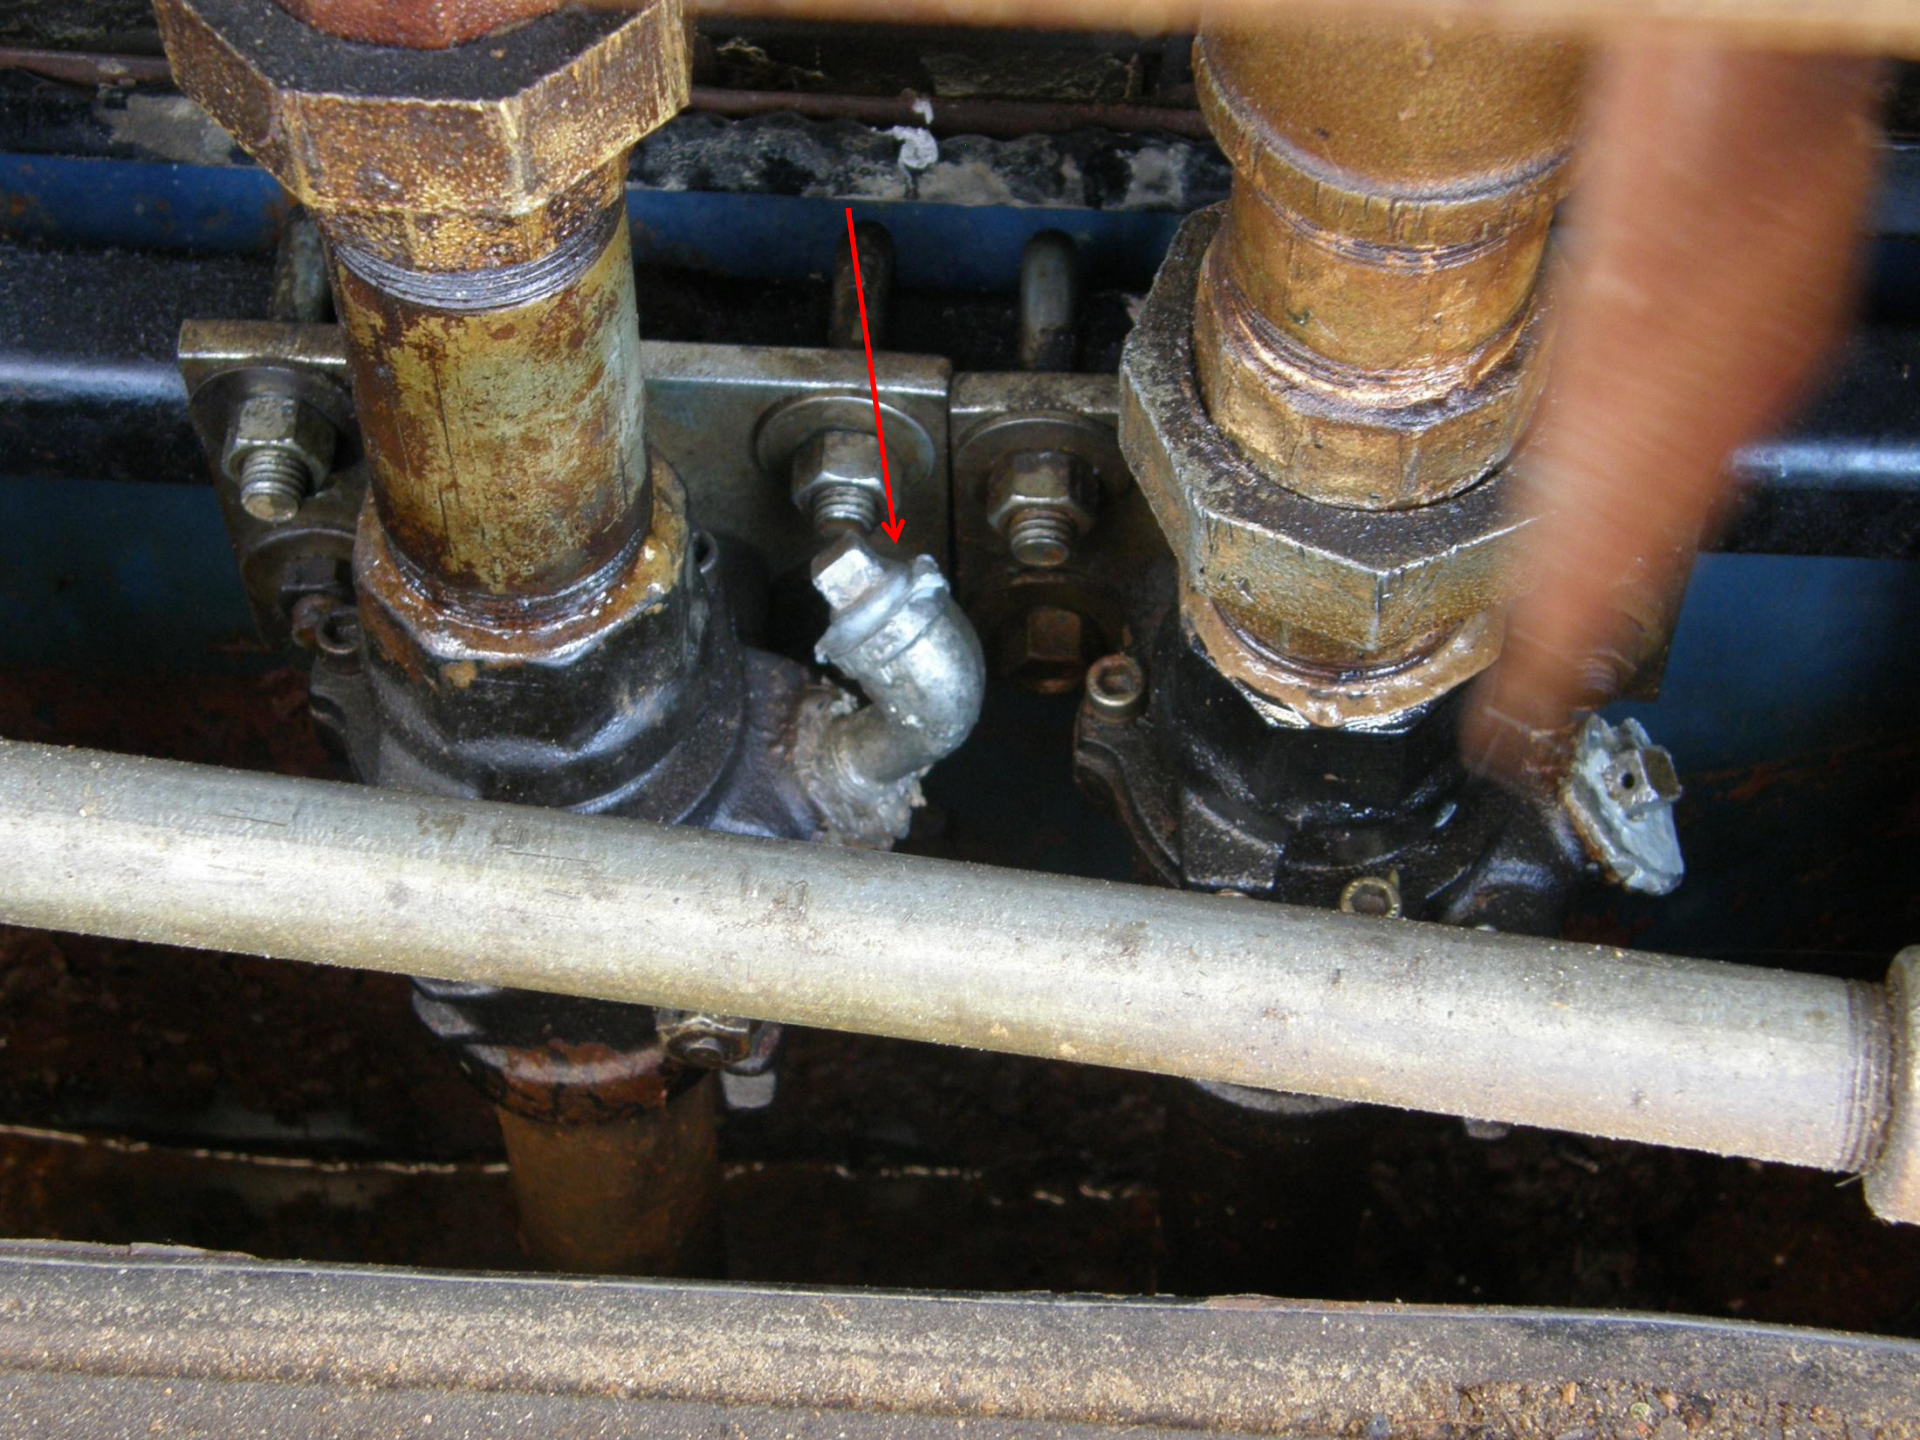
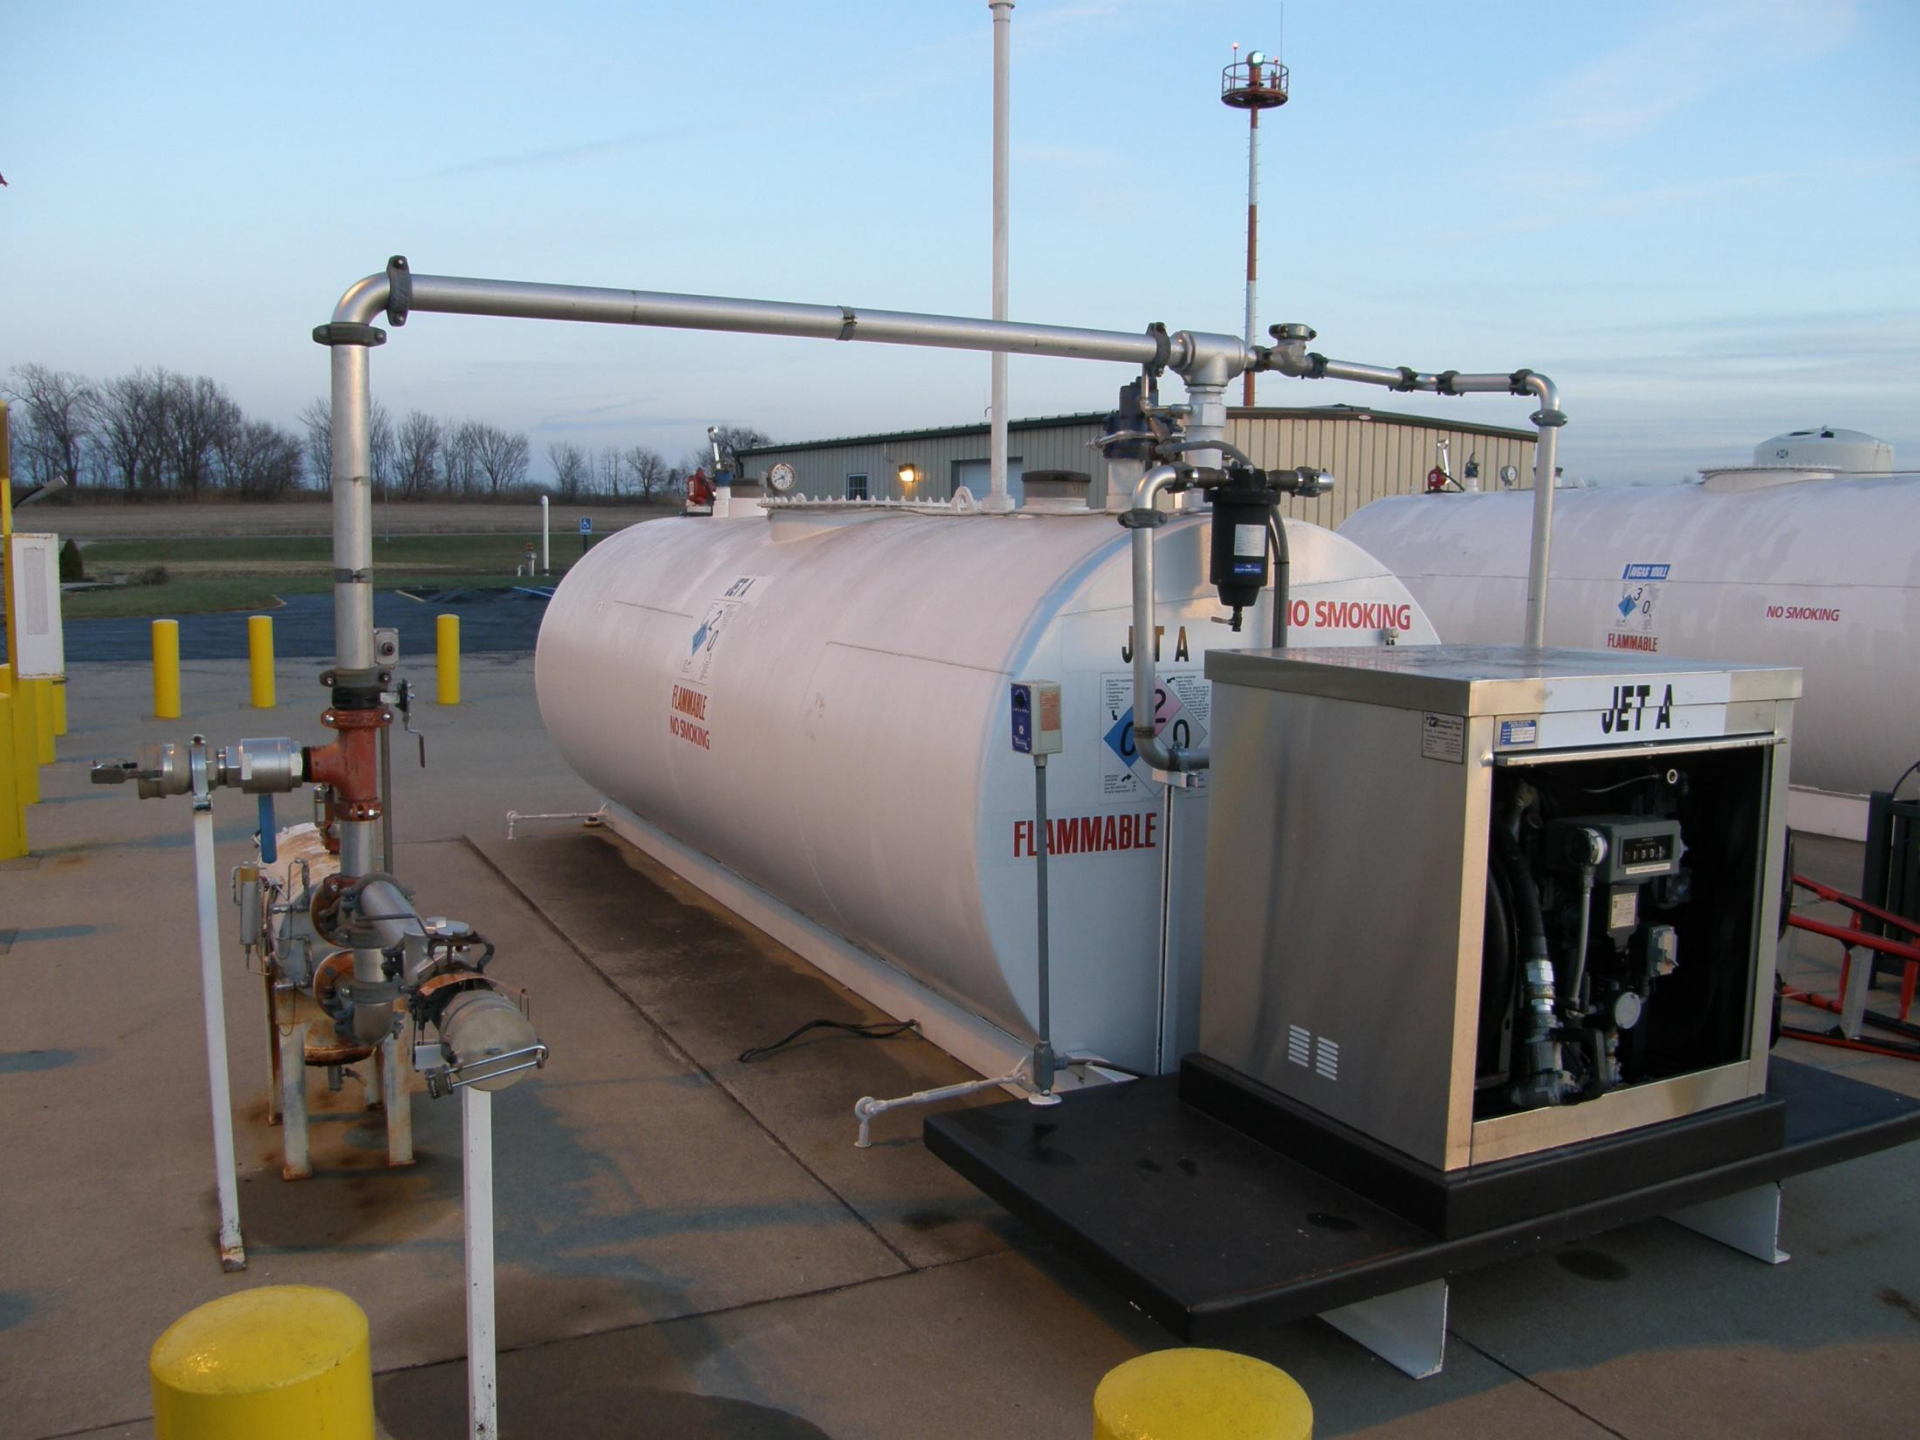
Other related piping issues
